# MIFACE INVESTIGATION #06MI193

## SUBJECT: Field Technician Dies When Struck By Geofoam Block

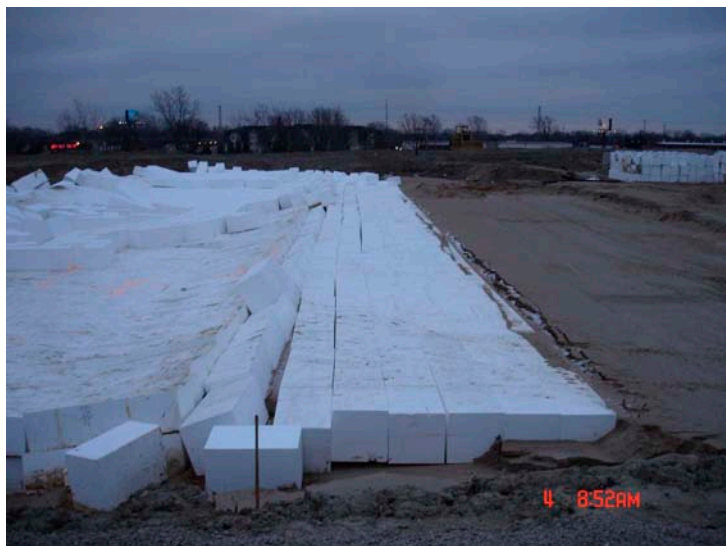
Figure 2. Ballasted edge of geofoam foundation

drains. Over this grid was a 4-inch layer of compacted sand. On top of this sand, geofoam blocks were placed in a series of tiers. Each tier of the blocks was laid 90-degrees to the one below it, creating an interlocking pattern. Once the tiers reached a height of 16 feet, then more sand was placed and compacted. Actual building construction would then be done on this large mat of geofoam. One section of the geofoam foundation had been completed and six inches of soil had been placed on the top of the blocks (Figure 2).

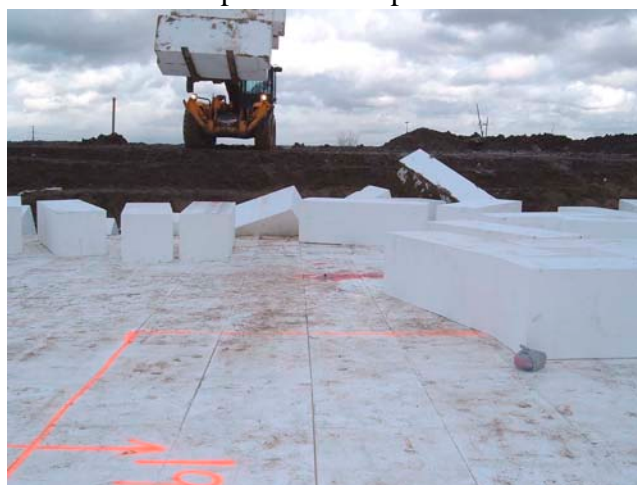
Figure 3. Incident site looking North

from the west/northwest towards the northeast. A pair of rough terrain forklift trucks was used to transport stacks of blocks from the northeast side of the excavation to a parking lot storage area (Figure 3).

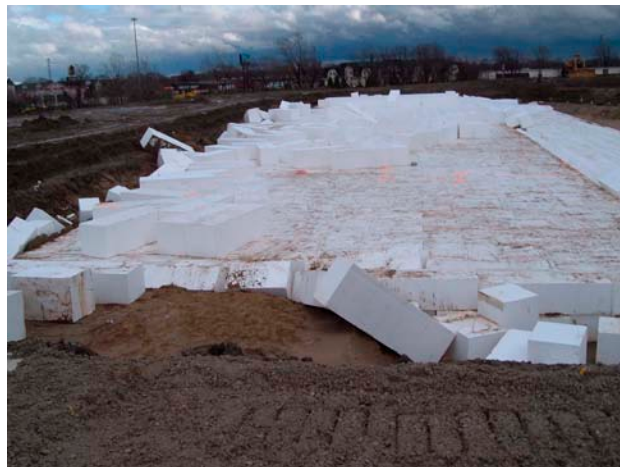
At least six Company A employees reported getting hit by the flying/tumbling blocks of foam (Figure 4). Some lost consciousness for a short while. No one saw the decedent being struck in the face and upper chest by one of the blocks. Company A employees found him lying on the foam pad bleeding from his nose. A Company A employee noticed that the decedent was having trouble breathing and rolled him on to his back and then onto his side to keep the air passage clear. The employees called 911 and began First Aid/CPR. Emergency response arrived and transported him to a local hospital where he was declared dead.

Figure 4. Incident site looking East
