Temporary Laborer was Fatally Injured when Caught between an Idler Pulley and Conveyor Belt at a Recycling Facility - Massachusetts

Investigation: # 05-MA-018-01

Release Date: September 10, 2007

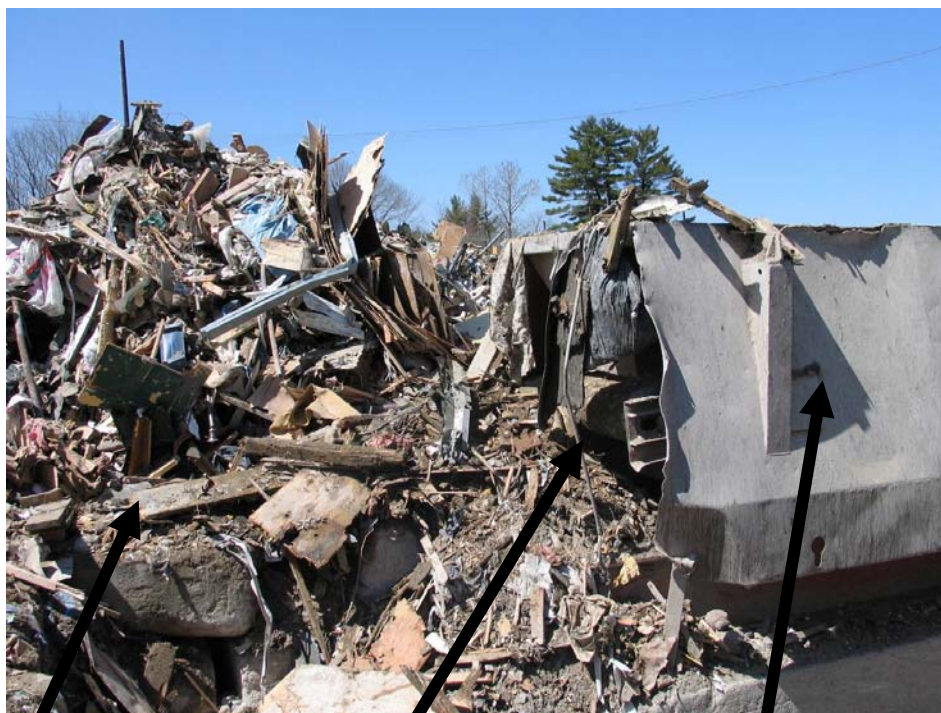
Figure 2 – Debris pile, system's conveyor belt and hopper, and incident location

**Conveyor belt and
location of incident.**

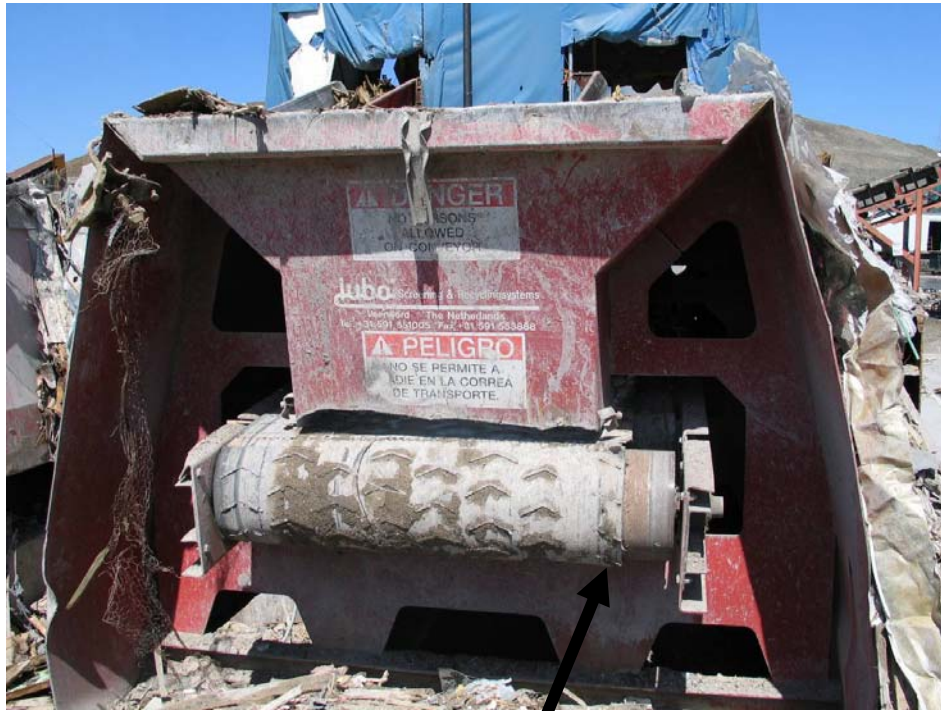
Figure 5 – Location of incident and conveyor belt

The victim and his brother were assigned to the maintenance task of realigning the conveyor belt (Figure 5). At the time of the incident, approximately 8:00 a.m., the victim and his brother had already made one adjustment to the conveyor belt with the conveyor turned off. The victim's brother then went to the screening/recycling system's control area to turn on the conveyor so they could observe the belt's motion. After this first adjustment the belt was still not perfectly aligned, and the victim's brother went back to the screening/recycling system's control area to turn the machine back off while the victim stayed by the conveyor belt (Figures 2 and 5). After turning off the machine, the brother returned to the conveyor belt and found the victim caught in the in-running nip point between the conveyor belt and an idler pulley. Nearby coworkers attempted to free the victim by cutting the conveyor belt, but they were unsuccessful.

In this case, the hazard that existed on the screening/recycling system was an unguarded in-running nip point created as the moving conveyor belt passed over the idler pulley. Although this unguarded section of the screening/recycling system's conveyor was located partially underneath the machine, it was still an accessible and exposed moving machine part and should have been guarded either with a point of operation guard or a barrier guard. When considering altering a piece of equipment, including adding a guard, employers should consult the manufacturer of the equipment and an engineer prior to the alteration.

Location where victim became caught.

Recommendation #1: Employers should ensure that all exposed and accessible sections of conveyors are guarded.

Recommendation #7: Manufacturers of equipment that have conveyors should ensure that all moving sections of conveyors are guarded.
