Airport Ramp Worker Dies after Being Struck by a Deicing Truck - Massachusetts

Investigation: # 04-MA-043

Release Date: January 17, 2007

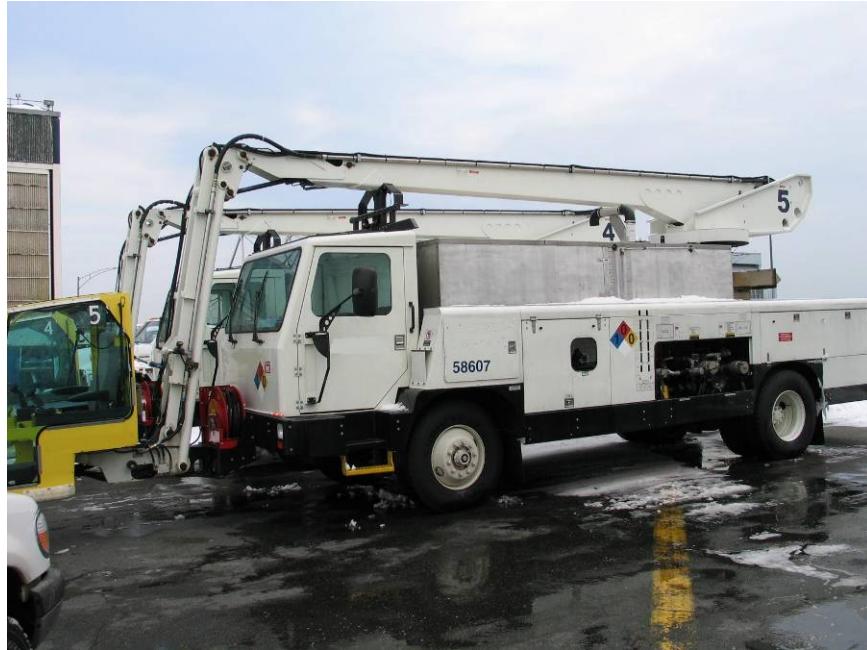
The deicing truck involved in the incident was manufactured in 2002 (Figure 1). The truck is equipped with an enclosed bucket attached to a hydraulic articulated boom. The bucket's measurements are 42 inches wide and 44 inches deep. The truck's windshield measures 62 inches wide. When the deicing truck is being driven, and is not in the deicing operation mode, the bucket is located in front of the truck's windshield. This is the "holstered" position (Figure 2). This design obstructs the truck operator's view when looking through the windshield (Figure 3). When the truck is in deicing operation mode, the bucket is "unholstered". The truck is equipped with a governor which limits its maximum driving speed. The truck's maximum speed while the bucket is holstered, as in this incident, is 25 miles per hour (MPH) and the truck's maximum speed when the bucket is unholstered is 4 MPH.

Figure 1 –Deicing truck similar to one involved in the incident

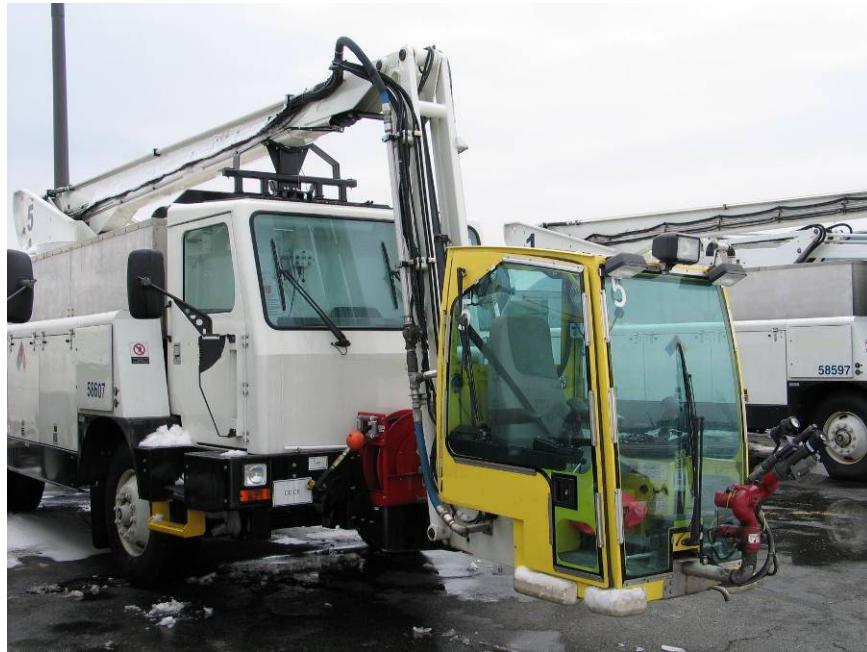
rear wheels. It appears that the co-worker driving the deicing truck never saw the victim because his view through the truck's windshield was obstructed by the deicing truck's bucket in the holstered position. Also, it appears that the victim did not hear or see the deicing truck because he was wearing hearing protection and had the sweatshirt's hood up, which might have blocked his peripheral vision.

Figure 2 – Deicing bucket in the holstered position

Recommendation #6: Employers using deicing vehicles where operators have obstructed views while driving should require a second employee to assist the vehicle operator during driving of the vehicle.

Discussion: During the site visit it was reported by the airline that since the incident, the company is requiring that a second worker ride inside the deicing vehicle's cab with the driver when the bucket is in the holstered position (non-deicing operation) and being driven. The

second worker's task is to assist the driver in seeing obstacles while driving the deicing vehicle, such as workers on foot, equipment, vehicles, and aircraft.

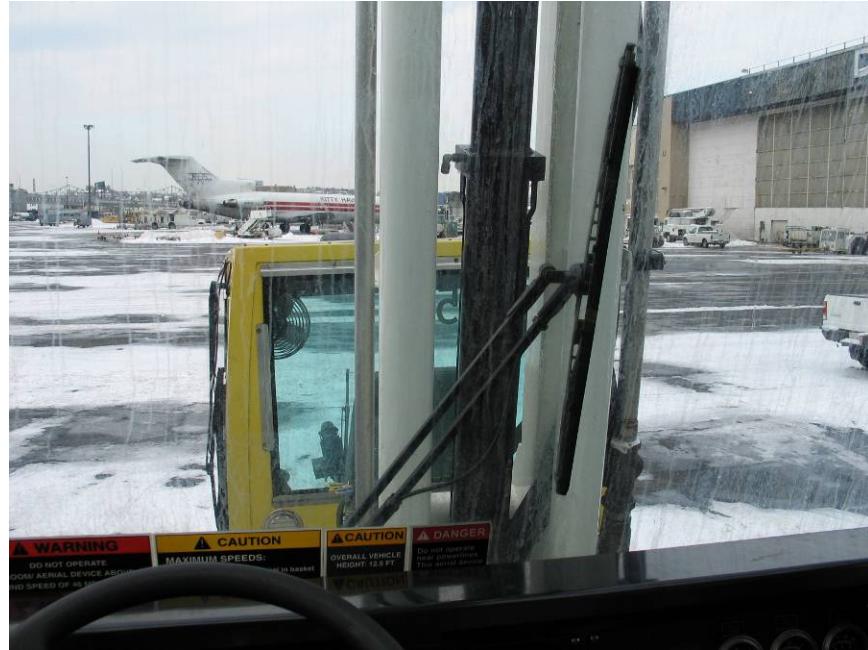
Discussion: In this case, the operator's view when looking through the vehicle's windshield on which the equipment was mounted was obstructed when the bucket was in the holstered position. The obstructed windshield prohibits the vehicle from being operated legally on Massachusetts public roadways. Manufacturers of airplane deicing equipment should develop designs that conform to visibility requirements for public roadway use.

Figure 3a – View through the windshield from inside the cab of the deicing truck

Recommendation #8: Manufacturers of aircraft deicing equipment and vehicles should design equipment such that the operator's view is not obstructed while driving.

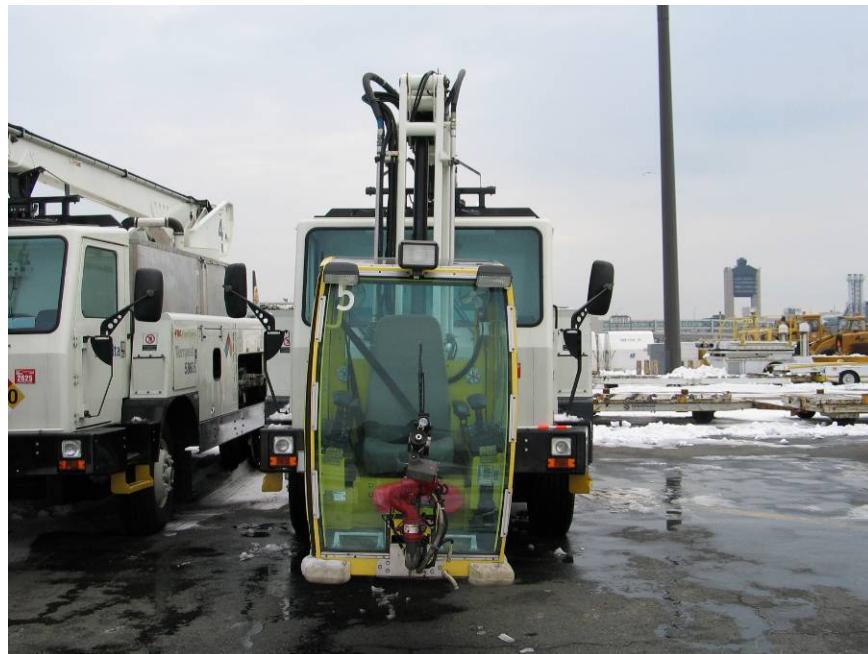
Figure 3b – View looking at the deicing bucket head-on

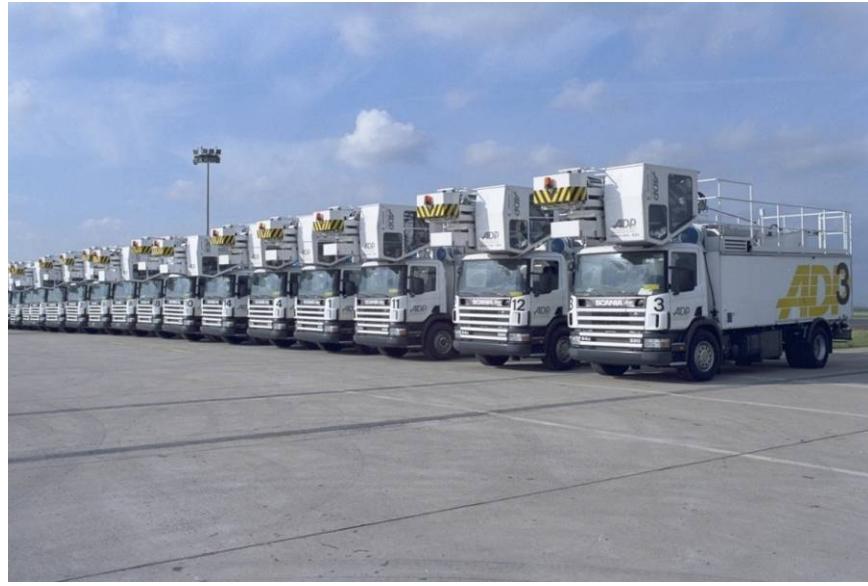
Figure 4 – Example of deicing trucks designed so the bucket is not obstructing the operator's view while driving

Recommendation #1: Employers should purchase and use deicing equipment that does not obstruct the view of the vehicle operator while driving.

Discussion: When deciding what equipment to purchase, employers should research and compare available equipment and take into consideration the health and safety of the employees that will operate and work near the equipment. Deicing equipment designed not to obstruct the

view of the operator is available (Figure 4) and should be considered as the top choice when purchasing equipment for deicing operations.
