Worker Killed when Caught Inside a Palletizer Hoist Area - Massachusetts

Investigation: # 04-MA-006-01

Release Date: August 28, 2007

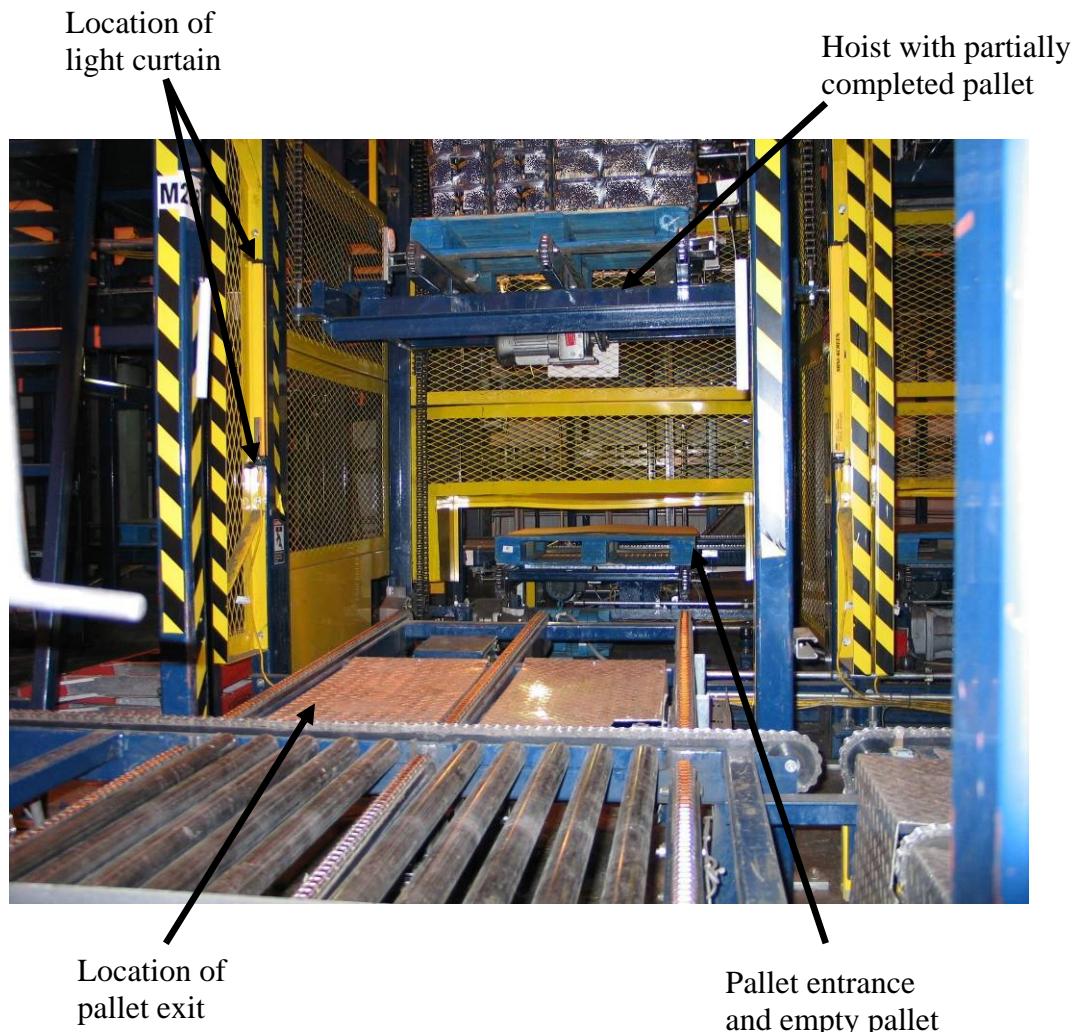
Once the ice cream containers reach the palletizer, via the conveyor, they are ejected off of the conveyor and on to a slide plate located on the top section of the palletizer. The palletizer's hoist raises a pallet to the bottom of the slide plate once the slide plate has a complete layer of ice cream containers. The slide plate then retracts, causing the layer of ice cream containers to drop a few inches onto the pallet below. At this point, the slide plate returns to the start position and the pallet's height is adjusted to prepare for the next layer of ice cream containers. Electronic eyes located under the slide plate determine the height at which the palletizer's hoist should stop to accept the next layer of product onto the pallet. This container stacking process continues until 14 layers of half-gallon containers are placed onto a pallet, at which point the pallet is considered complete (Figure 2). The complete pallet is lowered and ejected out of the palletizer through a presence sensing device (light curtain) onto a second conveyor. The completed pallet is transported by this conveyor to a plastic wrap machine where the pallet and the 14 layers of half-gallon ice cream containers are wrapped in plastic. The cycle starts over when an empty pallet moves into the hoist area via a third conveyor (Figure 1).

The palletizer's hoist area has four sides and three of these four sides are guarded by a fixed cage. The fourth side, the location where completed pallets exit the machine, is guarded by a light curtain (Figure 1). The hoist area's pallet entrance is located across from the pallet exit where empty pallets automatically enter the hoist area by passing under the section of the fixed cage.

Figure 1 – Palletizer with a partially complete pallet raised inside the hoist area

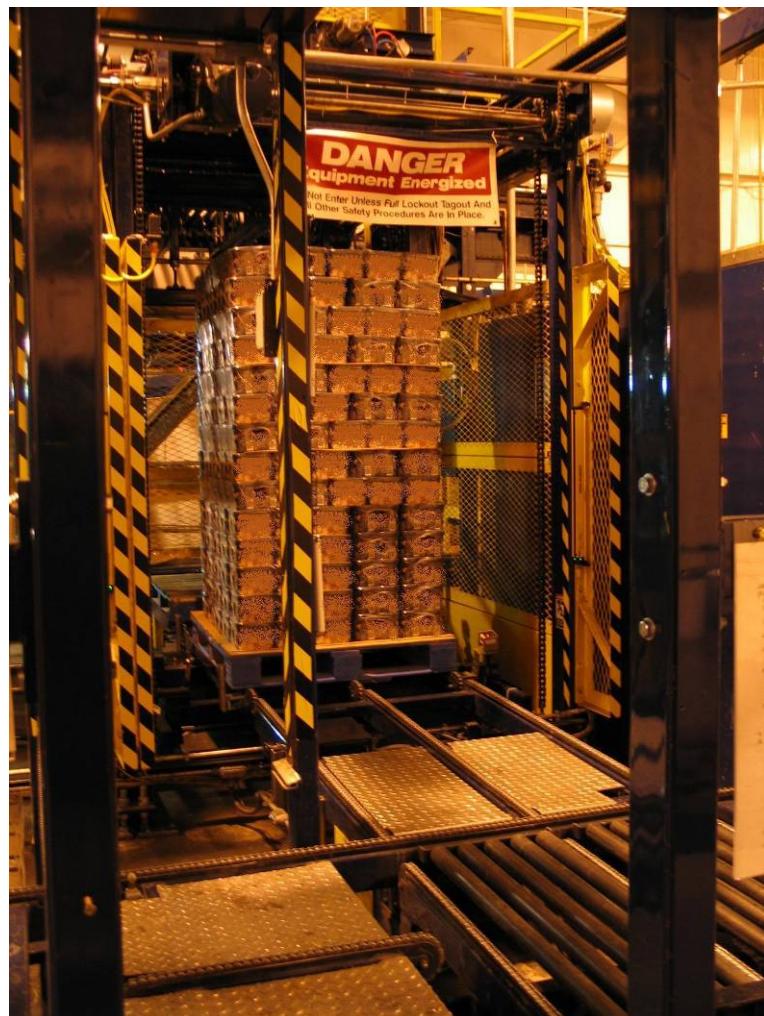
Figure 2 – Palletizer with a complete pallet getting ready to exit the hoist area
