# MIFACE INVESTIGATION #06MI209

## **SUBJECT: Heavy Equipment Operator Dies After Being Pinned Between the Boom and Cab of an Excavator**

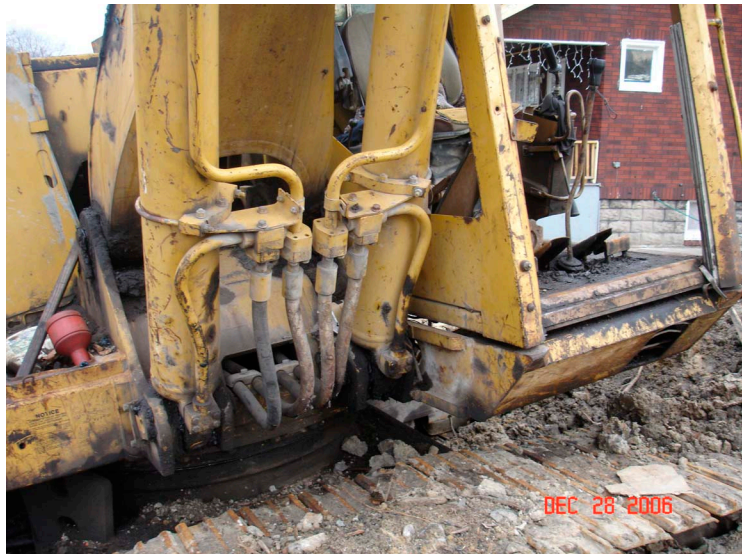
Figure 1. Position of excavator boom and cab at time of incident

Model 225 DLC excavator. The excavator cab was positioned perpendicular to the tracks of the excavator with the boom in an upright position (Figure 1). The cab window adjacent to the excavator boom was broken. The decedent jumped onto the excavator tracks under the raised boom and leaned through the cab window. His torso/arm contacted the excavator boom joystick-type control lever and the boom lowered pinning the decedent between the boom and the cab frame. Emergency response was called and arrived and transported the decedent to a local hospital where he was declared dead.

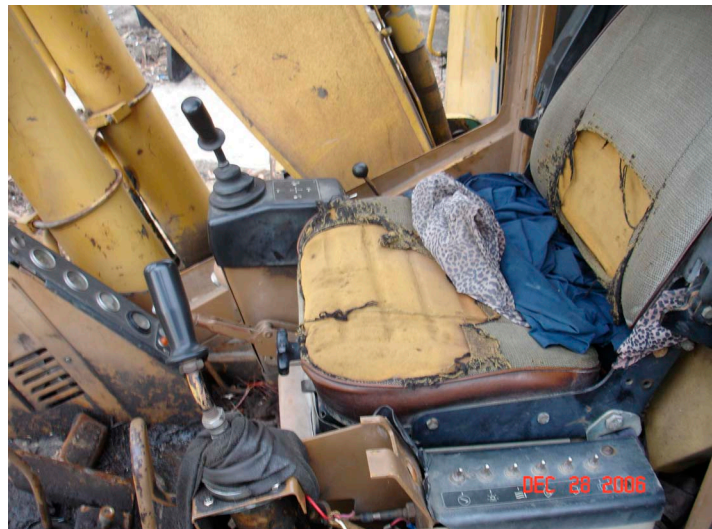
The site contractor had purchased the Caterpillar 225 DLC excavator involved in the incident in new condition in 1989. Figure 2 illustrates the condition of the excavator at the time of the incident. According to the site contractor, the excavator's maintenance schedule was determined by the number of days of service.

Figure 2. Cab condition and location of controls

- Equipment owners should ensure machines are red-tagged and taken out of service immediately when safety features are compromised or the machine is in poor condition.

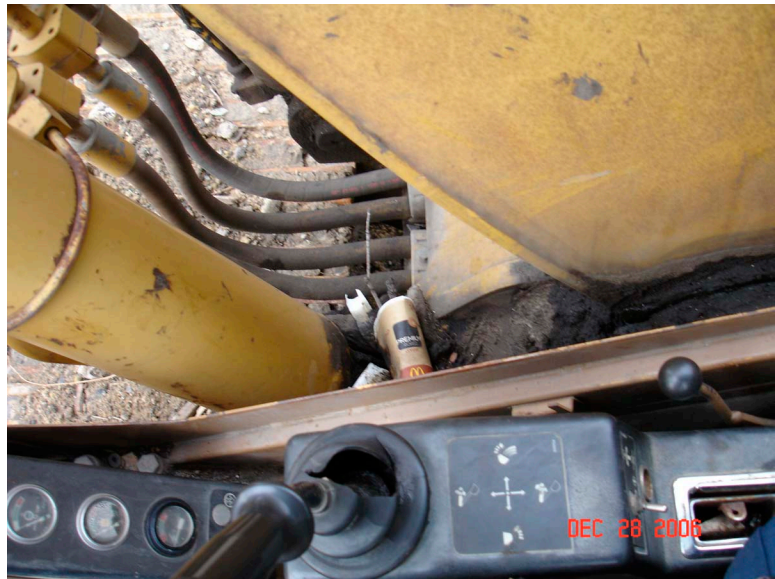
Figure 3. Position of excavator boom, boom control lever, and cab window area

unknown, the decedent "fell" into the cab (perhaps a slip on a dirty or muddy track) and his arm pressed the right lever, resulting in pulling the lever forward and causing the boom to come down, pinning him (Figure 3). The hydraulic cylinders and the boom pushed and twisted the decedent in between the cab and the boom. The excavator operator, after several attempts, was

- Employers should ensure that excavator operators have been trained on the use of the equipment. This training should include safety training in the importance of lowering the boom to a safe position with the bucket on the ground before permitting any site worker (including subcontractors) on foot to approach the machine.

The experience level of the excavator operator was unknown. Excavator operators should receive training that includes the equipment manufacturers' recommendations for safe equipment operation, including the requirement to lower the boom placing the bucket on the ground before permitting workers on foot to approach the cab and/or the machine.

- Employers should instruct and ensure that any worker (including subcontractors) on foot approach the excavator only after they signal the operator to lower the bucket, the bucket is lowered to the ground, and the machine turned off.

There are many safe work practices associated with excavators, for both the excavator operator and workers on foot working near the excavator. One of the safety practices that should be emphasized for any worker on foot is that they should approach the excavator only after they signal the operator to lower the bucket and the bucket is lowered and the machine turned off. Though the decedent was an experienced excavator operator, it is possible that his knowledge of the hazards associated with being a worker on foot near an excavator was not adequate. Workers, including subcontractors, who operate or work near hydraulic excavators and backhoe loaders are at risk of being struck by the machine or its components. Although workers may be experienced in their trade, periodic re-training and updates on new procedures and equipment are necessary. Employers should instruct and reinforce the importance of safe work procedures and the expectation that they would be followed is an important element the prevention of injuries.

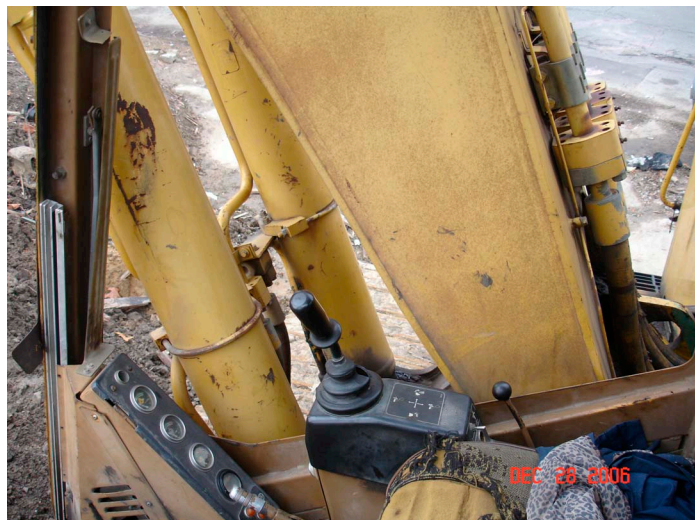
Figure 4. No glass in window of cab

Employers should ensure that the materials in windows (e.g., glass, plexiglass, etc) of heavy machinery are intact to prevent inadvertent contact with machinery controls. The excavator at the incident site did not have an intact window material (glass) adjacent to the boom, which allowed the decedent enter into the cab and contact the machinery controls while standing on the tracks. Although some equipment manufacturers provide the option to remove some of the cab's front glass to provide a better sight line, or the driver's side door glass to assist in ventilating the cab, the cab glass or other window material next to the boom is usually permanent and should not be removed by the operator. When the side window material is not intact or deemed unsafe, employers should red-tag the machine, remove it from service and replace the material (Figure 4).
