SUBJECT: An Electrician Was Electrocuted While Repairing a Lighting Circuit

SUMMARY
California FACE Report #06CA007

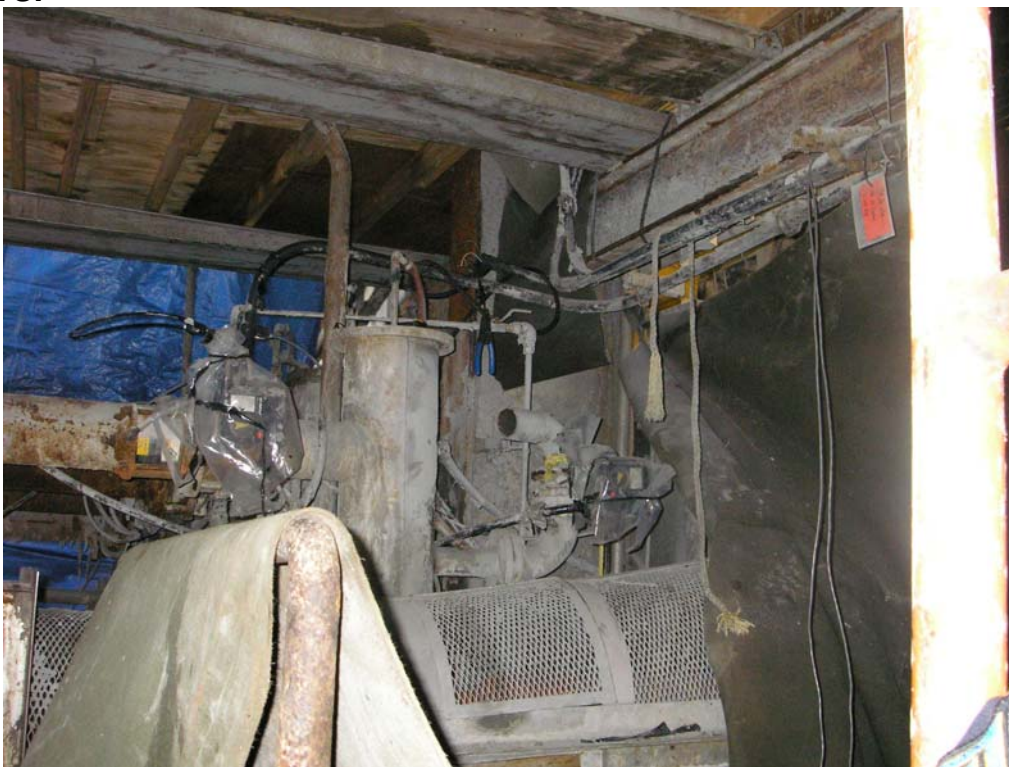
The site of the incident was a large industrial factory that made newsprint out of recycled paper. The incident took place on the second floor of the mill building. The factory was undergoing renovation with replacement and repair of the steel beams in the walls, floors, and ceilings of the mill building's third floor. The incident occurred at ceiling level on the second floor of the mill building.

Exhibit 1. A picture of the area where the victim was working.

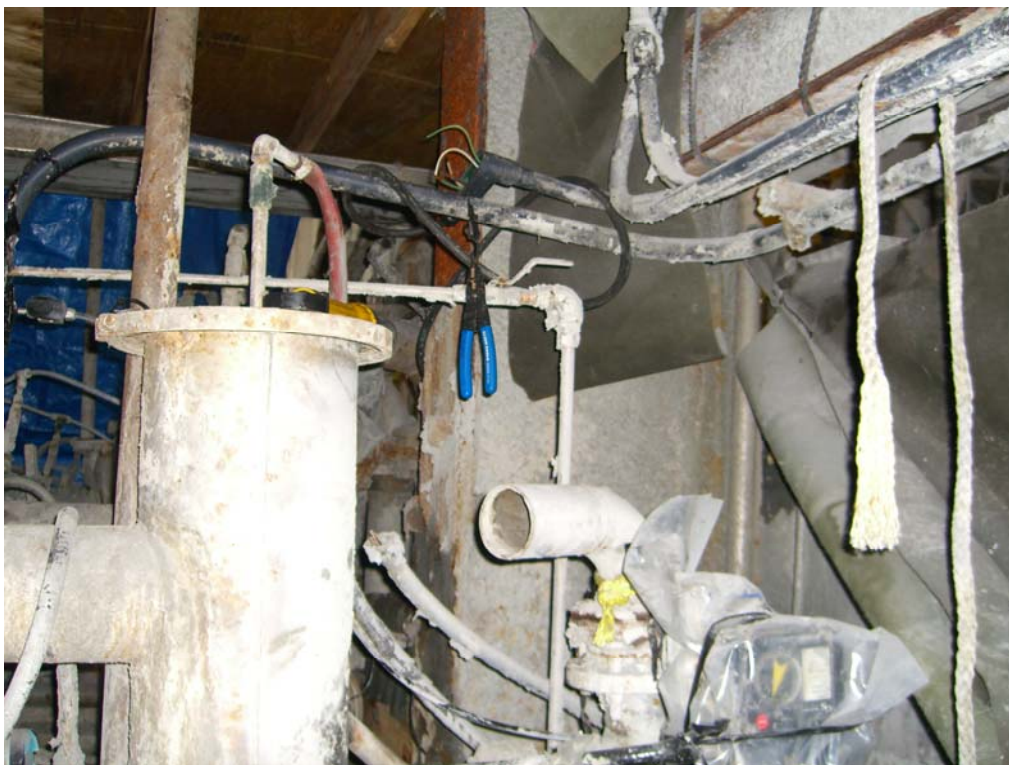
After the victim was removed from the incident scene by the paramedics, the victim's employer and local police did a preliminary investigation. They found the victim's pliers that were used for stripping electrical wire, still attached to a wire from the damaged circuit at ceiling level. Closer inspection showed that there were burn marks on the pliers and a pipe, indicating that contact was made at these points. The physical evidence indicated that the victim climbed up on the contractor's scaffold and then climbed onto a piece of machinery to gain access to the damaged lighting circuit. While the victim was working on the energized circuit, his pliers made contact with the pipe, completing a circuit, and he was electrocuted. It is not known how long he remained in contact with the energized system. It appears that when the electrical breakers finally tripped, cutting off the electrical current to the circuit, the victim fell off the machinery

and landed on the scaffolding planks just below him, where he was found by his supervisor. An inspection was conducted of the junction box where the circuit breakers were housed and it was determined that the circuit had not been manually turned off or locked out and tagged prior to the start of work. The circuit had been tripped when the victim made contact with the energized line. The victim's circuit tester, which is intended to be used to verify that a circuit has been de-energized before work, was found in his locker after the incident.

Exhibit 2. A picture of the victim's pliers attached to a wire.

Recommendation #1: Ensure that workers follow established lockout/tagout procedures for control of hazardous energy when working on electrical circuits.

Although the employer in this case had a lock out/tag out program, it was not being used when the victim was working on the energized lighting circuit that was damaged by a contractor. Had the victim followed the company's policy and procedures, this incident might have been prevented. Employers can enhance worker compliance with safe work practices through programs of task-specific training, supervision, recognition, and progressive disciplinary measures.
