**FROM:** Iowa FACE                   **Case No.** 2005IA042                   **Report Date:** 19 June 2007

**SUBJECT:** Handyman Plumber Asphyxiated in Entry into Water Service Manhole Vault

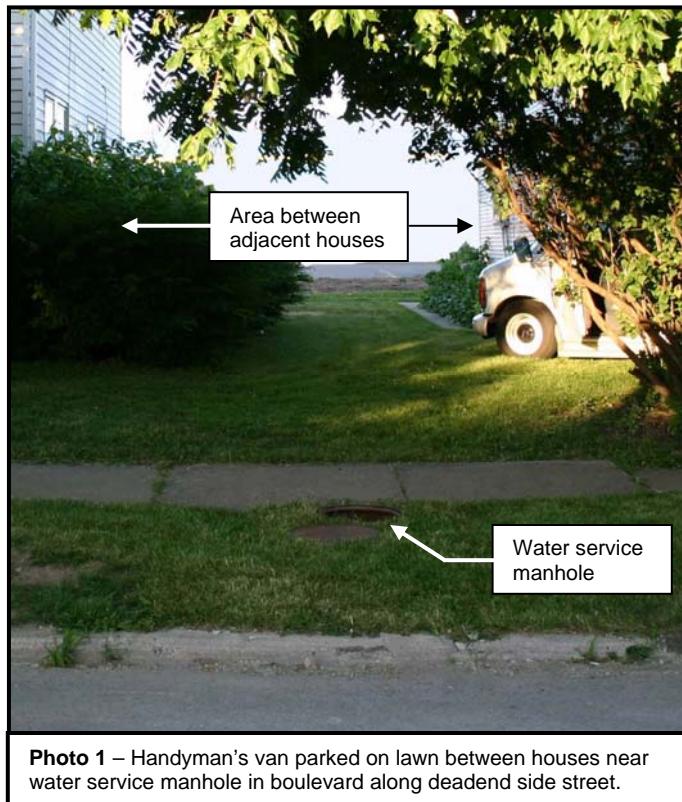
**Photo 1** – Handyman's van parked on lawn between houses near water service manhole in boulevard along deadend side street.

The manhole was located along a portion of a dead end side street, in the grass boulevard between the sidewalk and curb (Photo 1). The victim could not easily be seen where he was found. He was headfirst into the opened manhole with the full length of his body in the cylinder of the vault. The weight of his body forced his head to the side against the sandy bottom. Although a neck injury was initially considered a possibility, the autopsy revealed no such injury. His legs sagged limply against the sidewall of the cylinder with the bottoms of his feet just below the ground-level opening of the manhole.

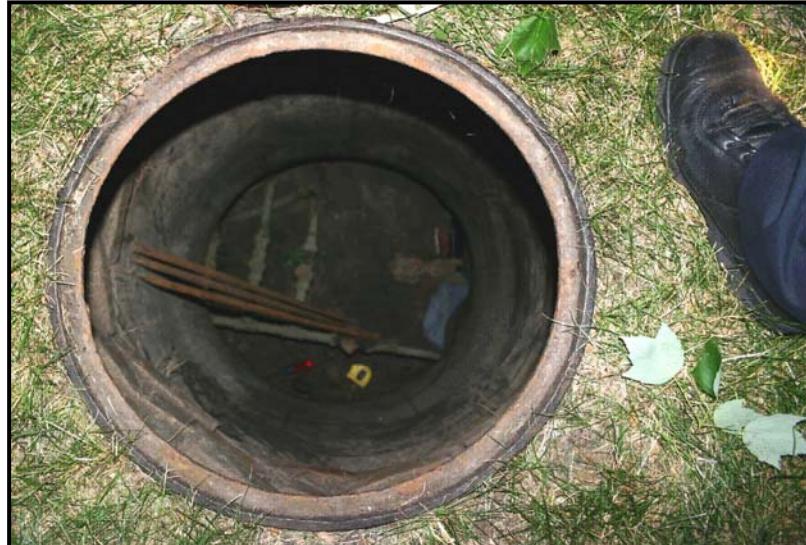
Approximately 175 mm (7 in) up from the sand floor, midway up in the flared-out bottom zone, a 25 mm (1 in) diameter water line ran horizontally, a little off of center, across the pit (Photo 2). Connected to this supply line were three water lines, one for each house served on that side of the street. Each water line had an inline shutoff valve. The private company supplying water for the city did not own nor did they lease this service manhole from the property owners. Hand tools (rods with tools attached to their ends) to operate the shutoff valves without entering the manhole were propped within reach against the side of the cylindrical shaft.

**Photo 2** – Shutoff valves at bottom of manhole vault controlled the supply of water to adjacent homes. Tools for operating them lean across the entry way.

The water valve to the residence experiencing the water leak had been turned off prior to the repair work. The victim completed the repair work and returned to the manhole, knelt next to its opening, leaned over and down into it blocking ambient light. It appears he was not using the hand tools stored in and propped against the side of the manhole to operate the valves. A flashlight, screwdriver, and the keys to the residences were found on the surface of the sand at the bottom of the pit.

Next, when the confined space cannot be eliminated, consideration should be given to enabling completion of the task from outside the confined space. Hand tools were provided to operate the water control valves in this incident without entering the manhole pit. The reason these tools were not used is unknown. Signage informing of the potential hazard, procedures to follow, and location of tools to be used should be considered for posting outside the closed manhole.
