MIFACE INVESTIGATION: #05MI123

SUBJECT: Truck Driver Dies When Straw Bales Fall Off Truck and Strike Him.

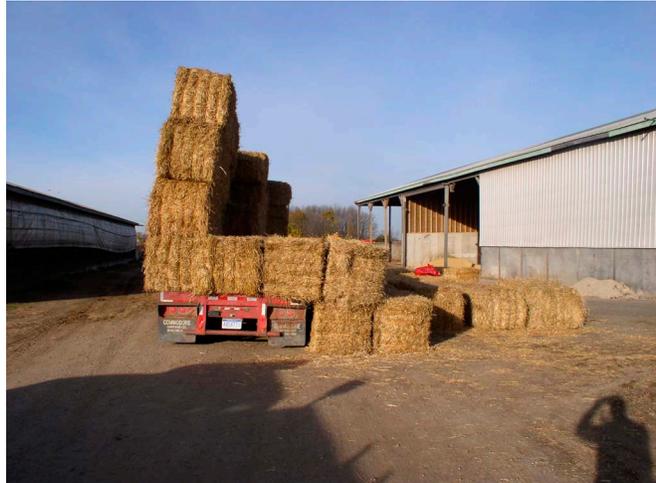
Figure 1. Trailer rear view, bales off trailer

Figures 1 and 3-6 show the bale stacks on the driver's side of the trailer still intact, although leaning toward the passenger side (in the direction of the bales that fell). Several scenarios to explain the load shift were developed:

Figures 1 and 6 show the bales on the driver's side of the trailer bed extend beyond the width of the trailer bed. Michigan Motor Vehicle Code, Section 257.717 allows agricultural commodities to be up to 108 inches wide but does not allow the outside width of the body of the vehicle hauling those commodities or the load on the vehicle to exceed 96 inches wide without a special permit issued by the jurisdictional authority. A jurisdictional authority means the state transportation department, a county road commission, or a local authority having jurisdiction of the highway the vehicle is traveling upon. Due to the friction coefficient of the bottom bale tier with the trailer bed, it is unlikely that the bales "slid" on the trailer bed.

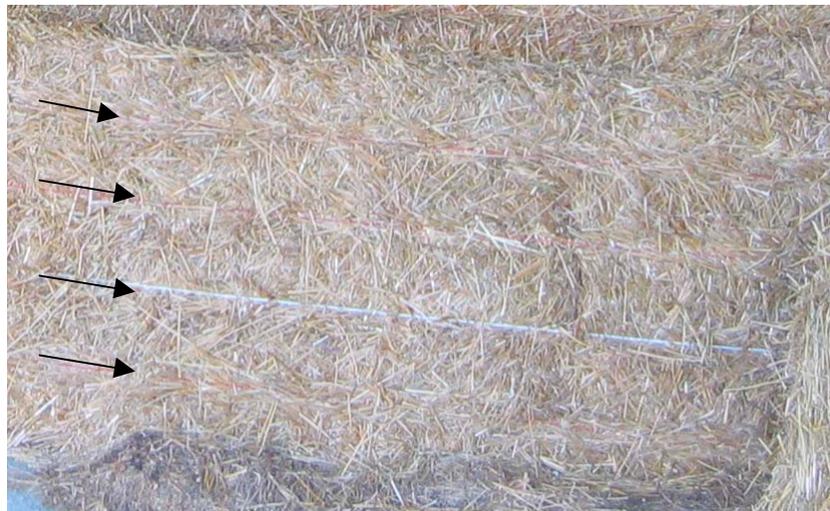
Each bale was tied with four nylon strings. Figure 2 is a picture of a similar bale while in storage. The arrows in Figure 2 highlight the four nylon strings used to maintain bale integrity. The 3- x 3- x 8-foot straw bales had been baled in August 2005 and weighed approximately 500-600 pounds. The bales were loaded with a front-end loader equipped with a bale spear and secured on the trailer the evening prior to the decedent hauling and delivering the load. The trailer with the secured load was kept outside.

Figure 2. Nylon strings indicated by arrows around the hay bale

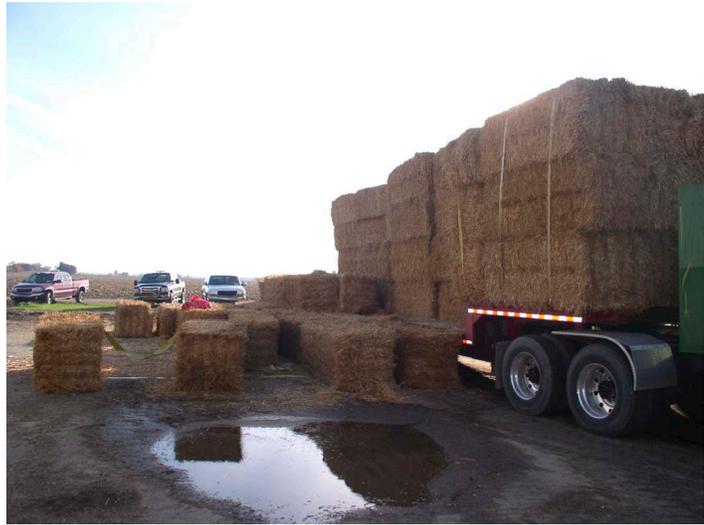
Figure 3. Double-strapped bales on gooseneck, bales that fell from trailer deck

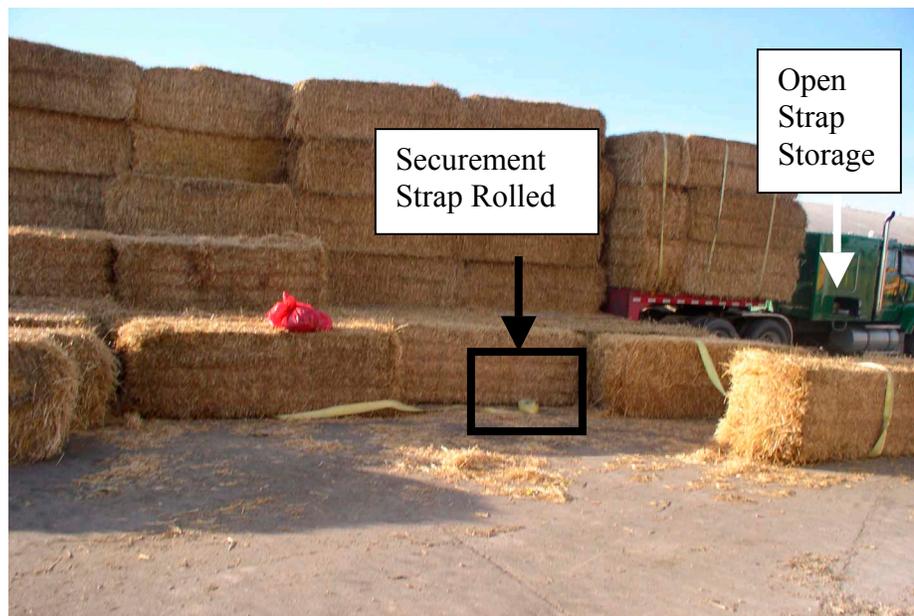
Figure 4. Straps on bales on gooseneck, rolled securement strap, open strap storage on cab

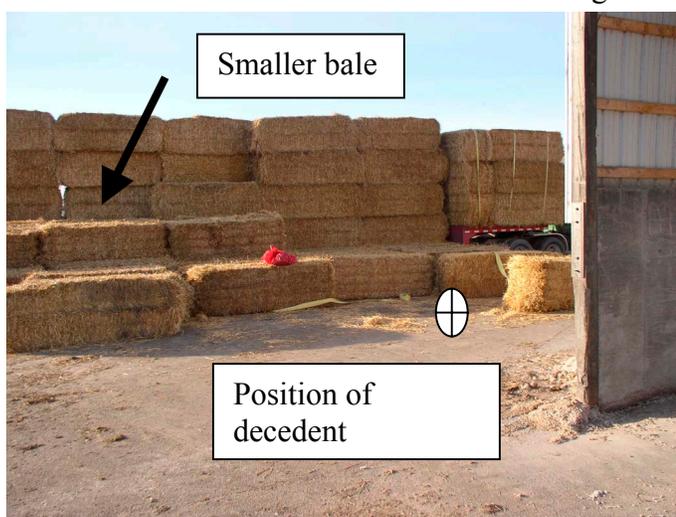
Figure 5. Illustration of variable sized bales and position of decedent

- The bales “racked” toward the passenger side. Racking refers to a bale content shift in one direction. During transport, straw and hay bales may have a tendency to rack, which causes a load to shift due to:
 - transportation vibration,
 - bale settling,
 - compromise of the bale edge through improper handling (e.g. rolling the bale),
 - non-uniform bale density,
 - different and/or irregular bale sizes in a stack (Figure 5), and/or
 - inadequate tiedown.

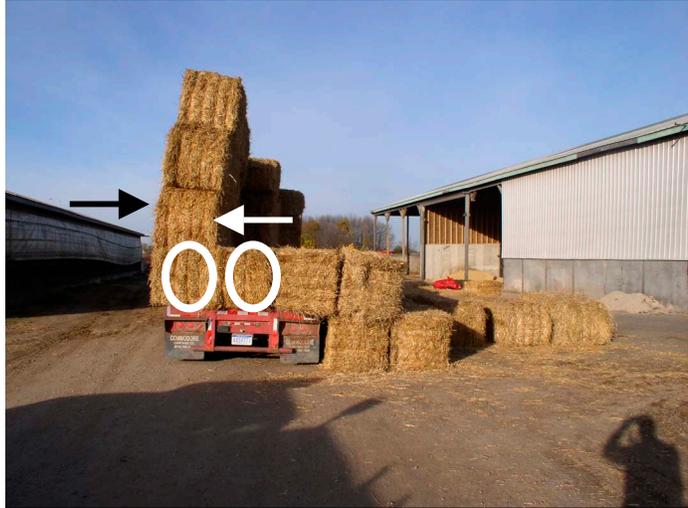
- Uneven bale drying. The exterior of the bale will dry before the interior, thus allowing for the bale edges to compress and the bale to become more “oval” in shape; the cut exterior sides become compressed by weight of bales above and pressure exerted by securement straps. Note in Figure 6 the driver’s side bale edge compared to the passenger side bale edge height). Bales can begin to “rock” back and forth due to the oval shape instead of sitting flat onto the trailer bed and each other.

Figure 6. Ovals to demonstrate compression on sides of bale
