SUBJECT: A Heavy Equipment Mechanic Died When a Scraper Tire Exploded.

SUMMARY
California FACE Report #06CA004

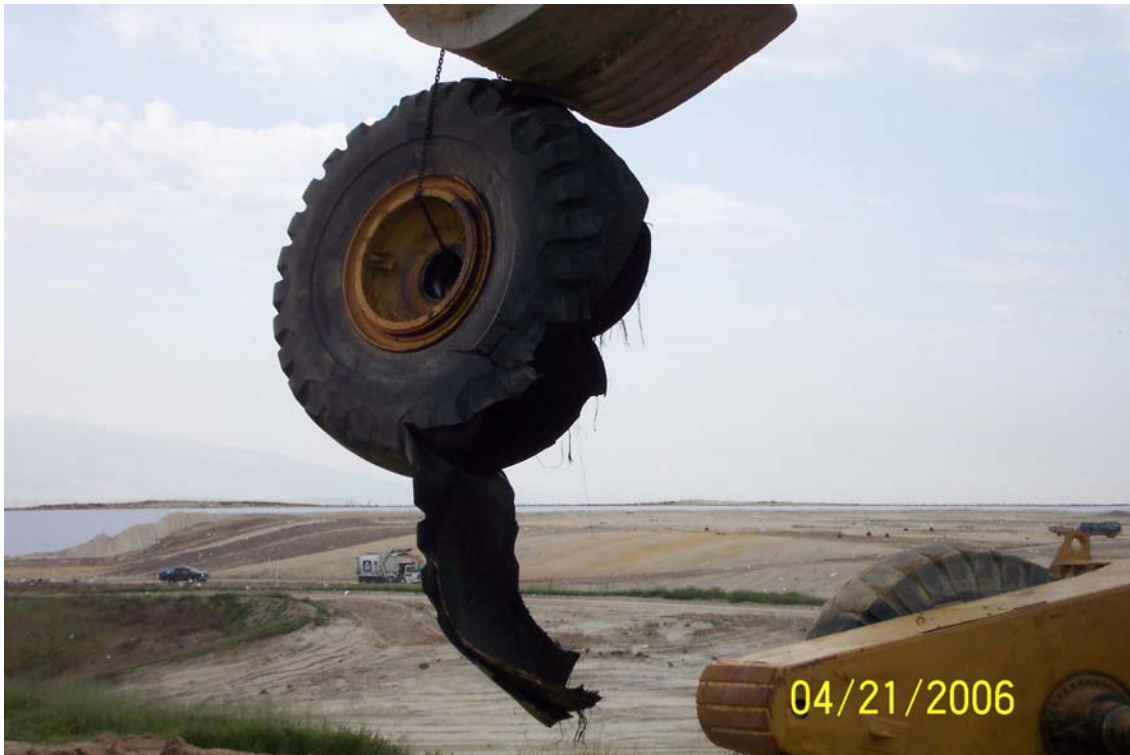
It was concluded that the use of a torch to cut the brake drum ignited the tire material which then generated combustible vapors, leading to the explosion. Removing the valve stem from the tire valve and keeping it out while work is being performed on the tire or tire components will prevent any pressure buildup in the tire and prevent another incident like this one.

Exhibit1. A picture of the tire that exploded.

Recommendation #1: Ensure that all heavy equipment tires are deflated and the valve stem removed prior to any work being performed on the tire or attached components.

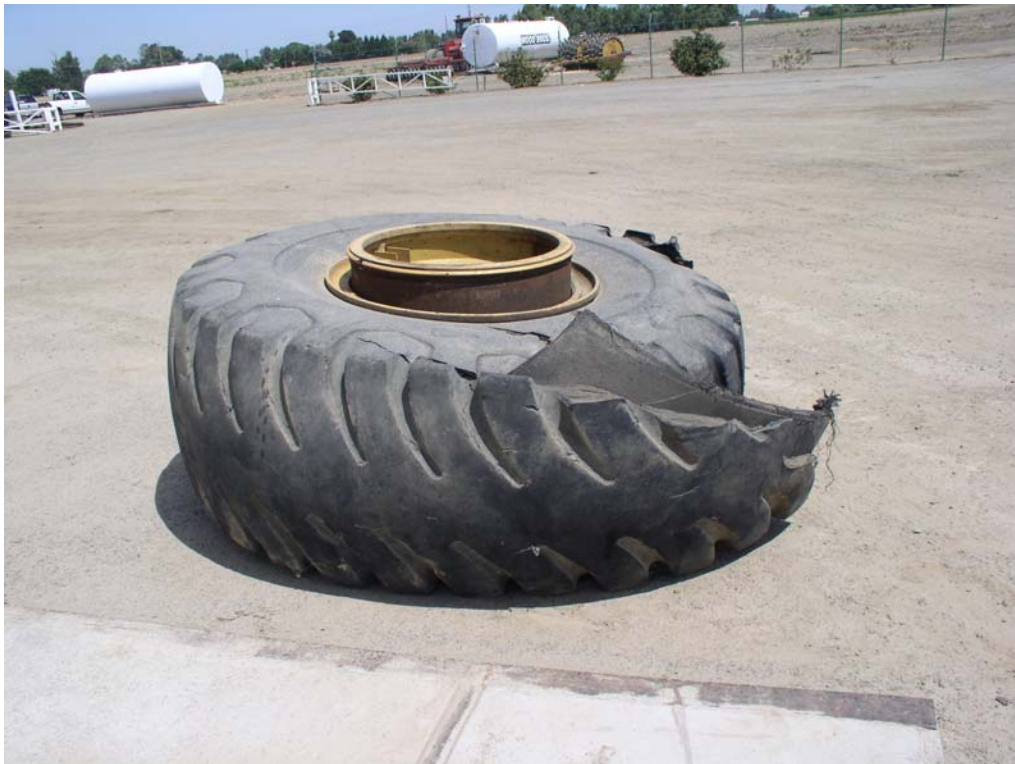
Exhibit 2. A picture of the tire and wheel assembly after the explosion.

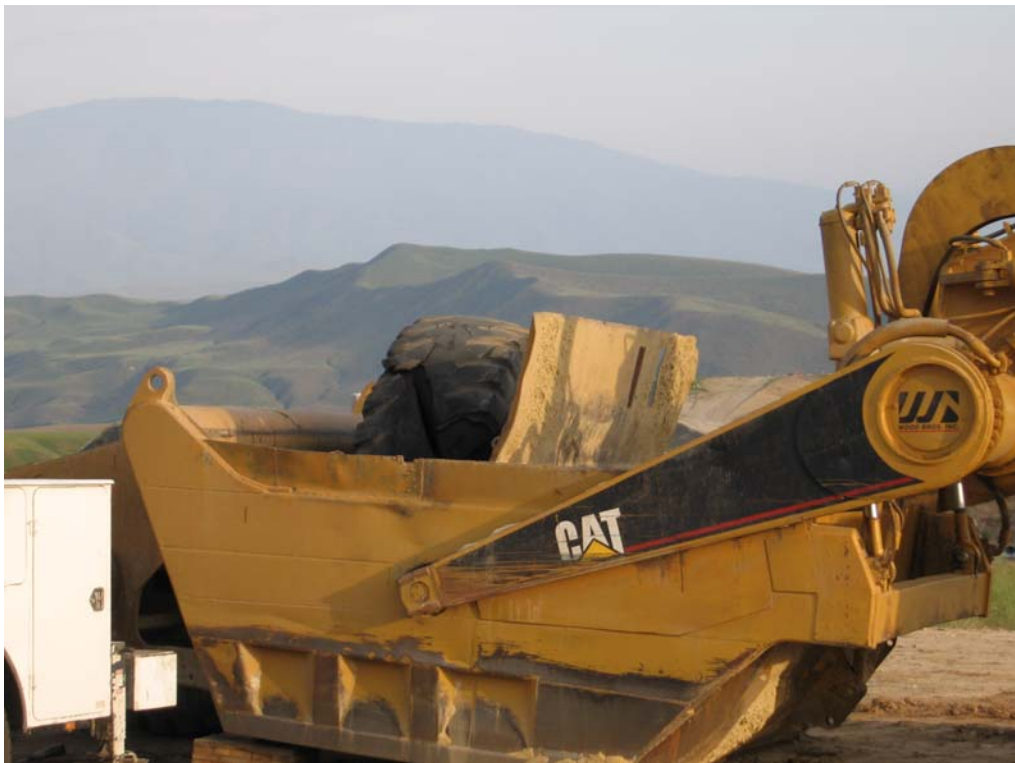
After the assembly was removed from the scraper, the victim attempted to remove the brakes from the hub but they would not come off. The victim retrieved a cutting torch from the truck, heated the brake assembly, and cut the drum into three sections. The brakes and drum did not come loose even after several attempts of heating and hammering. The victim decided to quit for the day and was picking up his tools and cleaning the work area when the tire suddenly exploded without warning. The victim was not working on the tire but was near it when the explosion occurred. The explosion was so great that the tire and entire wheel, hub, and brake assembly shot approximately 15 feet into the air and landed in the back of the scraper (Exhibit 3).

Exhibit 3. A picture of the tire after it exploded and landed inside the scraper.

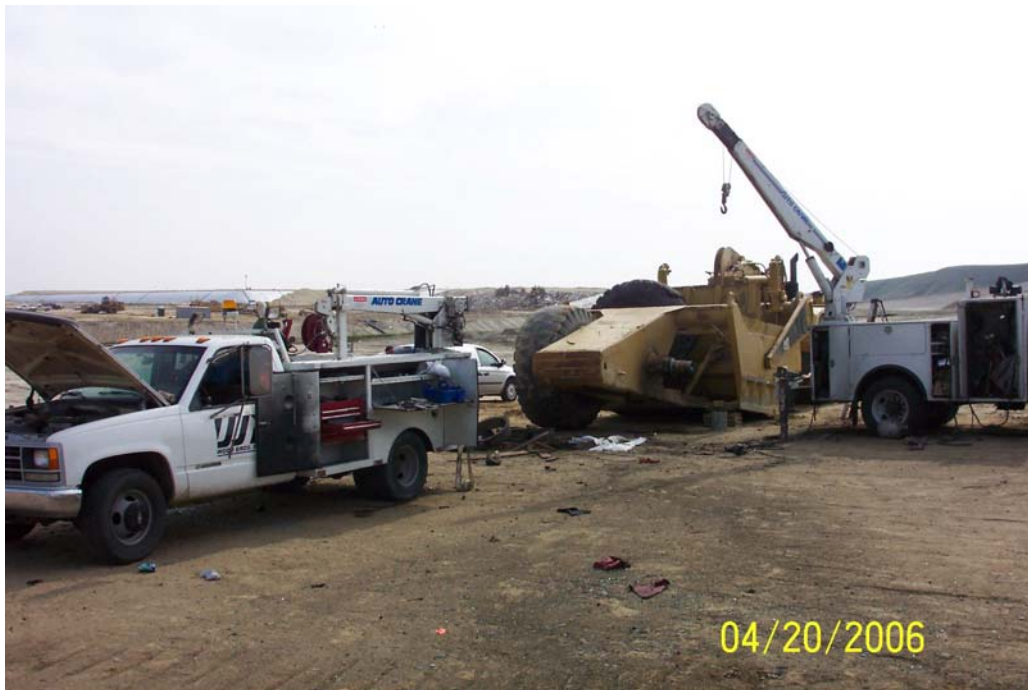
Exhibit 4. A picture of the incident scene.
