FROM: Iowa FACE

Case ID: 2005IA075

Report Date: 07 March 2007

SUBJECT: Farmer Fatally Injured in Tractor Posthole Auger Entanglement

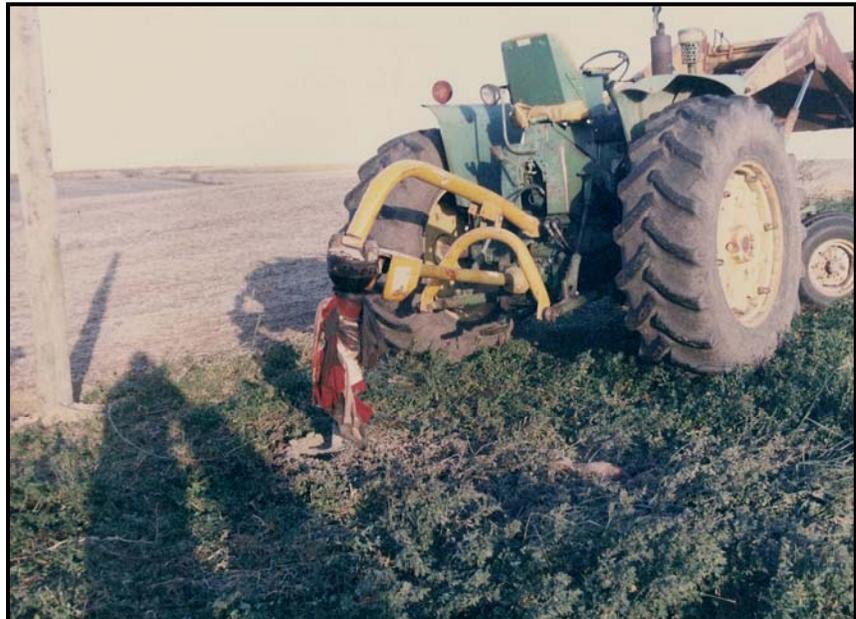
A 35-year-old, male farmer was fatally injured while operating a tractor PTO (power take-off) powered posthole auger. The incident occurred in central Iowa late in the fall of 2005. The victim was working alone in an alfalfa field near his farm home, digging post holes for a fence line (Photo 1). The incident was discovered early the next morning when a neighbor drove by and noticed the stationary tractor with its engine running and no operator in sight. The victim was found about 30 feet (10 m) from the tractor. The posthole auger was still turning about 2 feet (0.6 m) deep in its hole in the ground. Loose dirt at

Photo 1 – Tractor shown with three-point hitch, PTO-powered posthole digger attachment as it was found early in the morning after the incident.

ground level around the auger had been spread away from where the auger entered the ground. A shovel with a broken handle was found at the site and a loose strand of barbed wire snaked along the ground between the tractor and auger. The victim's shirts were wrapped around the top of the auger. There was no guard in place in this area where the auger connects to the gearbox output shaft. The incident resulted in amputation of the victim's right arm and multiple blunt force wounds. He was dead when neighbors found him.

- Tractor operators should disengage drive elements and shutoff the tractor's engine before leaving the operator's station.
- Operators, and others, should stay clear when the posthole digger is in operation.
- Posthole auger drive elements should be guarded with all shielding in place and functional.
- Work areas should be clear of slip, trip, and fall hazards.

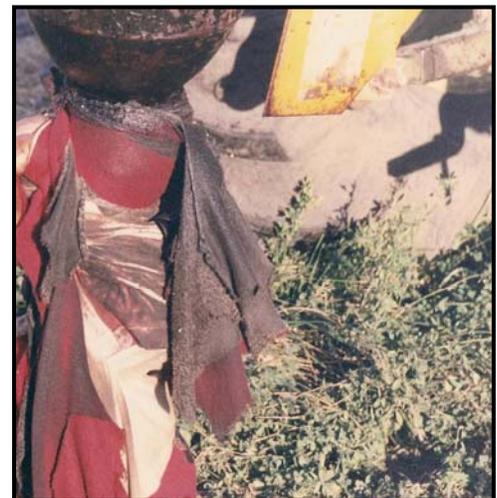
A bolt or shear pin is commonly used to connect the auger to the output shaft of the gearbox. A bolt or pin that is too long or has protrusions could snag clothing, and with the absence of guarding the potential for an entanglement in this area of the posthole auger increases. The victim was wearing jeans, sweatshirt, flannel shirt, and a t-shirt. Frayed or loose work clothes would be more susceptible to being snagged by moving machinery parts. Portions of the victim's clothing were entangled in the upper part of the rotating auger (Photo 2). His severed right arm was found near the posthole digger. His body was found about 30 feet (10 m) directly south from the rear of the tractor.

Photo 2 – Victim's clothing wrapped around the auger.

The posthole digger was several years old and showed some wear. The tractor's PTO master shield was missing, but the shielding on the driveline from the tractor to the implement gearbox was in place, including the shielding for the connection where the driveline connects to the gearbox input

shaft. The connection under the gearbox where the gearbox output shaft attaches to the auger did not have guarding in place.

Recommendation #3 – *Posthole auger drive elements should be guarded with all shielding in place and functional.*

Discussion: A tractor-powered posthole auger is a relatively inexpensive and common implement for digging holes for fence posts. It is attached to the three-point hitch of a tractor, which raises and lowers the auger. The digger's auger is powered from the tractor's power take-off (PTO) through a PTO shaft and a right angle gearbox. This changes the direction of power transmission from horizontal to vertical. The gearbox also reduces the rotational speed of the output shaft to the auger to a third or quarter the speed of the tractor PTO, which typically operates at 540 RPM (revolutions per minute) or 1000 RPM when the tractor engine speed control is set at the rated PTO speed.

Operation of a posthole auger may require removal of dirt from around the hole so loose dirt does not fall back into the hole when the auger is lifted by the three-point hitch. Contact with moving machinery parts such as the auger, couplings, or driveline can lead to an entanglement, especially if guarding is missing, out of position, or not properly maintained. In this incident, there was no guarding around the coupling that connected the gearbox output shaft to the auger.
