FROM: Iowa FACE Program Case No. 2005IA004 Report Date: 23 September 2005

SUBJECT: Part-time Metal Salvager Died when Crushed in Tractor Overturn with Loader

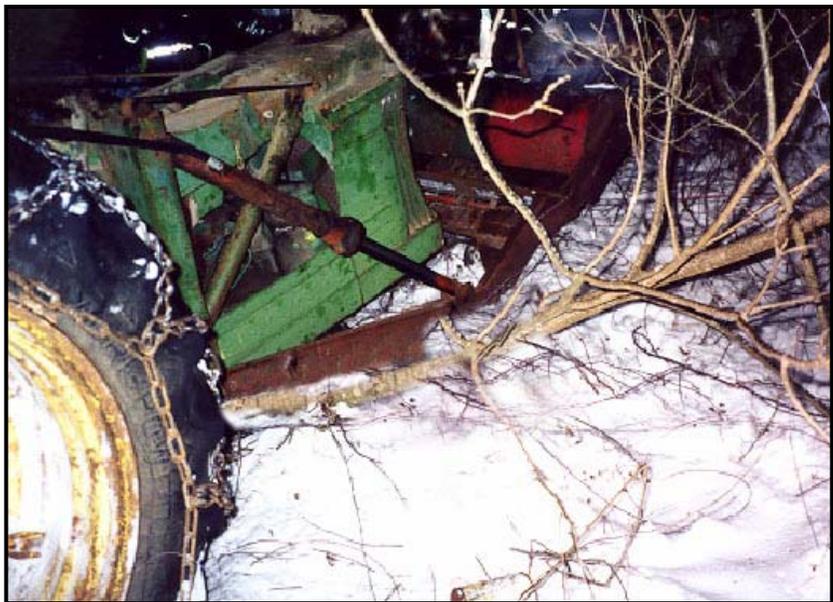
Photo 1 – Victim (not shown) was pinned against tree with loader frame across his abdomen.

pinned between the tractor and the tree with the lift arm of the loader frame across his abdomen (Photo 1). His brothers who worked with the victim in their scrap metal salvaging enterprise found him hours later, after midnight. Emergency medical services were called and arrived within ten minutes. No life signs were detected and it was determined the victim died at the scene.

During the overturn, the man either jumped or was thrown from the operator's station. His lower body was subsequently pinned across a small, bent-over tree. With the rear of the tractor swung somewhat downhill, his legs were partly under the tractor hood near its exhaust stack with the lift arm of the raised loader across his abdomen. The loader was in a partially raised position with the bucket about the same height above level ground as the top of the tractor's hood.

Recommendation #1 – All tractors used with front-end loaders should be equipped with ROPS and seat belt.

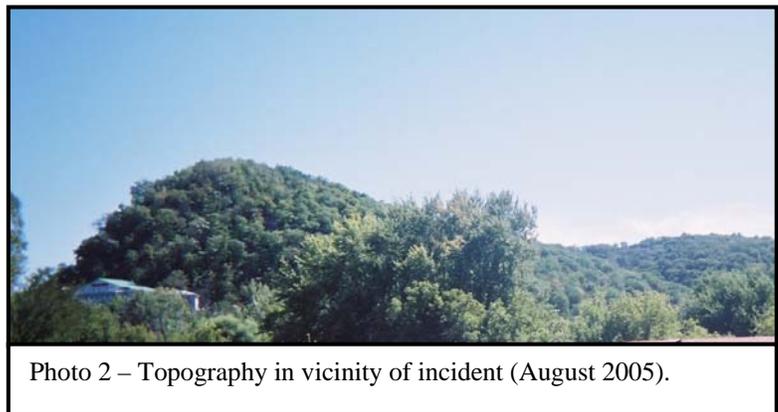
The leaves had fallen exposing the round-topped bluffs (Photo 2) that surrounded the town where this part-time metal salvager lived. His assigned task for the morning was to drive his tractor with loader a few short blocks to the edge of town and go up the bluff to collect some scrap metal from the back of a neighbor's property. On the way down the bluff his tractor overturned pinning him underneath.

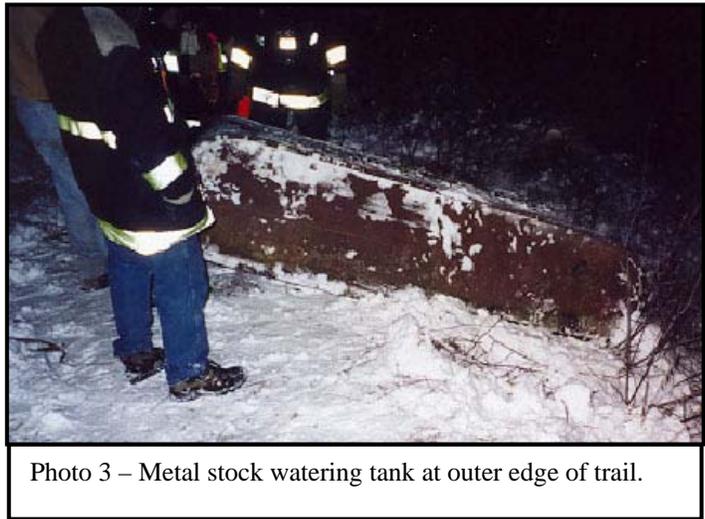
He drove his tractor to the edge of town and navigated his way up the steep trail to the back of his neighbor's property to salvage the thin-walled, metal water tank. It was an open, oval-shaped tank about 8 feet (2.4m) long, 2-3 feet (0.6m – 0.9m) deep and about as wide (Photo 3). He emptied snow and debris from the tank, then hoisted it with the loader and steered forward down the trail.

Apparently, control of this light but awkward load was difficult to maintain. Markings on the ground indicate the tank had to be retrieved and reloaded at least twice along the upper portion of the trail. Tire skid marks on the path immediately before the incident site suggest the application of the tractor's brakes as one might do if the load was about to come loose. In the process of retrieving the tank which may have fallen or been brushed loose toward the outside edge of the trail, the tractor with its loader was positioned at a slight angle to the trail, aimed toward the tank and somewhat toward the ravine which sloped steeply downward from the trail's outer edge.

Proper attachments and means to secure loose, awkward, or shiftable loads should be used to prevent losing control of the load.

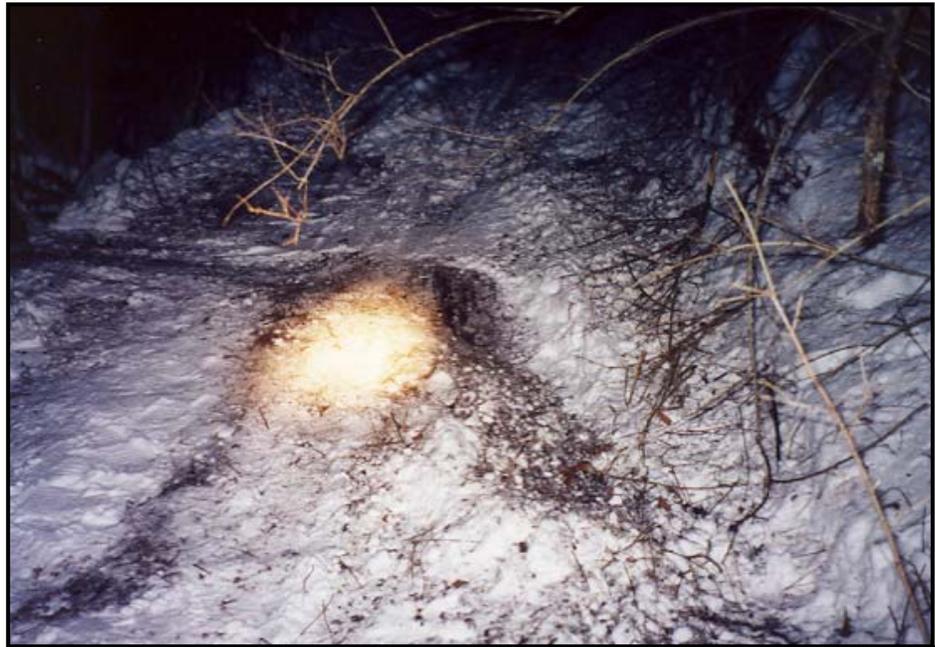
Marks on the trail made by rear wheels spinning indicate he placed the tractor's transmission in reverse, engaged the hand clutch and began backing up aggressively to reposition the tractor, its loader and load, on the narrow pathway (Photo 4). Chains around the tractor's rear wheels dug into the snow and ice backing up the grade of the trail. The rear of the tractor slipped to the right on the

trail and away from the bluff as the wheels continued to churn. First the right rear wheel then the left went off the outer edge of the trail. The tractor and front-end loader overturned down the wooded hillside coming to rest upside down 40 feet (12m) down hill from the trail.

Photo 4 – Tracks of spinning rear wheels as tractor backed up grade of trail then slid to its right off edge of trail.

Recommendation #5 – *Operators should use extreme caution when operating tractors on or near steeply sloping terrain and on pathways with ditches or embankments.*
