Truck driver fatally injured after falling into an ore hopper

FACE 00-AK-007

Release Date: March 30, 2001

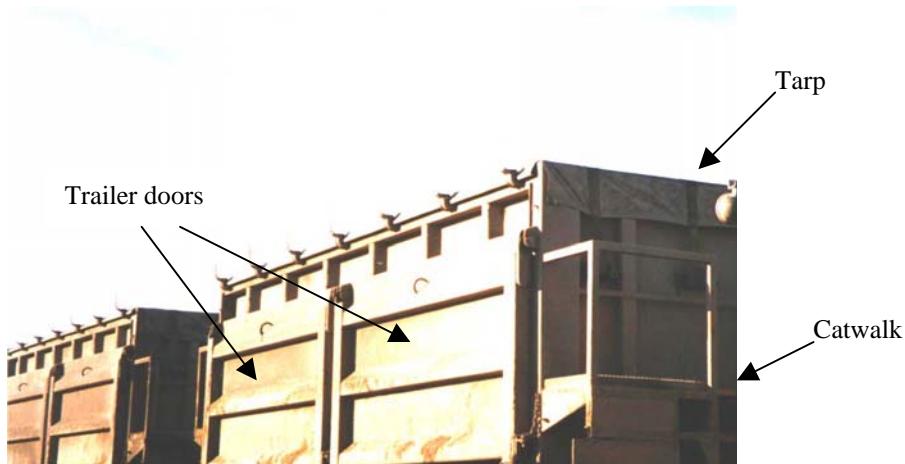
The trailers involved in the incident were two 24-foot side dump trailers, connected in tandem behind a Mack truck with a 40-ton capacity (Figure 1). The overall length of the tractor-trailers was 74 feet. The trailers had 3-foot wide catwalks on either end.

Figure 1. View of trailer and front catwalk

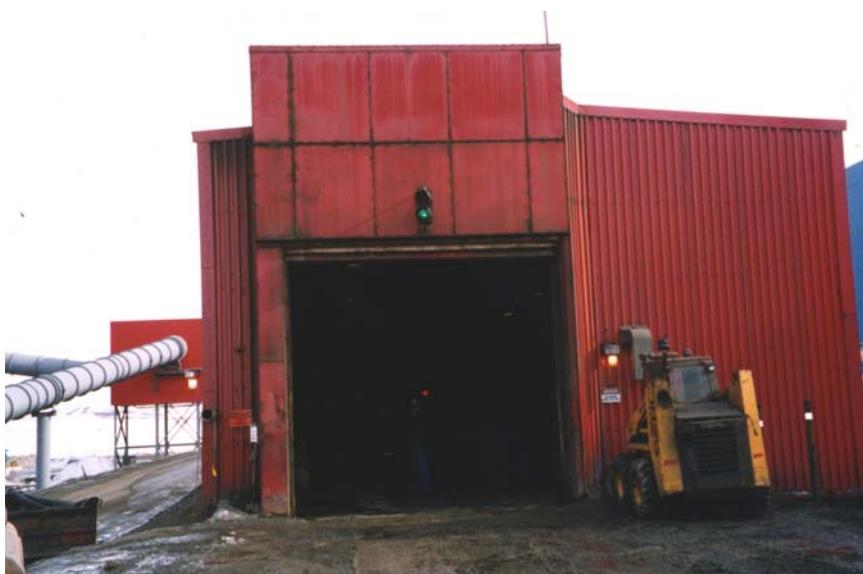
Figure 2a. Entrance to dump building

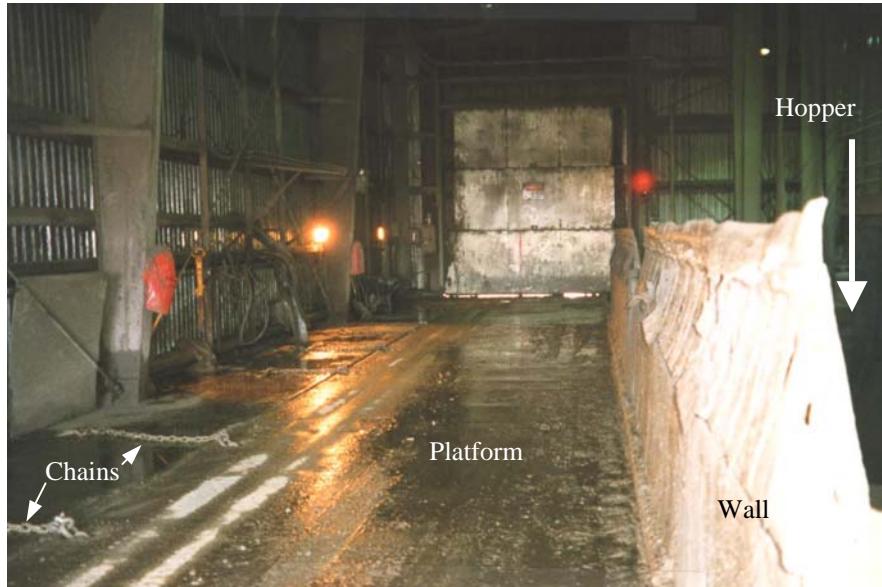
Figure 2b. Dumping platform and wall adjacent to hopper

The platform was 76 feet long and 10 feet wide. Four chains (two per trailer) were used to secure the driver side of the trailers to the platform. A hydraulic lift then raised the driver side of the platform and tipped the tractor-trailers as a single unit to unload ore concentrate through the trailers' side dump doors. A wall, 41 inches tall and 76 feet long, separated the platform from the hopper. The wall was equipped with a lower guard to allow drivers to position the trailers close to the wall without damaging the tires and rims. Two spill aprons (one for each trailer) rotated into position under the trailer doors to help guide the ore concentrate into the hopper. The aprons were positioned with an approximate 4 feet long gap at the center, similar to the gap between the two trailers.

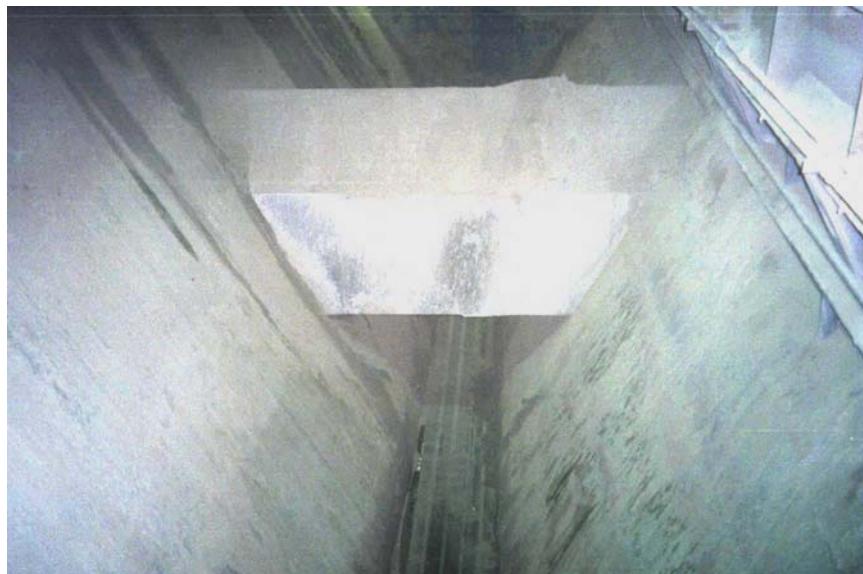
The hopper was 55 feet long and 13 ½ feet deep. It was 14 feet wide at the top and narrowed to a conveyor belt, approximately 3 ½ feet wide, at the bottom (Figure 3). When in operation, the belt moved at a speed of 20 to 35 feet per minute. A permanent ladder inside the hopper near the control room was used to access the bottom of the hopper to break-up large clumps or perform maintenance. Ore concentrate was transferred from the hopper to storage buildings (located on either side of the dump facility) via a series of conveyor belts. Ore concentrate was moved to the end of the hopper where it fell down a shoot to another belt.

Figure 3. Hopper, center divider, and conveyor belt at bottom

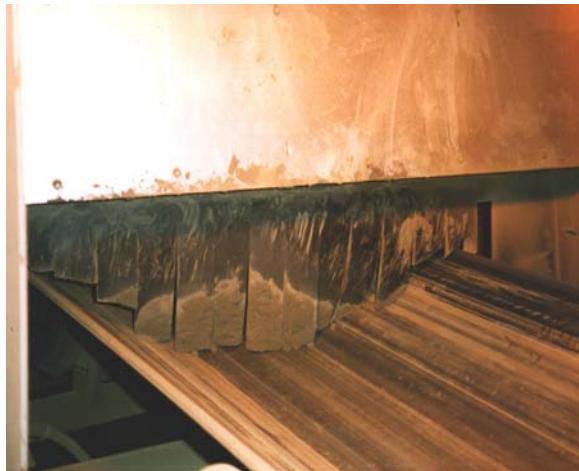
Figure 4a. Second conveyor belt exiting shoot below hopper

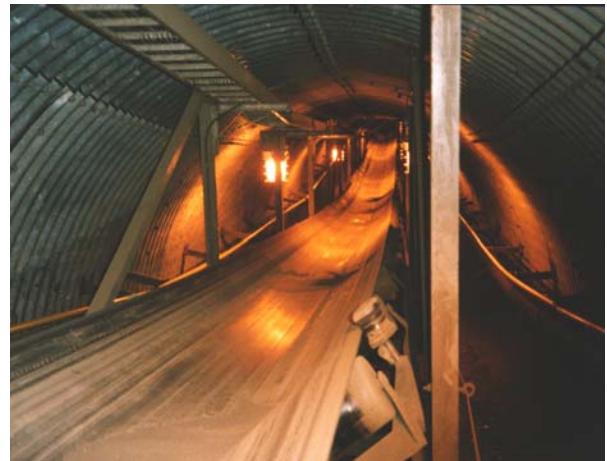
Figure 4b. Second conveyor belt

The second and third conveyor belts were also involved in this incident. The total distance along these belts was 1,016 feet with a maximum belt speed of 204 feet per minute. It was estimated that the time to travel the distance from the beginning of the second belt (below the hopper) to the end of the third belt was approximately 4 ½ minutes. At the beginning of the second belt, a clump sensor automatically stopped all belts if the sensor detected an ore height over 15 inches. Vertical clearance exiting the shoot housing (at the center of this belt) was 15 inches (Figure 4a). At the end of the third belt, a video camera was housed in the top of the shoot; a monitor for this camera was located in the control room. This allowed the operator to observe the ore transfer to a fourth and final belt (to the storage buildings).

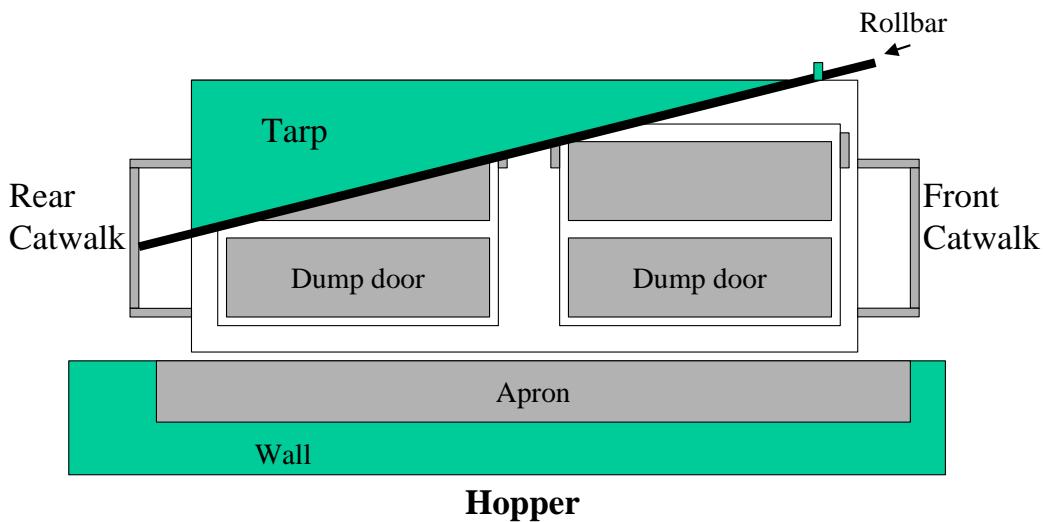
The incident was not witnessed, however two boot prints found on top of the ore concentrate in the front passenger side of the first trailer suggested that the victim had climbed onto the load while parked on the dump platform. Immediately after the incident, the tarp and rollbar was hanging at an angle; the back of the rollbar was about halfway down the back of the trailer

(Figure 5). A portion of the tarp was found on top of the load (passenger side). In addition, a possible boot print was found on the top surface of the wall between the spill aprons. With the restricted area between the driver side of the tractor-trailer and the building wall, it was highly unlikely that the victim walked around the tractor-trailer without being noticed by the operator. Based upon these circumstances, the victim must have fallen into the hopper and then been carried by the first conveyor belt to the end of the hopper. He then fell through the first shoot and was carried by the second conveyor belt. He fell through the shoot at the end of this belt and was carried by the third conveyor belt in the transfer system to the third shoot, where his body became trapped.

Figure 5. Diagram of tarp and rollbar hanging over side of front trailer (not to scale)

Recommendation #1: Employers should require tarps to remain secured to trailers until the trailer is ready to be unloaded.

Discussion: In this incident, the victim followed prescribed work practices that required the tarp to be secured to the trailer while driving to the storage facility. However, it was not an unusual practice for drivers to leave the load covered and loosen or release tiedown straps while waiting to unload. Employers should consider conducting random work site safety inspections and supervisor observations to evaluate compliance with and understanding of established standards and practices and assess possible additions and modifications to standard work practices. In addition, steps for specific practices to be outlined in a safety, health, and environmental program should be discussed with employees to identify routine practices and reasonable actions for unusual occurrences to ensure worker compliance.
