MIFACE Investigation #06MI117

Subject: Male Siding Installer Dies After Falling From a Roof While Installing a J Channel on a Dormer

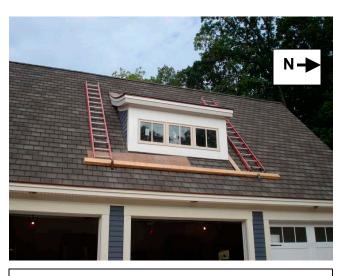
Figure 1. Re-enactment of incident scene showing placement of the roof brackets, planks and ladders.

After arriving on the worksite, the decedent, who was working by himself, installed the metal roof brackets for the roof bracket scaffold platform. The brackets were designed for a 2x4-inch wood plank (Figure 2). He positioned the brackets 11 feet apart (Figures 1 and 2). The employer stated that the decedent had not screwed the bracket in the way the had been trained nor in the way the company normally installed the roof brackets.

• Employers should ensure employees use the correct roof brackets and are trained and follow the "best safe work practice" when installing a roof bracket scaffold platform – using the correct roof bracket for the roof pitch and securing the bracket by 16d nails anchored into a roof rafter.

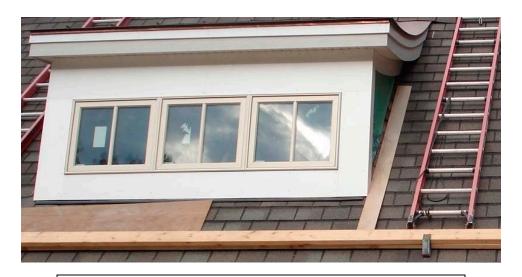
Figure 2. Another view of the re-enacted incident scene. Note placement of 2x6-inch planks

After installing the roof brackets, the decedent placed two 2x6-inch pieces of wood planks in the bracket channel parallel (instead of perpendicular) to the roof surface across the roof bracket span (Figure 2). After placing the straight wood ladder against the 2x6-inch wooden plank, he used the ladder as a climbing device to access the dormer to install the 12-foot J channel. The decedent was not wearing any equipment that would protect him in case of a fall from the roof.
