# MIFACE Investigation #06MI007

## Subject: Forklift Driver Pinned Under an Overturned Forklift Dies

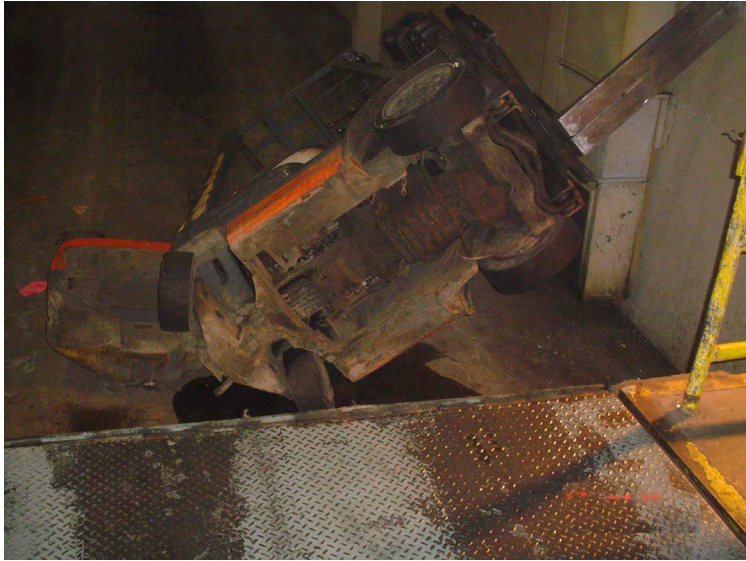
Figure 1. Forklift on dock floor

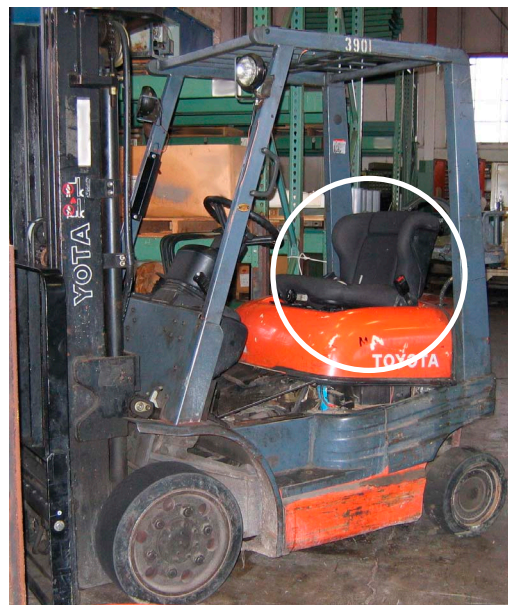
The forklift involved in the incident was a propane-powered Toyota Model 426FGCU25 weighing 8,670 pounds. The forklift's rear tires were smooth and the front tires had treads. The forklift had an overhead guard and was equipped with a functional seat belt system (Figure 2, circle). The deceased operated the forklift in all areas of the plant and was familiar with the plant's layout. The forklift controls were not clearly labeled. The assistant plant manager stated that the firm's forklift training included a requirement that seatbelts must be worn when operating a forklift equipped with a seatbelt. Daily forklift safety checks were performed and verbal information passed on for the equipment concerning inspection and maintenance. No documentation was maintained for daily operator checks. Employees stated that forklift maintenance was timely; when a machine was taken out of service, a rental machine was acquired.

Figure 2. Forklift involved in incident

The forklift involved in this incident was equipped with an overhead guard and a seatbelt for operator restraint. The overhead guard was relatively undamaged during the tip-over. If the operator had been restrained with a seatbelt, the severity of the injuries may have been significantly reduced.

- Employers should enforce employee use of the operator restraint provided by the forklift manufacturer (in this case, a seatbelt).

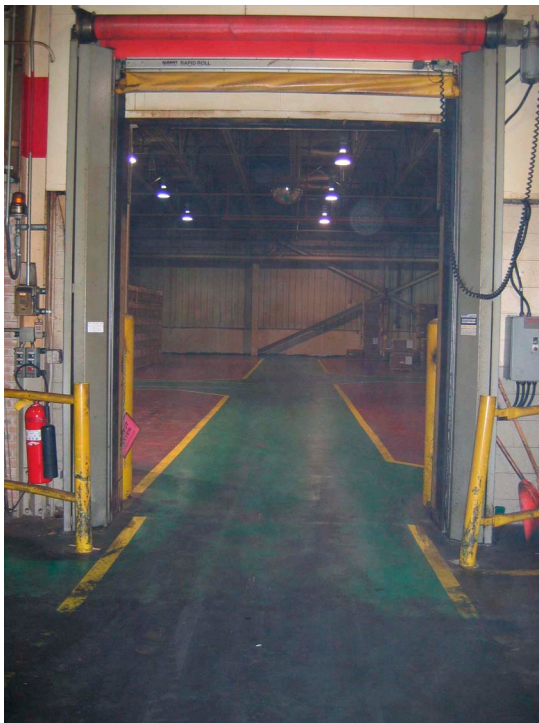
The incident occurred at a loading dock. Standard guardrails were installed six inches away from the edges of the 6-foot wide loading dock plate. The loading dock floor was approximately four feet below the plant floor. Adjacent to the loading dock was an 8-foot-wide overhead door leading to Area #1. On either side of the overhead door were guardrails protecting the entrance to the door (Figures 3 and 4 and Diagram 1). At the time of the incident, the loading dock entrance had a chain across the opening.

Figure 3. Overhead door near loading dock platform

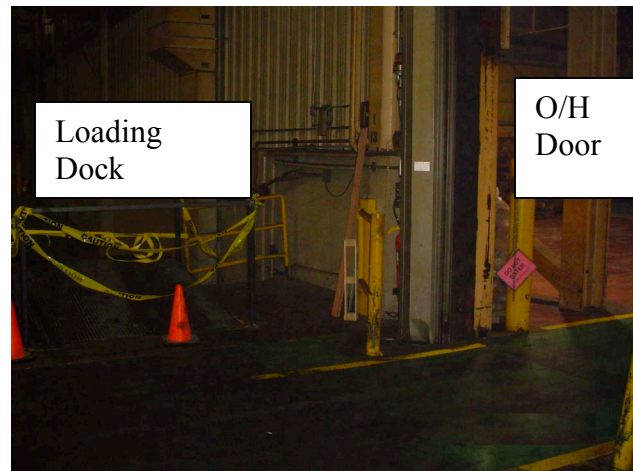
Figure 4. Position of loading dock in relation to overhead (O/H) door

- Employers should install drop-off protection capable of withstanding forklift impact on a loading dock entrance when the dock entrance is near a normal path of travel for a forklift or pedestrian.

A barrier chain was the only device used to protect the loading dock platform. Loading docks that are vacant can create a hazardous situation for dock personnel, material handlers and pedestrians in the area. Providing drop-off protection at the platform by installing a safety barrier that can be manually positioned and removed by a single forklift operator can be a solution for this problem. When the drop-off protection is in position, it can also provide a constant visual safety reminder of the dock area. There are several manufacturers that provide easy-to-use and relatively inexpensive drop-off protection devices to eliminate this hazard and prevent an injury.

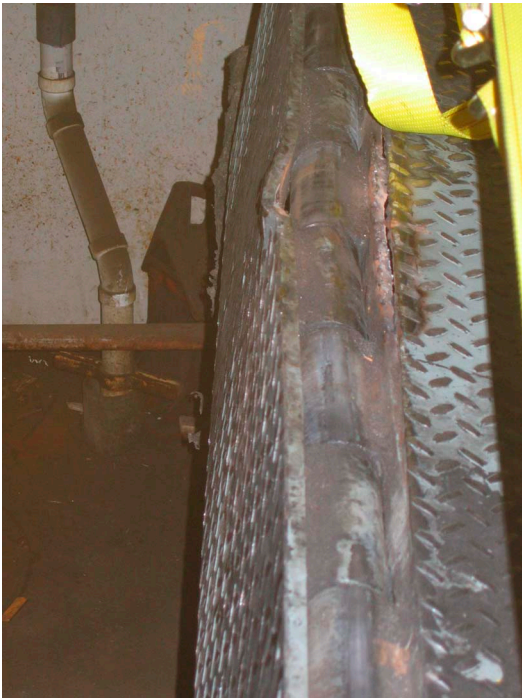
Figure 5. Bent dock boarding plate

This distance suggests that the forklift was traveling at a fairly fast rate. The barrier chain across the dock opening was sheared off. The dock boarding plate had a significant bend on the edge and the chain's fastening loop was sticking straight out (Figures 5 and 6).

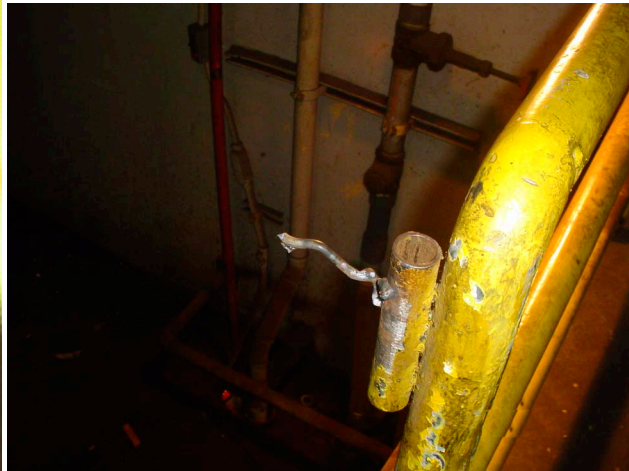
Figure 6. Straightened chain fastening loop

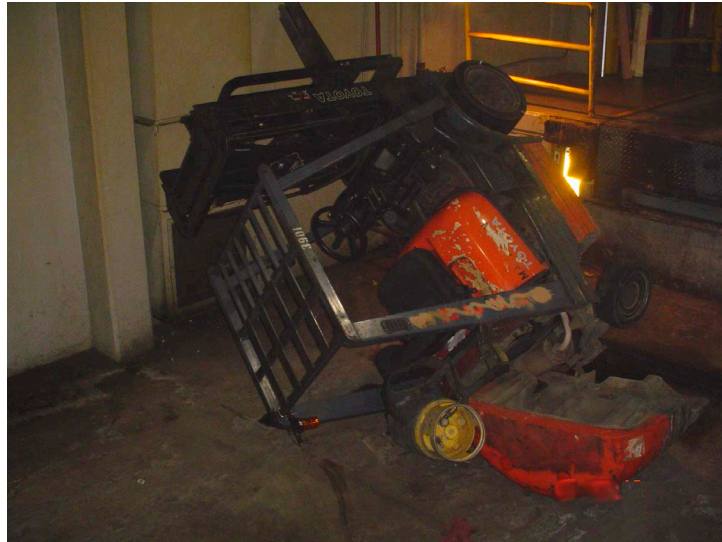
Investigation of the incident scene noted that there were no skid or brake marks on the plant floor. The decedent was not carrying a load at the time of the incident. It appears that the forklift was driven off the dock while traveling in reverse based upon the position of the truck. Neither the forks nor the mast appeared bent, as would have been the case if he had been traveling forward and drove off of the dock edge. The counterweight attachment bolt sheared, and the counterweight had detached from the machine and was lying to the side. A fresh impact point was noted in the cement of the truck well approximately three and one-half feet from the top of the loading dock. The left rear tire was approximately five and one-half feet from the edge of the loading dock platform.

The event was unwitnessed. It is unknown what caused the decedent to back off the end of the loading dock, but a likely scenario is that he was driving in reverse at a significant rate of speed. The damaged/bent dock plate and the location of the machine, several feet from the loading dock edge, after falling to the dock floor supports this hypothesis. A less likely hypothesis is that the decedent was moving slowly, and as the forklift's rear wheels came off of the dock edge, he panicked. Forgetting to place the gearshift in forward, he applied the gas in an attempt to

Figure 7. Position of forklift in relation to loading dock platform

- If the truck is not transporting a load that obstructs forward vision, forklift operators should limit the distance that the truck travels in reverse.
