## **MIFACE Investigation #06MI006**

### **Subject: Truck Driver Killed After Falling Through Unprotected Skylight**

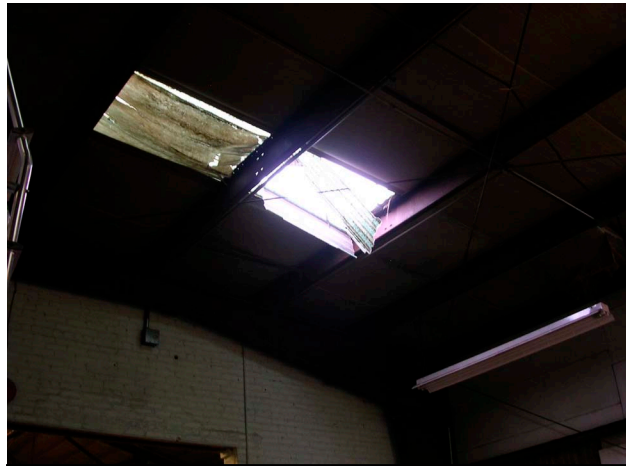
On February 3, 2006, a 44-year-old male truck driver/crane operator was killed when he fell through a 3 x 8-foot unprotected corrugated fiberglass skylight that was approximately 1/8 to 3/16 inch thick (Photo 1). The decedent was delivering roofing materials to a firm contracted to re-roof the southwest section of a warehouse. He climbed a ladder to the roof and spoke with three roofing contractors about placement of the roofing materials. For reasons unknown, the decedent stepped over a roof parapet wall onto the low-sloped

Photo 1. Picture of broken skylight

Building owners should install protective guards over individual skylights meeting Part 2 requirements, or consider installing guardrail systems around the perimeter of the skylight area that comply with the requirements contained within Part 45 to eliminate the hazard of an employee falling through the skylight.

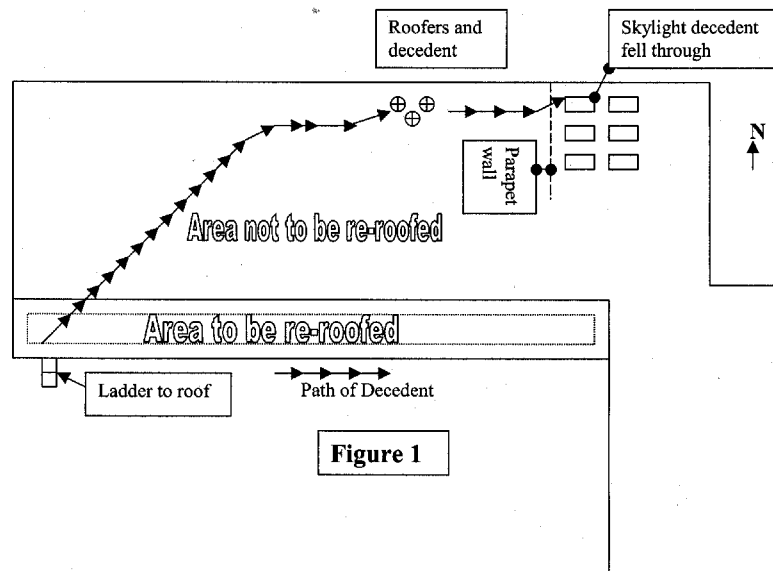
The decedent exited the crane truck. The outriggers had not yet been placed. He climbed a ladder to get onto the roof (Figure 1). It was common practice for the decedent to go onto roofs when delivering material, as stated by an employee of both the roofing contractor and the employer's operations manager. The operation manager stated that the work practice at the time required the crane truck driver to go up on the roof to look for obstructions, wires, and to make sure the roof could handle the load. The operation manager stated that the contract language at the time of the incident stated that that if the roofing material was attached to the crane, the responsibility for the load was the decedent's employer, not the roofing contractor. Therefore, the company's individuals who delivered the roofing materials would check the roof prior to unloading the truck.

On the roof were employees of the roofing company that subcontracted the decedent's employer. While walking on the roof with the roofing company employees, the decedent discussed the location of roofing material placement. When the discussion was completed, the decedent continued walking northbound on the roof stepping over a parapet wall onto the roof of warehouse #2.

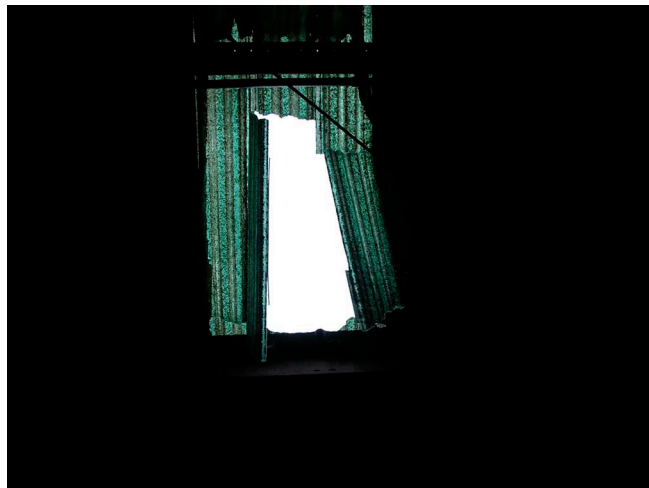
Warehouse #2 had six skylights that were installed to provide additional lighting for the building. The roof was dry and not snow-covered. Both the roof and fiberglass panel were weathered and dark in color. Although no work was to be performed in the area, neither the roofing company nor the owner of the building had installed visual markers or barriers to identify the skylight area nor covered the skylights in accordance with MIOSHA requirements.

As the decedent was walking northbound toward the Warehouse #2 roof, one of the roofing company employees warned him about the presence of the skylights. After stepping over the parapet, the decedent took several steps and fell through one of the 3x8-foot corrugated fiberglass panels that were flush with low-sloped metal roof (Photo 2). He landed on the concrete floor 20 feet below. The fiberglass panels were not designed as a weight-bearing skylight. It is unknown why the decedent continued northbound and walked on Warehouse #2 roof, which was so far away from the construction area. The roofing company employees stated to the police that they were not hired to repair that section of the roof. They were contracted to repair the front section or the section to the south/southwest of the building.

Photo 2. Broken skylight
