**SUBJECT:** A carpenter died after falling 20 feet from a roof.

## SUMMARY

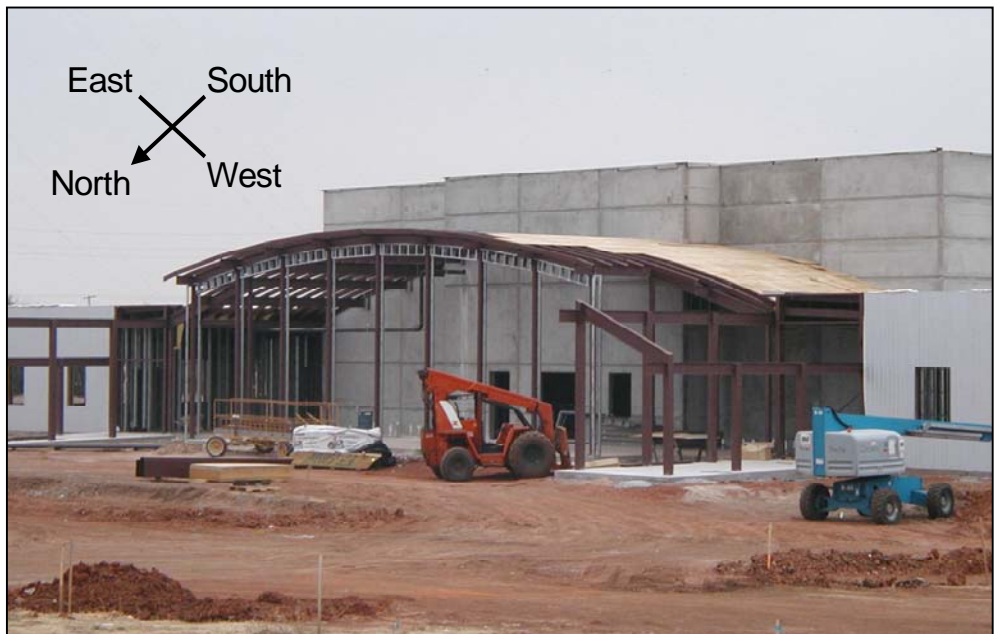
Figure 1. Construction site where the incident occurred

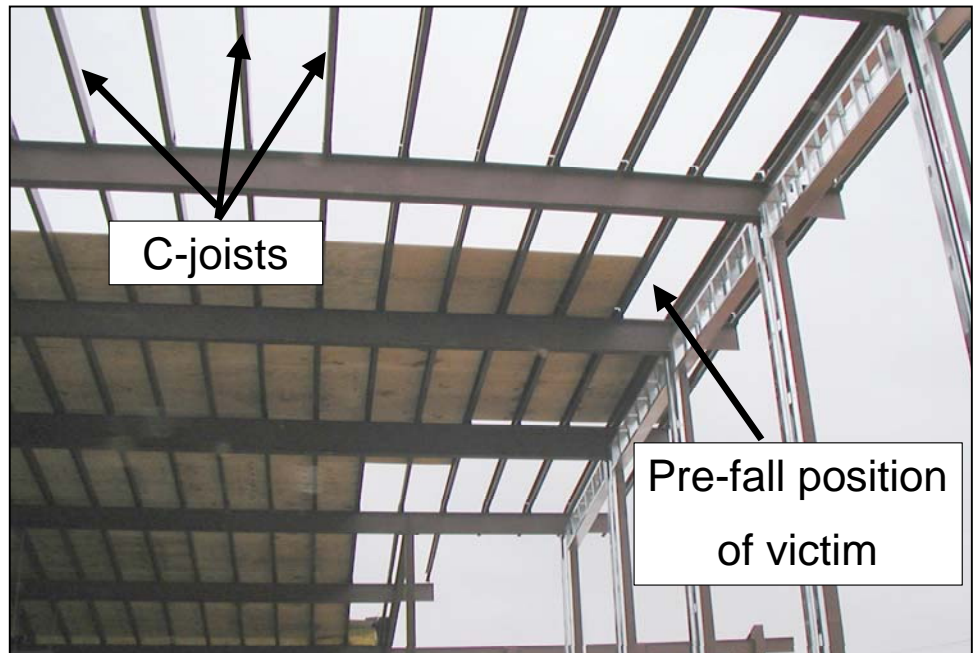
Figure 2. Photo illustrating C-joints and the position of the victim before falling

working on top of a structural steel frame that formed a broad arch shaped roof over a concrete slab. The east and west corners of the steel frame were 17 feet, 8 inches tall and arched to 21 feet, 9 inches in the center. The north roof edge, from which the victim fell, was approximately 20 feet tall. The front edge of the roof was located to the north and the roof extended southward until stopping at a concrete wall (Figure 1). A rough-terrain forklift had been used to lift  $\frac{5}{8}$ -inch thick, 4-foot by 8-foot sheets of plywood to a flat metal roof located just to the west of the work area. The work area was in view of the job superintendent's office that was located 100-150 feet north of the structure. Safety harnesses were located in the office, but no anchors were available.

Physical evidence collected during the investigation indicated that the victim's weight was over the piece of plywood during the incident when the plywood and the victim fell. Two screws had already been placed into the plywood before the fall occurred. One screw was completely drilled into the plywood and C-joint and the second screw was partially in when it broke. When the plywood was found, a very small section of the board with the completely drilled screw was separated from the rest and still attached to the C-joint. The employer did not have data regarding the load bearing capacity of the plywood or the decking screw's resistance to sheering forces.

During this decking operation, two pieces of plywood met on top of the 2 ½-inch wide C-joint, leaving 1 ¼-inch of plywood-joint overlap when perfectly cut. As the workers installed the plywood decking, there was a period of time when there were no or few screws engaged between the plywood and joists. During these times, shifting the plywood could cause it to fall off of narrow joists and result in the worker falling, particularly if the worker's weight was over the plywood.

**Recommendation #1: Employers should ensure that employees working from surfaces elevated more than six feet above a lower surface or the ground are provided with and use fall restraints, such as a fall arrest system, guardrail, or safety net.**

Discussion: OSHA regulations require employees constructing a leading edge six feet or more above a lower level to be protected from falling by guardrail systems, safety net systems, or a personal fall arrest system. A personal fall arrest system includes a full-body harness, lanyard, connectors, and appropriate anchorage points. Harnesses, as part of a personal fall protection system, were available the day the incident occurred, but were not used. The General Duty Clause of the Occupational Safety and Health Act of 1970 requires employers to furnish a place of employment that is free from recognized hazards and requires employers and employees alike to comply with occupational safety and health standards. During this incident, the use of a safety net or personal fall arrest system may have reduced the severity of injuries and prevented the death of the victim.
