SUBJECT: An Apprentice Mechanic Died When the Truck Tire He Was Standing Over Exploded

SUMMARY
California FACE Report #05CA007

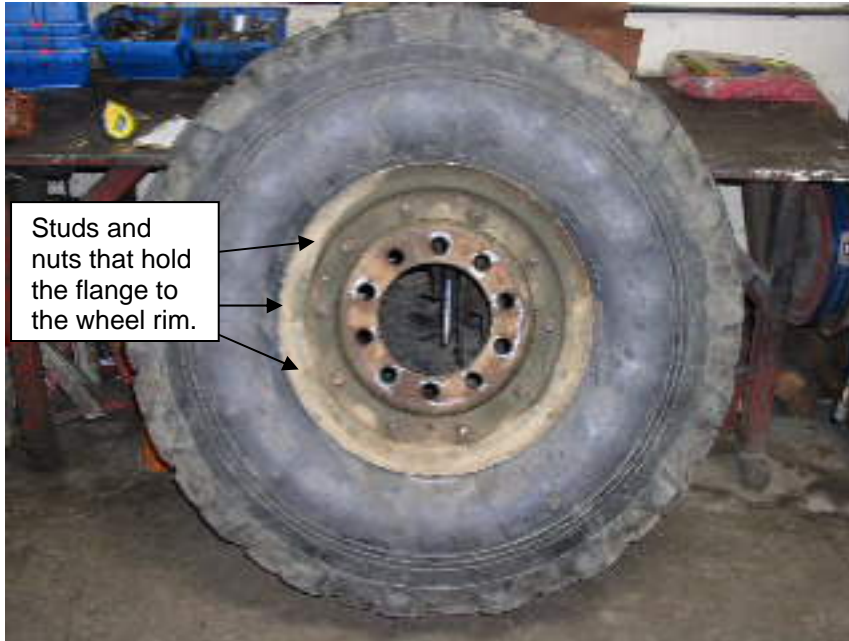
Exhibit 1: A front view of a truck tire mounted on a ten-bolt military wheel similar to the one involved in the incident.

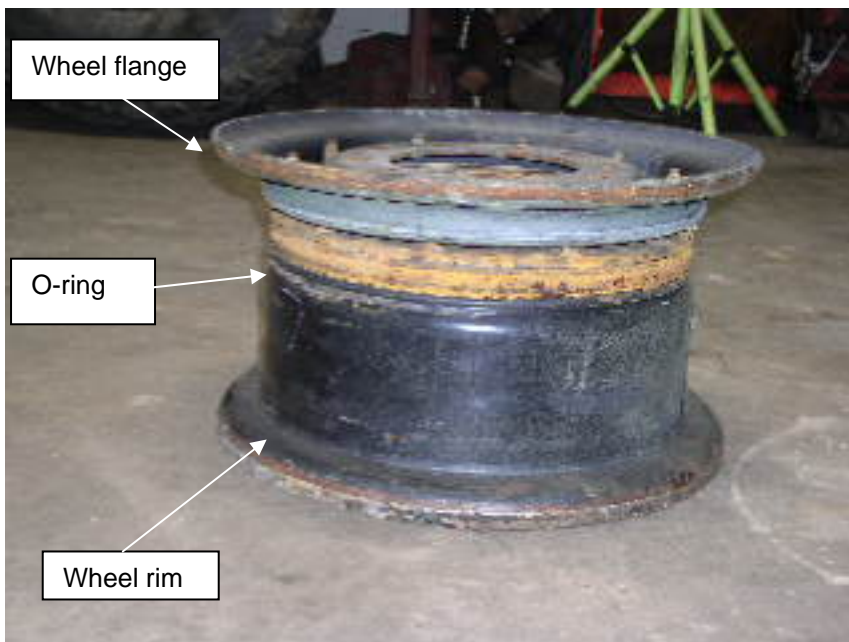
The site of the incident was an industrial park that housed a one-stall maintenance and repair shop and office that were the headquarters for the company. The tire size involved in the incident was 1,400 x 20. The wheel was two-piece, ten-bolt military rim. This type of wheel requires special preparation before the tire is mounted so that no air leaks will occur once it is inflated to the desired air pressure. All parts and components must be inspected and replaced if defects are found. The rim flange must fit securely once the tire is installed. An O-ring installed around the rim creates a seal where the flange mates with the rim. The nuts on the wheel studs must be tightened in a designated sequence in order to seal against the O-ring. Once inflated, the tire and wheel assembly must be inspected for leaks and if any are found, the tire must be completely deflated before the leak can be repaired.

Exhibit 2: A picture of a military wheel showing the rim and flange and O-ring.

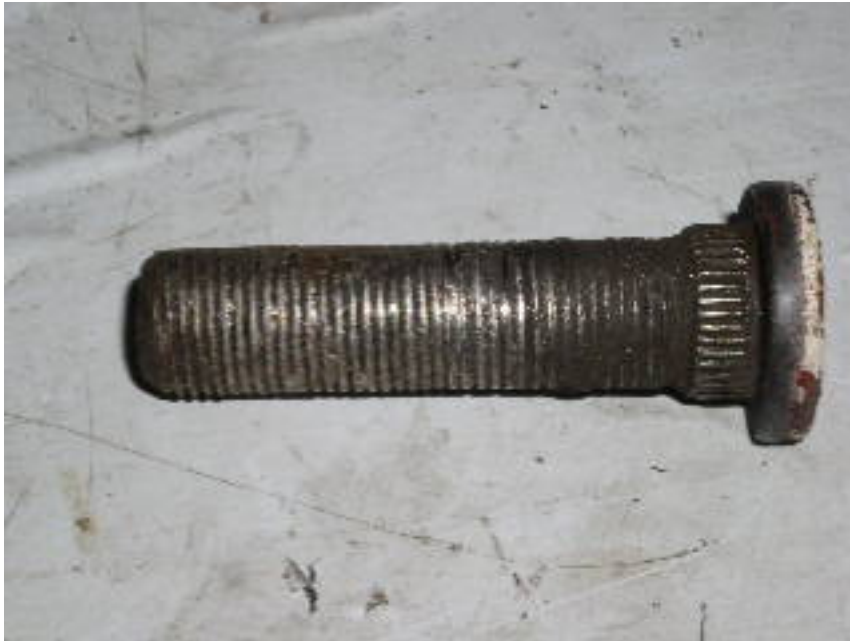
According to the employer of the victim and the lead mechanic, they believe that when the victim checked the air pressure in the tire, he detected an air leak around one of the studs holding the flange and rim together. The sound of the impact gun just before the explosion indicated that he probably was attempting to tighten or loosen one of the flange nuts. Inspection of the wheel studs showed all the threads were shredded off by the bolts when the tire exploded. Further investigation revealed that the wheels and their components were all bought at local auctions. It is not known whether or not the bolts and nuts

purchased by the company's owner were in compliance with the original specifications for the wheel. When the truck and components were bought at auction, they were purchased "as is."

The safety factor built into most wheels is such that when one bolt should fail, the remaining bolts should be sufficiently strong to keep the wheel together. In this case that did not happen. Without having the original specifications available to ensure proper fit, there is no way to determine if the stocked bolts and nuts were appropriate for this type of wheel.

Exhibit 3: A picture of a wheel stud involved in the incident showing all the threads flattened by the explosion.

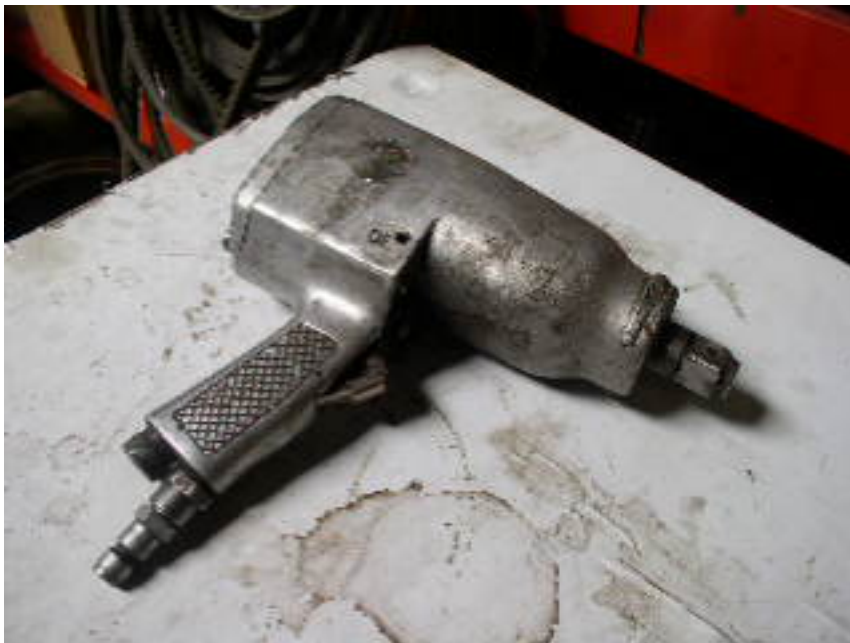
Exhibit 4: A picture of the impact wrench used by the victim.

Recommendation #1: Ensure employees never perform maintenance or repairs on an inflated tire.

Discussion: The pressure inside a tire inflated to 80 psi exerts a force greater than 40,000 pounds against the rim flange. This is why all safety procedures for working on tires recommend always deflating a tire completely before doing any work on it. The general tire safety precautions the employer had for this type of rim specified "never hammer, strike or pry on any type of tire/rim assembly while the tire contains inflation pressure. Do not attempt to seat any part while the tire contains an inflation pressure." Most accidents involving truck tires with split rims usually occur either during inflation, performing improper procedures as a result of mismatched or damaged components, or a combination. In this particular case, the studs on the rim that hold the flange in place were completely stripped of their threads when the tire exploded. This suggests that wheel components might not have met the original specifications for this type of rim. It is unclear whether this was a factor in this incident; however, the owner of the company admitted that he bought the rim components from an auction, and had no way to verify if they were of the exact specification required for this type of rim. When working with such extreme pressures, exact specification should be met in order to prevent such incidents in the future. When these safety precautions are followed, the chances of another incident occurring are greatly reduced. Employers can enhance worker compliance with safe work practices through programs of task-specific training, supervision, recognition, and progressive disciplinary measures.
