# STATE OF NEW YORK DEPARTMENT OF HEALTH

## FATALITY ASSESSMENT AND CONTROL EVALUATION

### Three Construction Workers Killed after being Struck by a Bus in a Highway Work Zone Case Report: 05NY039

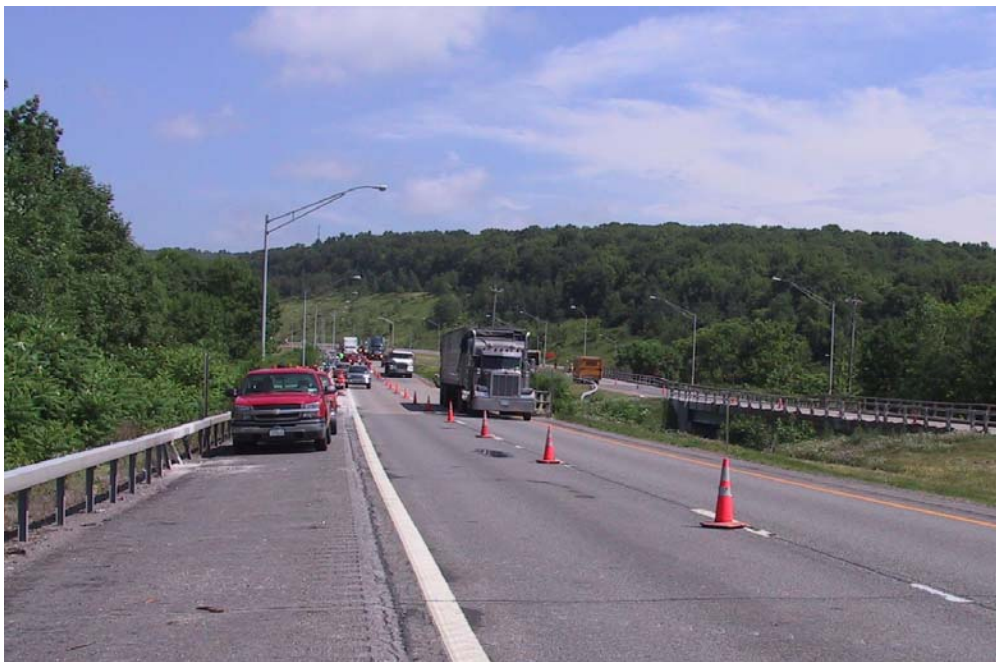
Photo 1. The site of the fatal incident where the southbound driving lane was closed to the traffic and the work zone was demarcated with orange traffic cones.

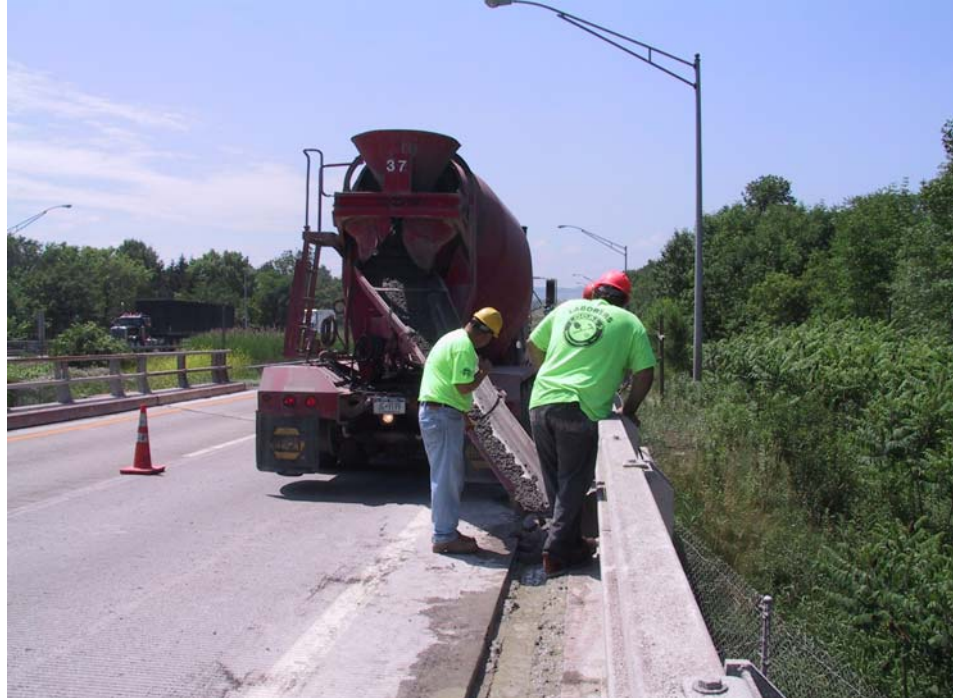
Photo 2. Paving company employees working at the rear end of the cement truck. (Photo was taken the day after work resumed, one month after the fatal incident. The cement truck and the workers pictured are in the same position as the victims at the time of the fatal incident.)

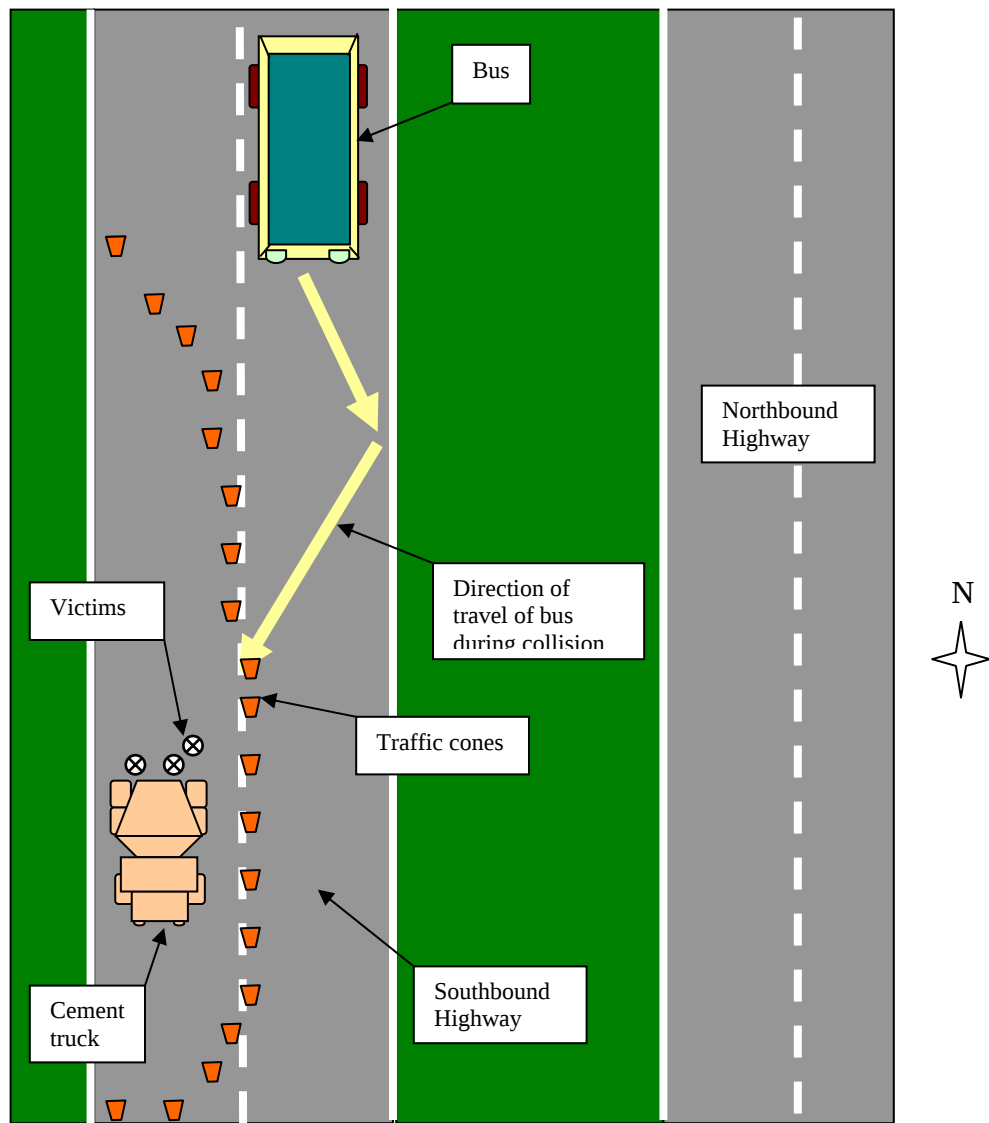
The section of the interstate highway where the fatal incident occurred was a four-lane divided highway for travel in a north/south direction. A grassy median divided the two southbound and two northbound travel lanes (Figure 1, pg. 9). The width of the southbound driving lane was approximately 11.6 feet and the width of the passing lane was 10.6 feet. The bridge shoulder on the east side was

Figure 1. Diagram of incident scene. (Diagram not drawn to scale).

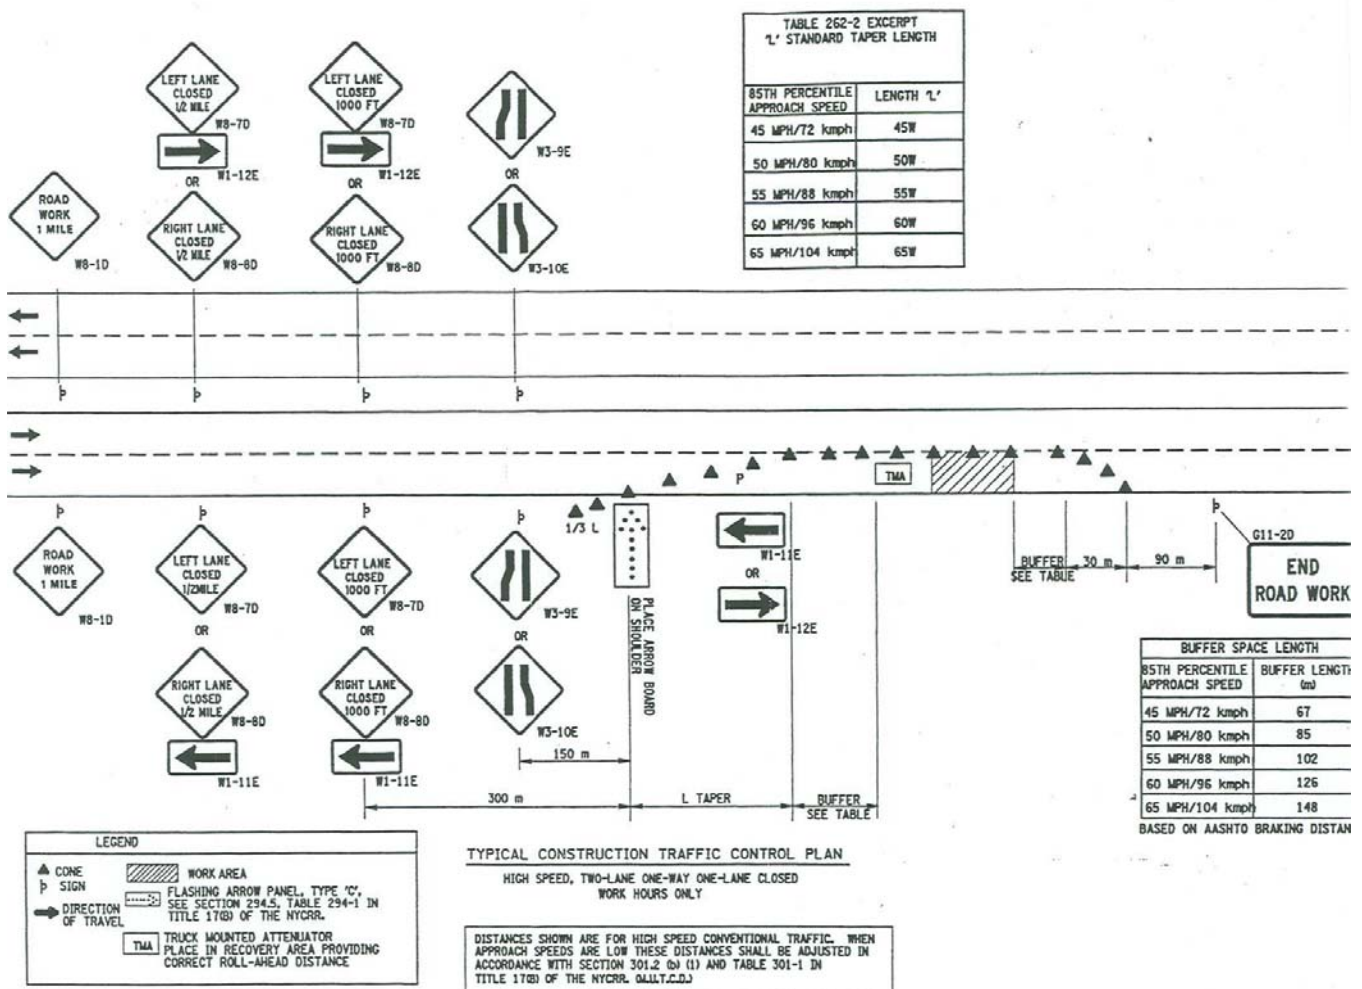
The temporary traffic control plan (Figure 2) was designed by NYSDOT based on the Federal Highway Administration's Manual on Uniform Traffic Control Devices (MUTCD). The speed limit was reduced to 55 mph within the temporary traffic control zone. The southbound driving lane was closed and the passing lane was open to traffic (Photo 1). According to the state police collision reconstruction report, signs reading "Construction Ahead", "Right Lane Closed", "Reduced Speed Ahead" and "55 MPH Speed Zone" as well as an electronic arrow board were placed along the 1.5 miles north of the construction zone to warn travelling motorists. The arrow board had an illuminated arrow pointing to the left (east) towards the passing lane, indicating that the driving lane was closed and motorists should merge into the passing lane. The work zone was demarcated by orange traffic cones starting approximately 0.2 miles north of the collision scene. The warning signs and orange traffic cones were set up by the paving company and inspected by NYSDOT inspectors. According to the NYSDOT representative, all traffic control devices were set up correctly.

Figure 2. Construction traffic control plan.

The NYSDOT suspended the construction operation immediately following the incident. The temporary traffic control plan was reviewed and revisions were made. Under the revised plan, the State Police Traffic Units sent trooper cars to patrol the work zone and enforce the traffic control. The NYSDOT also further reduced the speed limit within the work zone to 45 mph and the State Police increased the fine associated with speeding violations. On June 28, the first day when work resumed following the fatal incident, the troopers issued 40 speeding tickets at the incident site, according to the State Police.
