SUBJECT: A Construction Foreman Dies When the Construction Equipment He was Operating Tipped Over on Him

SUMMARY
California FACE Report #06CA003

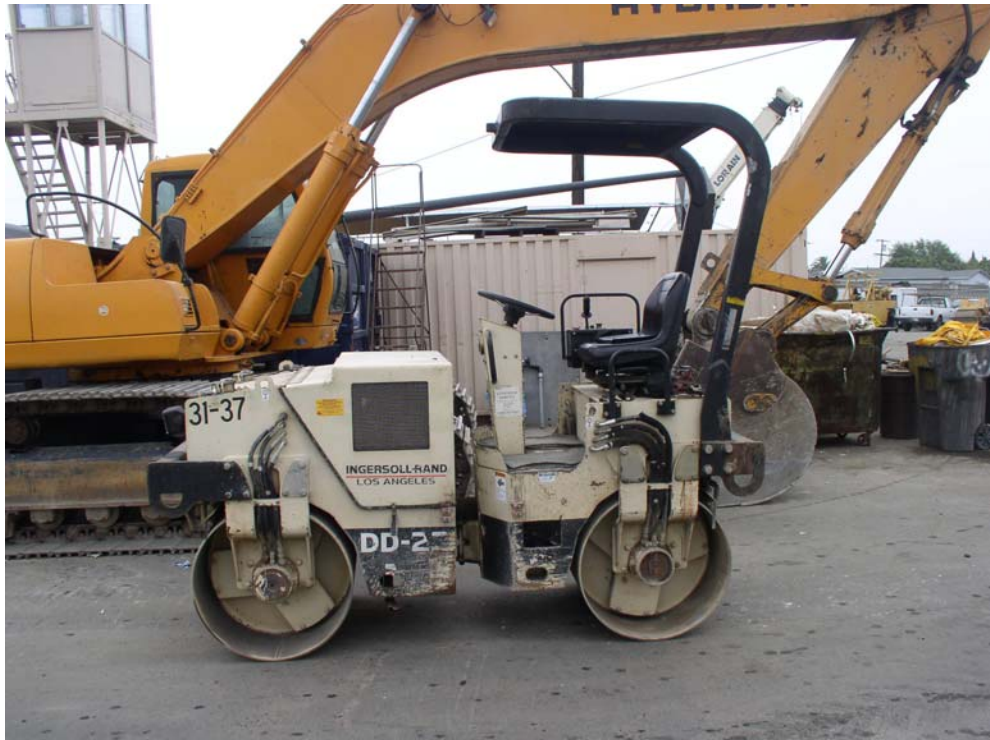
The operator was compacting the soil on the north bank of the newly constructed roadway. He was parallel with the roadway heading west when the rear drum on the compaction roller shifted rapidly to the left, causing the roller to start sliding down the incline and start to tip over. The victim jumped off the roller to his left. The compaction roller tipped over and the ROPS landed on the victim. A guard at the bottom of the roadway witnessed the incident and ran to get help from the project engineer. The project engineer called 911 and then went to assist the victim. He checked the victim for vital signs and found none. He waited for the paramedics to arrive and they pronounced the victim dead. The compact roller involved in this incident came equipped with a retractable seat belt that was in working condition at the time of the incident. The victim was not wearing his seat belt when the incident occurred.

Exhibit 1. A picture of the articulating vibratory tandem-drum compactor roller involved in the incident.

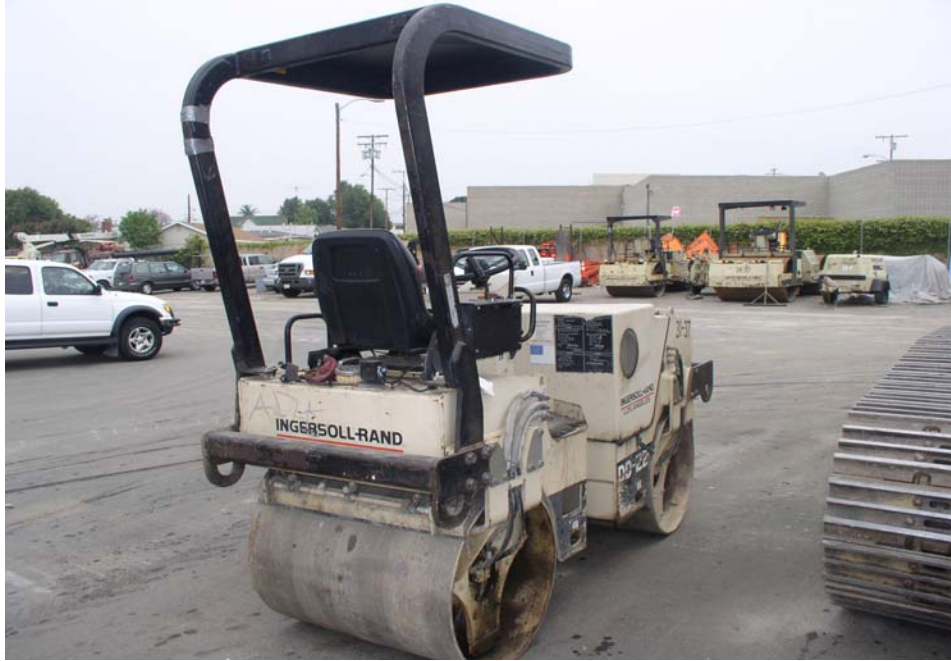
Exhibit 2. A picture of the rear of the compact roller involved in the incident.

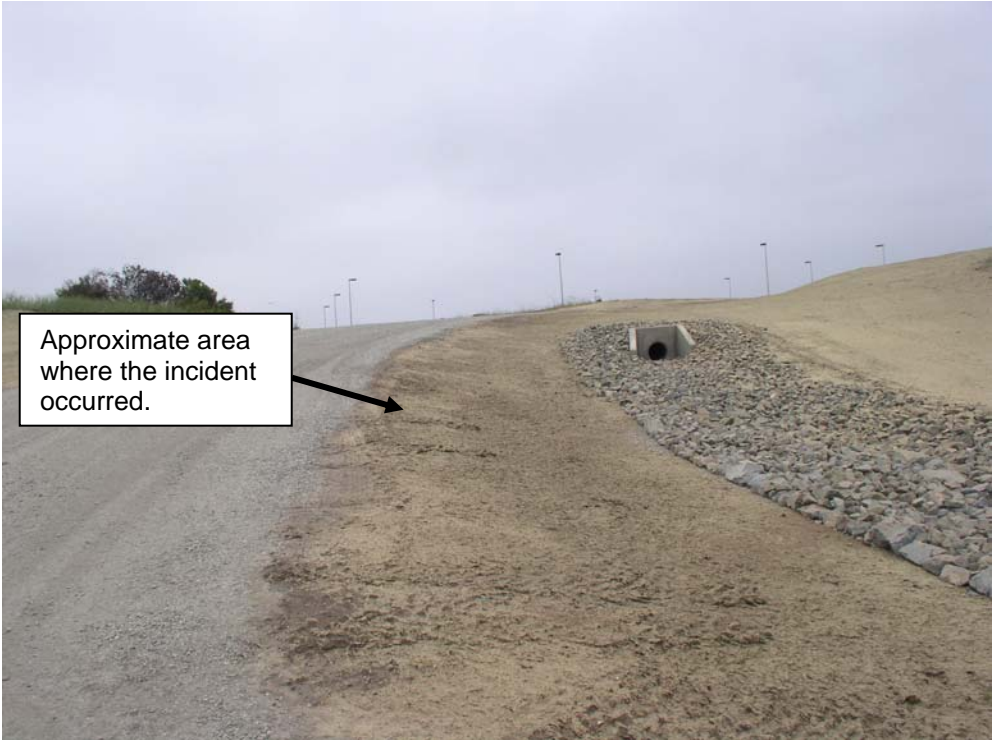
The site of the incident was a construction site on the perimeter of an international airport. The heavy equipment involved in the incident was a 3.5-ton articulating vibratory tandem-drum compaction roller. A vibratory compaction roller compacts surfaces with its weight and vibration. On the day of the incident, the victim was operating the compaction roller on a newly constructed roadway that was formed out of crushed aggregate. The roadway ran in an east/west direction and down an incline where the incident occurred. The north bank of the roadway where the incident occurred angled downward approximately 25 degrees.

Exhibit 3. A picture of the roadway where the incident took place looking east.

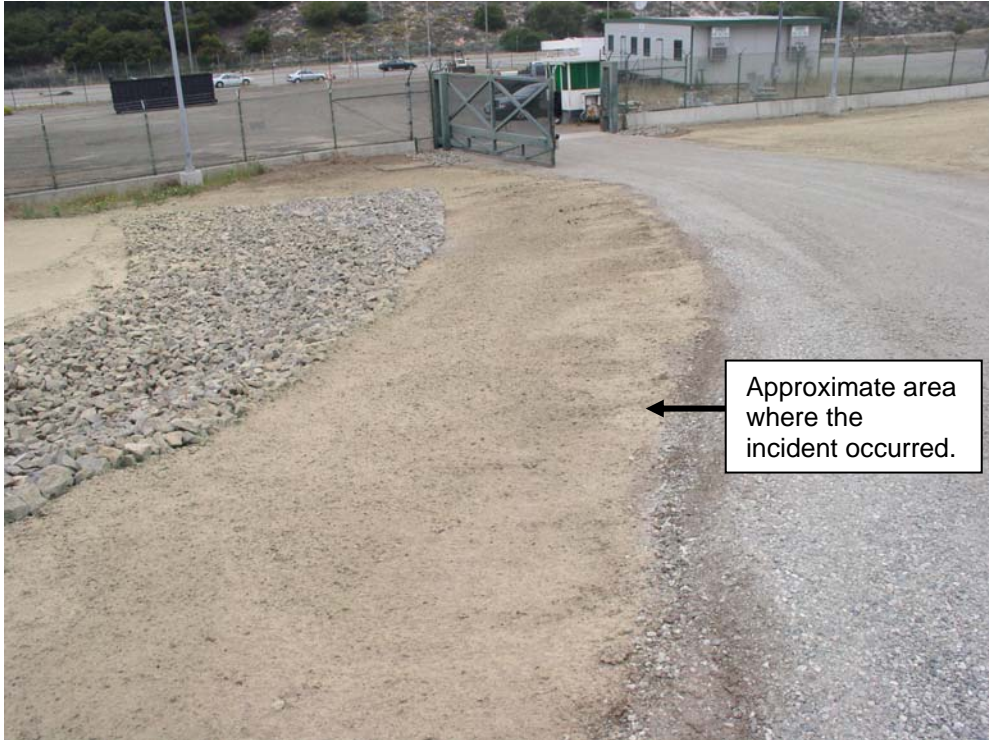
Exhibit 4. A picture of the roadway where the incident took place looking west.
