SUBJECT: A Hispanic laborer operating an overhead crane died when he was crushed between two steel frames when the rigging failed

SUMMARY
California FACE Report #06CA001

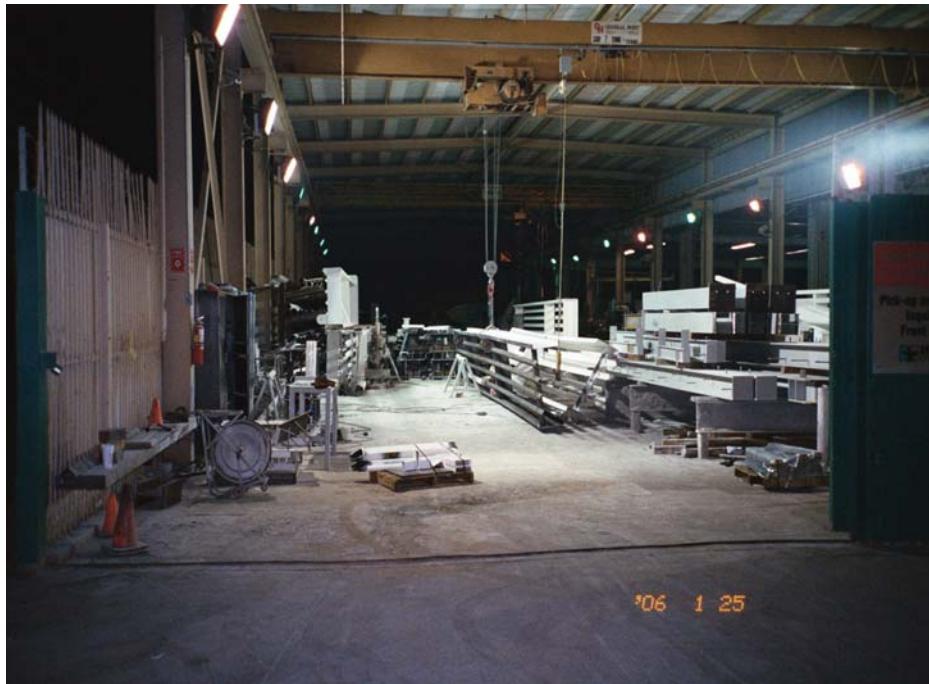
Exhibit 1. A picture of the work area where the incident took place.

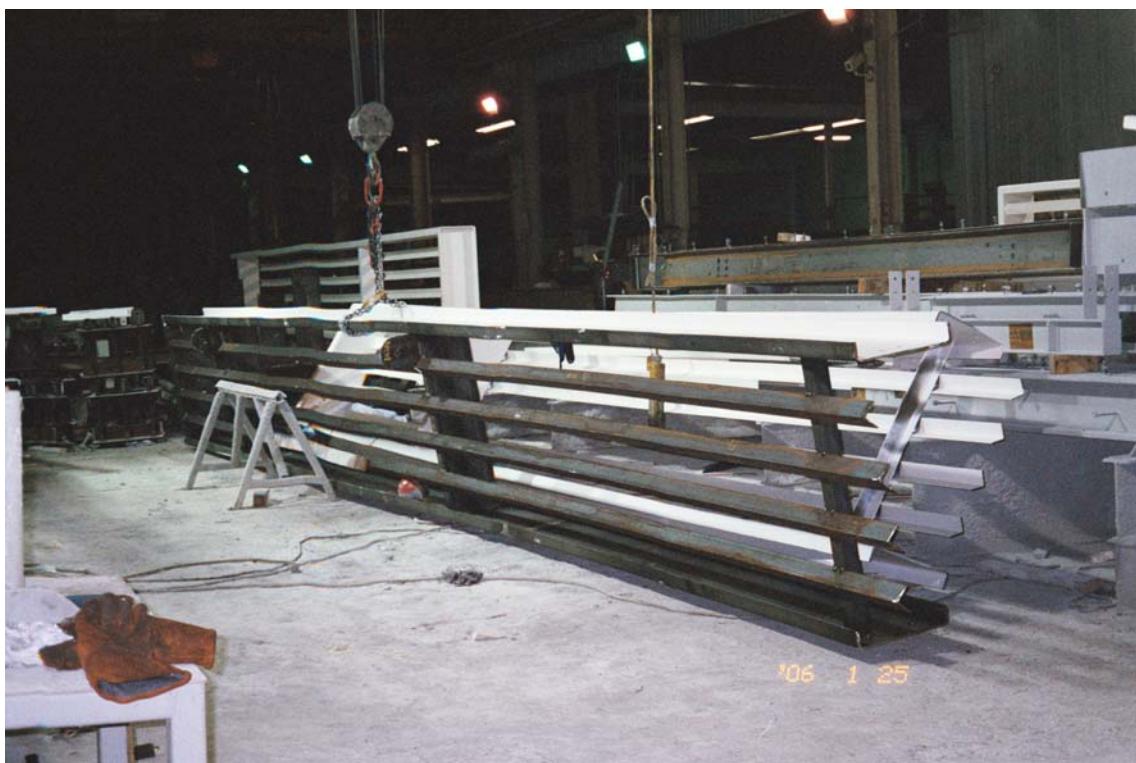
Exhibit 2. A picture of the steel frames that were involved in the incident.

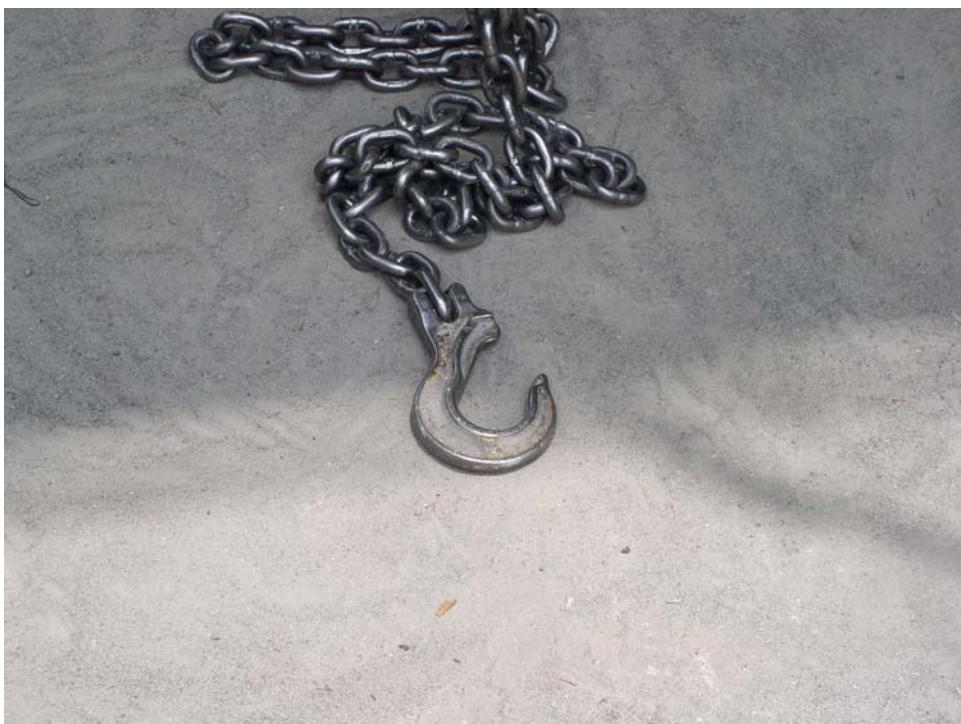
Discussion: The chain sling that the victim was using to move the steel frame was the standard sling he had used on numerous occasions. The safety latch attached to the hook had broken off at some point before the day of the incident, and had not been replaced. The latch was designed to prevent the hook from disengaging from the chain when properly rigged to lift material. Without the safety latch, there was nothing to prevent the hook from becoming disengaged from the chain when the tension was released from the sling. A thorough inspection of alloy steel chain slings performed by a qualified person designated by the employer should have discovered the missing safety latch as well as excessive wear, defective welds, deformation, and increase in link length.

Exhibit 3. A picture of the chain sling that was used to lift the steel frame from a horizontal position to a vertical position.

Recommendation #2: Ensure that the tools and equipment used in the shop are periodically inspected for defects and safety compliance, and are repaired or replaced as needed.

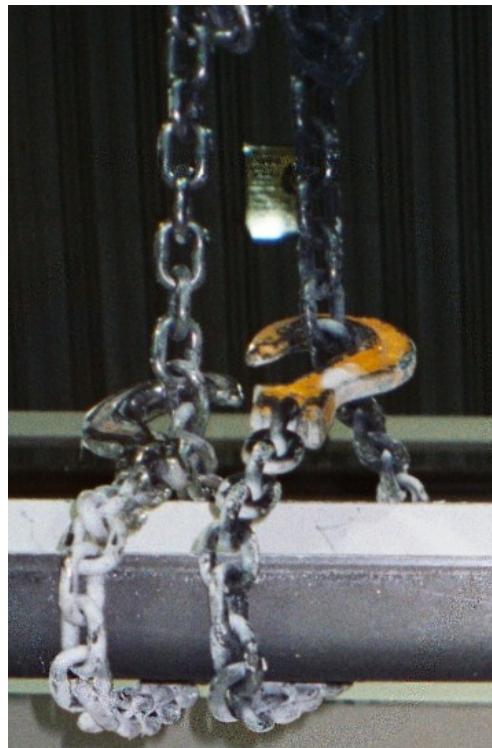
This released the tension on the chain because the steel frame remained on edge instead of lowering onto its side. Without any tension on the chain sling and no safety latch on the chain sling hook, the single choker hitch came undone. The wood beams, not strong enough to hold the full weight of the vertical steel frame, broke and the steel frame dropped to the ground. It fell forward toward the victim, crushing him between the two vertical pieces of steel. No one witnessed the incident. Two employees working in the same area heard the crash when the steel frame fell and called for help. They re-attached the chain sling to the steel frame and lifted it off the victim. Other employees dragged him from underneath the steel frame. The paramedics arrived at the incident scene and pronounced the victim dead.

Exhibit 4. A picture of a chain sling in a choker hitch position that was used to pick up the steel frame.

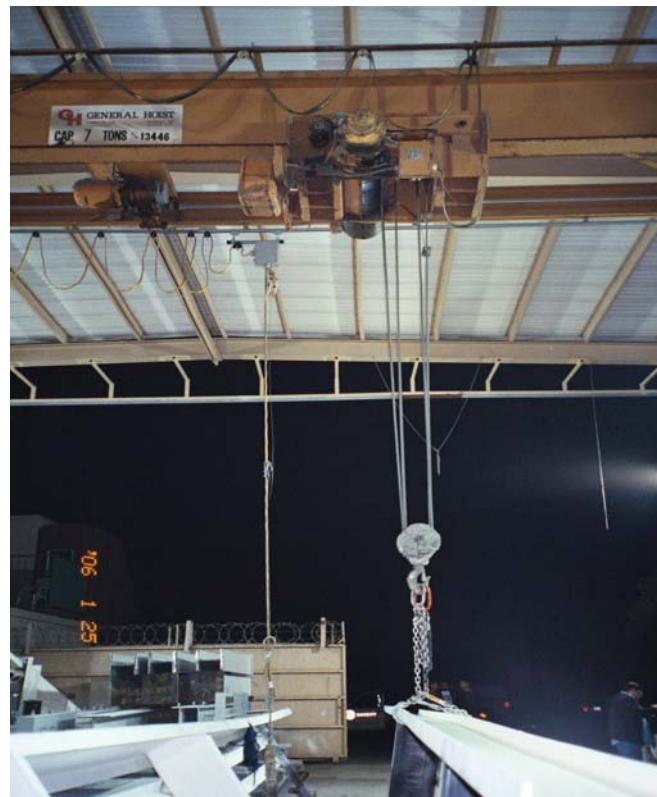
Exhibit 5. A picture of the overhead crane and controls involved the incident.

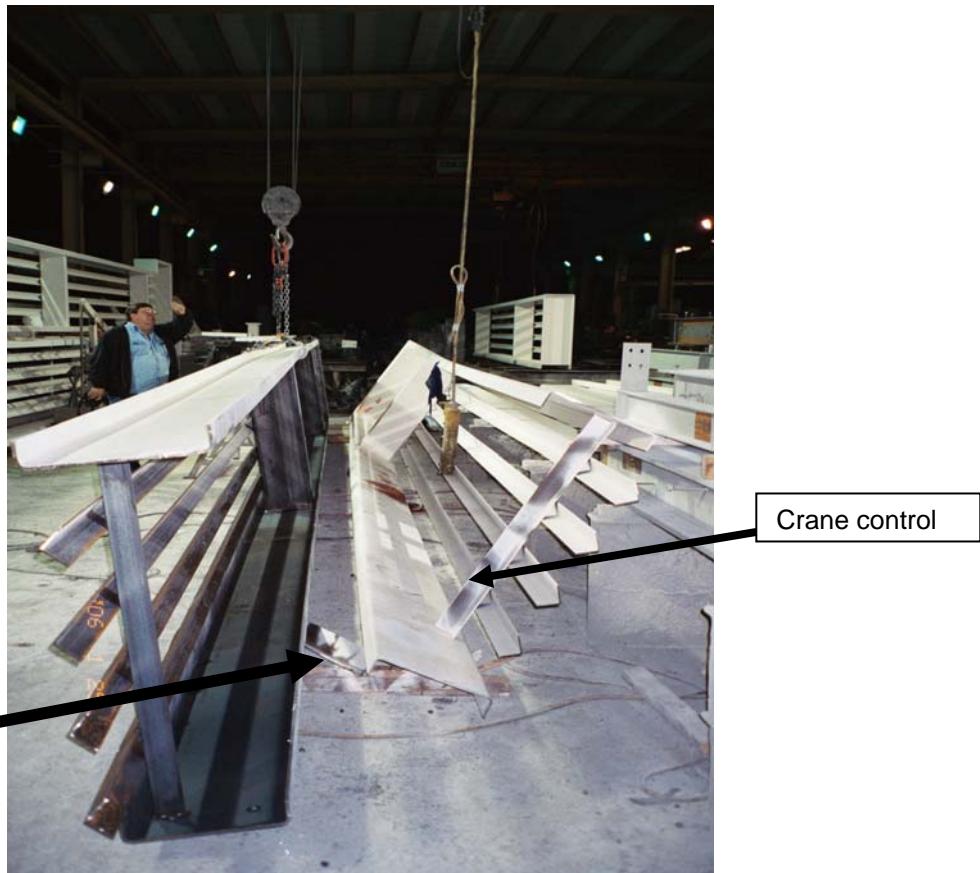
Discussion: In order to protect themselves and other employees, operators of overhead cranes must be constantly aware of their surroundings, and move their load in a controlled manner. In this particular case, the victim stood in an area where there was no exit should something go wrong. The victim should have avoided the areas directly under and close to the load. Employers can enhance worker compliance with safe work practices through programs of task-specific training, supervision, recognition, and progressive disciplinary measures.

Exhibit 6. A picture showing the area where the victim was standing and the crane control that the victim used to lift the steel frame.

Recommendation #1: Ensure employees do not place any part of their bodies into areas where they might become trapped when operating an overhead crane.

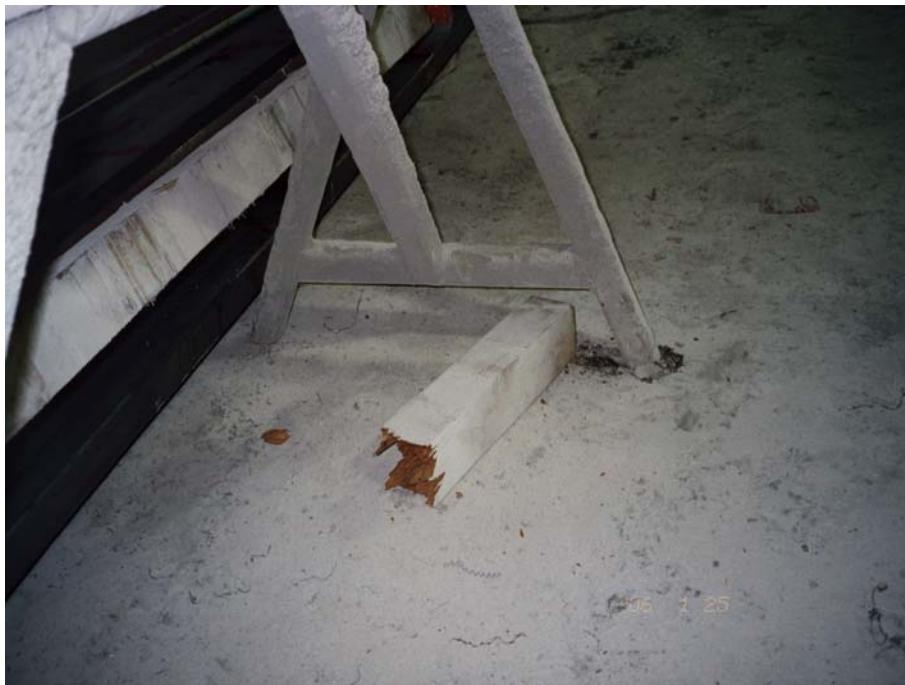
Exhibit 7. A picture of a piece of the wooden beam that broke under the weight of the steel frame.
