## Heavy Equipment Operator Killed During Rollover of Front-end Loader

### **Fatality Assessment and Control Evaluation (FACE) Project**

**Alaska Occupational Injury Prevention Program  
Section of Epidemiology  
PO Box 240249  
Anchorage, AK 99524-0249  
Phone (907) 269-8000  
FACE 99-027**

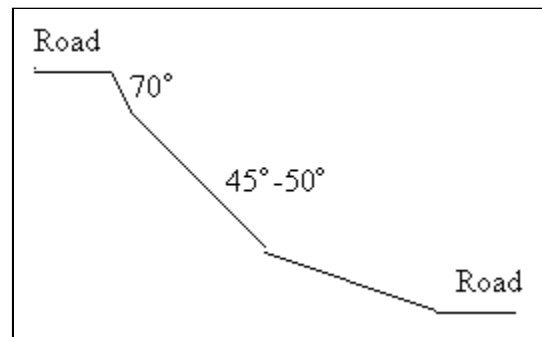
The terrain of the logging area varied in slope, altitude, and ground conditions. The yard and main camp areas were primarily flat. Roadbeds consisted of compacted dirt and crushed rock. The roads were graded on a regular basis to remove ruts and potholes created by the heavy equipment and logging trucks. The road at the incident site was at the top of a hillside (Figure 1). The road was cut into the slope and had less than a 10-degree grade at the top of the hillside. The road turned back 180 degrees; the grade increased through the curve and then flattened at the base of the hillside. The hillside immediately below the upper road section was approximately 70 degrees for the first few feet then reduced to 45-50 degrees before tapering to the lower road section.

**Figure 1. Slope of hillside (not drawn to scale)**

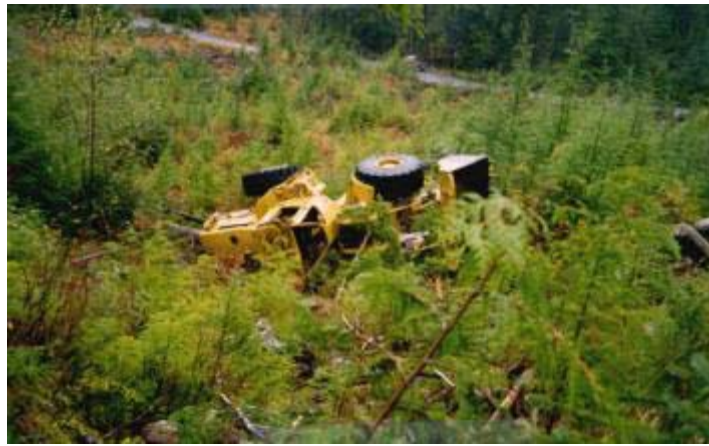
At approximately 10:45 A.M. on the day of the incident, a log truck driver saw the victim as he drove the loader from a staging area toward the main camp. At that time, the two vehicles were about ½ mile from the incident site. At approximately 12:00 noon, another log truck driver observed the loader lying on its side, halfway down a slope (Figure 2). He radioed the camp manager that the loader was off the road and had rolled down the slope. After completing his radio communication, the driver went down the slope to see if he could find the driver.

**Figure 2. View of front-end loader from top of slope.**

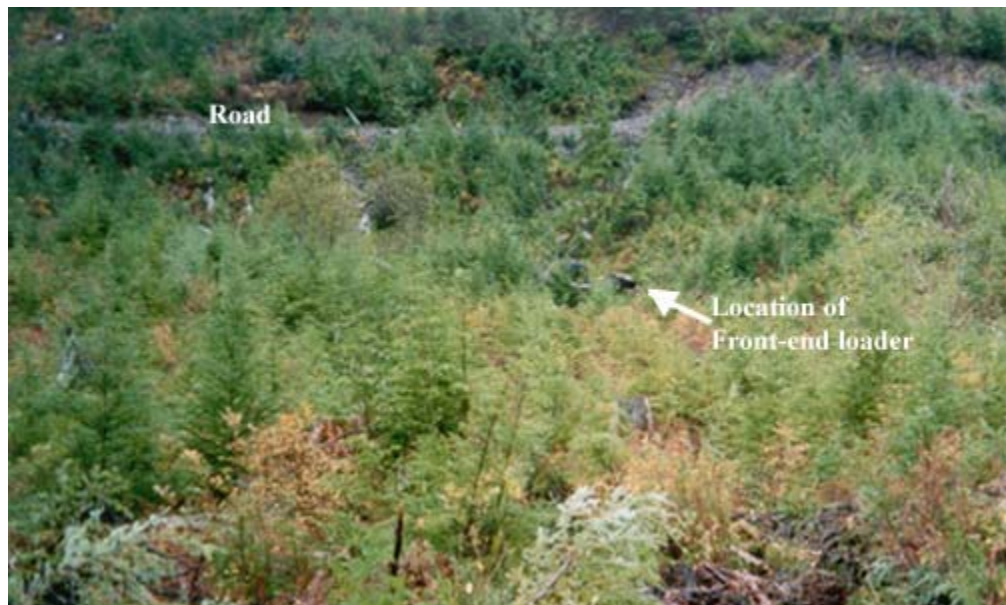
He found the victim between the road and the loader. He had been thrown from the operator's compartment and appeared crushed. A section of the operator compartment windshield and the driver's seat was 18 feet downslope of the victim (Figure 3). The loader came to rest 52 feet below the windshield and driver's seat (Figure 4). Alaska State Troopers were notified. The victim was pronounced dead at the scene.

**Figure 3. View of slope and upper section of road.**

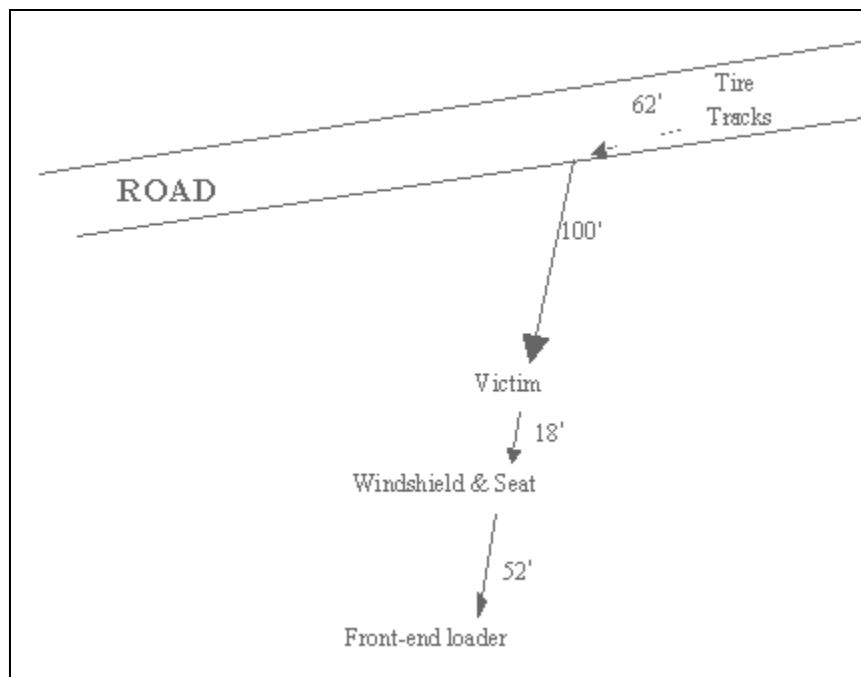
**Figure 4. Diagram of incident site**

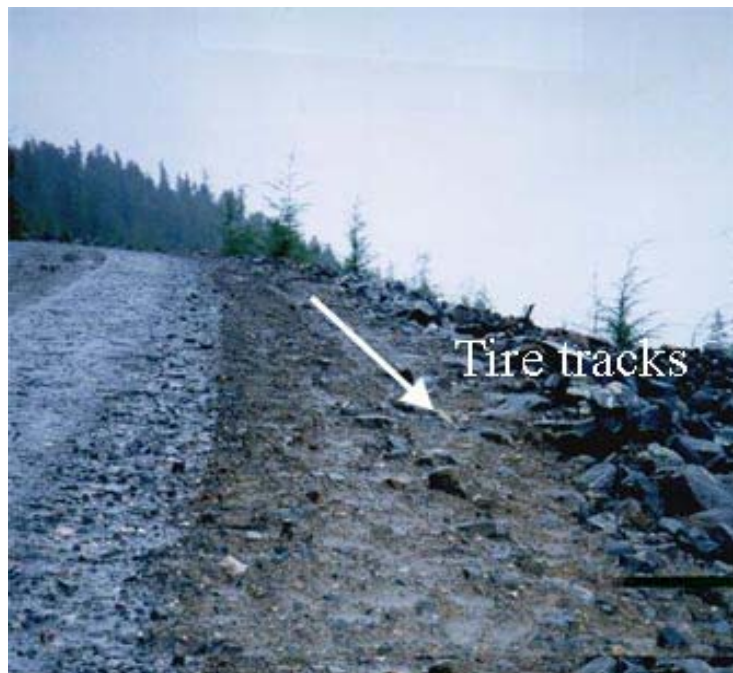
During the investigation, 62 feet of tire tracks, resembling those of the loader, were noted along the road. The tracks were along the edge of the road and ended at the point above the loader's location on the slope (Figure 5). Since the incident was not witnessed, it was surmised that the loader moved to the road edge before going off the road and rolling over.

**Figure 5. View of tire track approaching road shoulder and departure point from road.**
