# MIFACE INVESTIGATION #05MI089

## SUBJECT: Retired Teacher/Farmer Dies When Pinned Under Overturned Tractor.

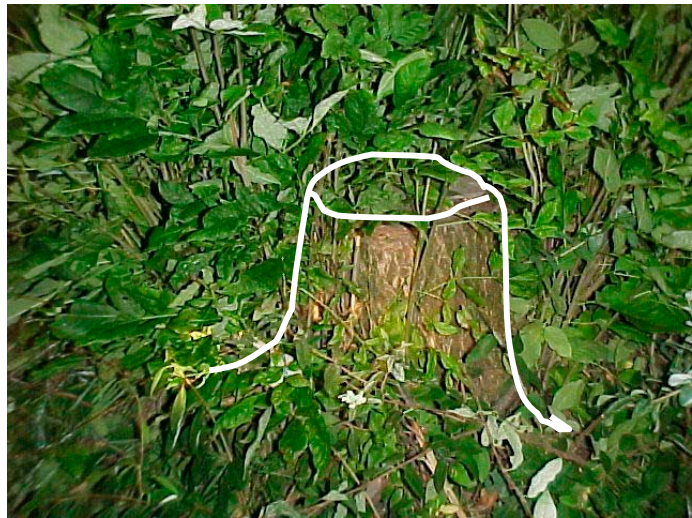
Figure 1. Police Photo of stump that was struck by tractor and/or brush hog

Approximately one year earlier, the decedent had cut down a tree in the area between the driveway and the bean field (Figures 1, 4, and 5). Due to the growth around the stump at the time of the MIFACE site visit, the stump height and diameter could not be measured. The MIFACE investigators estimated that the stump was from a mature tree and measured 10 inches in diameter by 12 inches in height. At some point during the day, after 7:30 a.m. when his wife left for the day, the decedent began to cut the area between the bean field and the driveway. The slope varied in the area between the driveway and the bean field. He had completed two cuts. The first cut was on the edge of the grass on a fairly flat area next to the bean field. His second cut was the grass area between the driveway and the slope. After turning, his third cut was higher on the slope. The tree stump that had been cut the year before may not have been visible to him because of the new tree growth or the brush growth on the slope. It appears either the tractor wheel or the brush hog, or both struck the stump, causing the tractor and brush hog to both turn over to the side and land upside

A contributory factor to this tragic incident was the presence of the one-foot high stump. The stump showed fresh damage caused by either the tractor or brush hog running onto/over it. Cutting the stump as close to the ground provides a travel area that will not have the elevation changes (either above ground, or in the case of grinding out a stump, a depression) which would minimize the possibility of the equipment overturning.

- When trees are cut down in areas where farm equipment and tractors will travel, the stumps should be cut as close to the ground as possible, removed, or ground down.

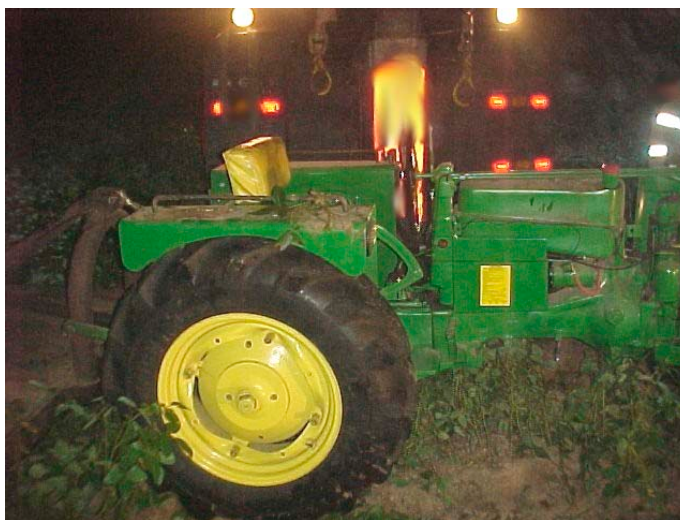
Figure 2. Tractor after being turned upright by tow company

The tractor involved in the incident was a restored 1957 John Deere 420 U model (Figure 2). It was a 2-cylinder tractor and was in good running order. The hand clutch was on the left and the brakes were located on the right. The power take-off (PTO) lever was on the right side. The tractor was equipped with an umbrella. The owner had fashioned rectangular fenders that he placed over the existing tractor fenders. Due to his knee problem, he had secured handholds on the fenders to assist in ascending/descending from the

- Retrofit older tractors with properly designed, manufactured and installed rollover protective structure (ROPS) and seat belt when available.

Older tractors can be equipped with rollover protection structures and seatbelts. Rollover protection structures (ROPS) have been required by federal and state law for all tractors used by employees (with limited exception) in agricultural operations that were built after October 25, 1976. There are two basic types of ROPS for farm tractors: protective frames (two- or four- post structures attached to the tractor chassis) and protective enclosures (cabs or enclosures built around a protective frame). ROPS are designed to help limit a tractor overturn to 90 degrees and to provide the operator a “zone of protection” (Figure 7). The operator must stay within this zone. The operator will not be protected by the ROPS during an overturn if the operator is not wearing a seatbelt. Without a seatbelt, the operator may be totally or partially thrown off the tractor. The seatbelt keeps the operator within the "zone of protection" provided by the ROPS. Even inside a cab, seat belts are important to keep the operator from being thrown against the frame, through a window, or out a door. Therefore, when an older tractor is retrofitted with a ROPS, approved seatbelts must also be installed. Seat belts may or may not be included with an available ROPS package.

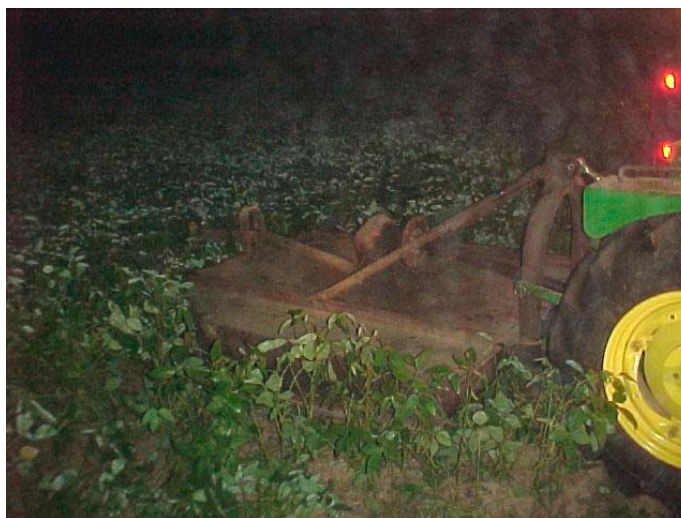
Figure 3. Brush hog after tractor turned upright by tow company

The brush hog had a 5-6 foot cutting width and was wider than the tractor frame/wheels (Figure 3).

Because the decedent's wife sold both the tractor and the brush hog, MIFACE investigators were not able to see the machinery. She stated that when she used the tractor with this brush hog to mow hay she needed to travel slowly or the front of the tractor would bounce. The extra weight on the rear of the tractor was not compensated for by weights on the front of the tractor (if allowed for by the manufacturer) and therefore was likely a misapplication of equipment attached to this size and weight of tractor.

- Ensure accessory equipment is properly sized to the tractor.

Too large of an implement can create not only equipment damage, but also safety issues for the equipment operator. Proper matching of accessory equipment with a tractor is generally obvious but it deserves attention. Operators are occasionally tempted to operate an implement with tractors that are too small or too large to operate or control them. A tractor that is too small for the equipment may become unstable because of the extra weight on the three-point hitch. The mower appeared to be a seven-foot mower because it extended just beyond the tractor rear wheels. Generally, the ability of the three-point hitch to lift this mower is an indication of capacity. While this model tractor was known to have a better lift, it did not have overlift capacity. Due to the length of the mower, the manual for the mower or tractor may have recommended counter weights on the front and possibly rear wheels to counteract any shift in the oversized mower the center of gravity. The decedent did not have an operator's manual to determine the maximum accessory size for this restored old tractor.

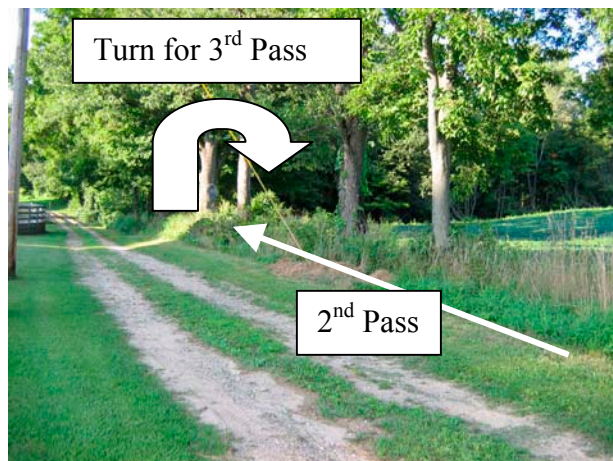
Figure 4. View of bean field on right of slope and driveway

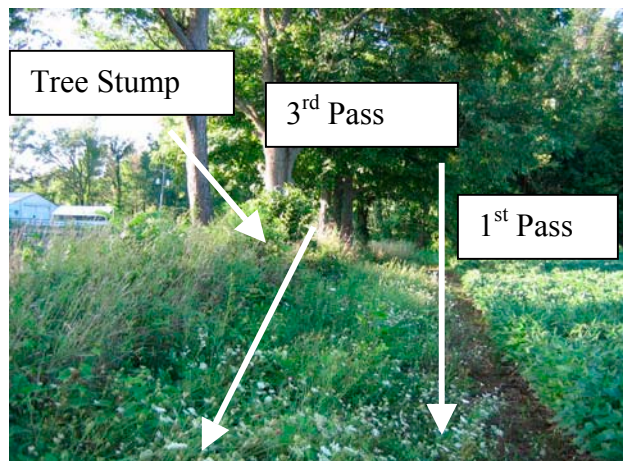
Figure 5. View of bean field and area being cut by decedent

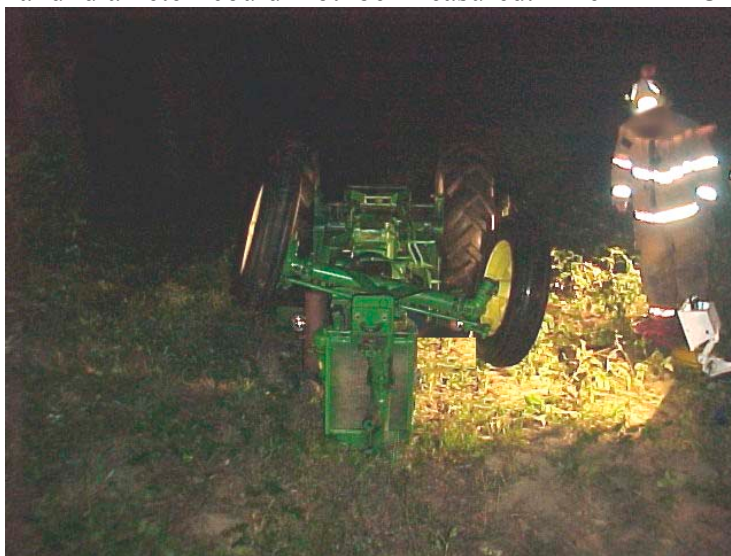
Figure 6. Overturned tractor
