# Fatality Investigation Report

OR 2005-07-1

## Technician crushed when aerial platform lift engaged

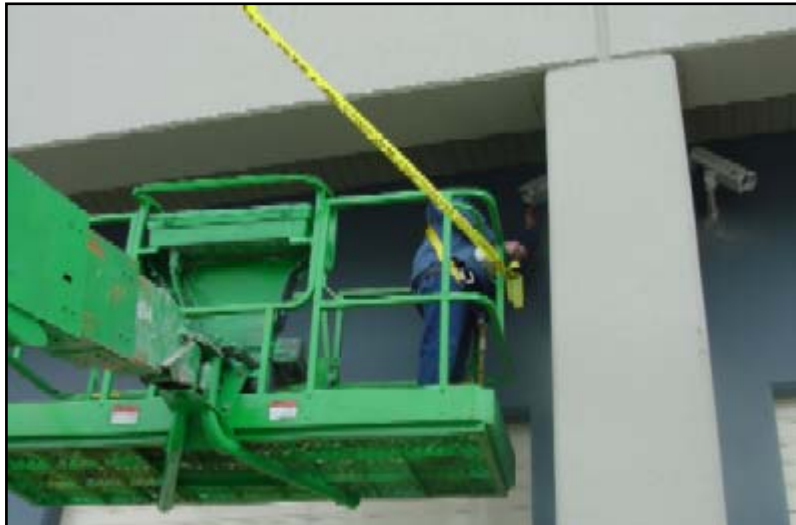
View of aerial platform during OR-OSHA investigation.

The technician may have had difficulty with the operation of the lift's foot pedal and control lever. He apparently depressed the foot pedal and the control lever, and was leaning over the platform railing when the mechanism engaged. When the lift rose, the technician's head hit the roof overhang. The lift continued to rise, pinning the bent-over technician between the base of the roof overhang and the lift railing.

- All workers using mobile machinery should have adequate training on the proper use and safe operation of the equipment.
- Read and follow the manufacturer's operating manual before using machinery.

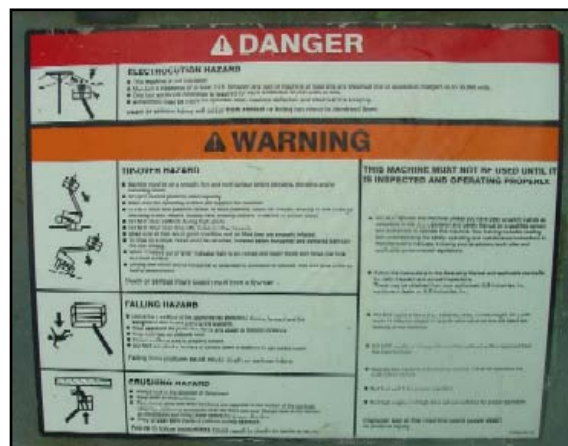
The warning label on the aerial platform illustrates the hazards of electrocution, falling, or striking an overhead obstacle.

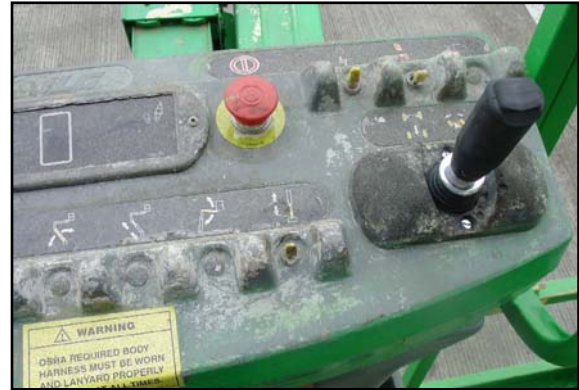
not depressed for a period of 7 seconds, and will not respond for 2 seconds after being reengaged. There is also a 2-second delay from leaving the control to stop, which equals about 9 in. of travel. Inspection of the machine by the rental company following the incident found no mechanical malfunction, but a separate inspection found the lift mechanism hesitated slightly longer than expected.

The lift mechanism involves both hand and foot controls.

The manufacturer’s operating manual, containing operating and maintenance instructions, is required to be with the equipment, as provided by ANSI/SIA A92.5 (1995). In this case, the operating manual and the ANSI manual were attached to the lift. The lift was posted: “Operator required to read and understand operation and ANSI manuals before operating,” and the bucket was posted with required body harness and attached lanyard requirements. The Gradall operating manual outlines user responsibilities and operator training, including safety precautions, use and limitations of the controls in the platform and at the ground, emergency controls, safety systems, recognition of a malfunction, use of fall and head protection, and machine operation around overhead obstructions, other moving equipment, and obstacles.
