Fatality Investigation Report

OR 2003-21-1

Worker killed in wood-dust fire sparked by faulty fuse

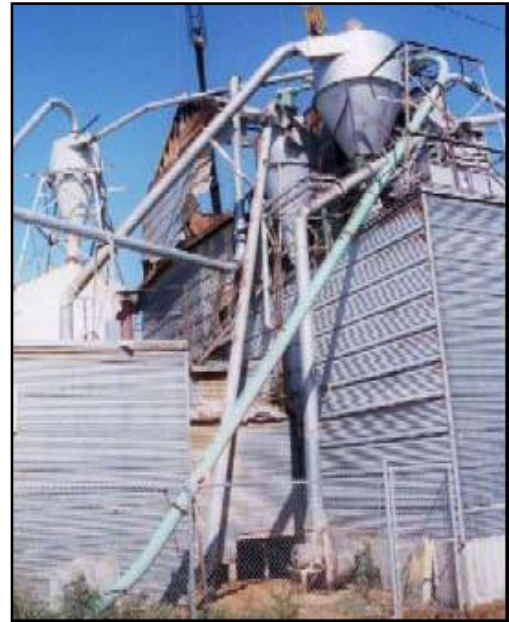
The top of the factory roof was destroyed in the wood-dust explosion.

The concussion from the initial blast caused wood dust on other surfaces in the area to become airborne, creating a rapid succession of at least three explosions that combined into one very loud, superheated explosion. The required isolation of the fuse-panel room was compromised by a large hole in the wall (1 ft x 3 ft), created during an earlier installation of an I-beam to support the main flour bin. The hole had allowed wood dust to collect on surfaces in the fuse-panel room. When the explosion occurred, the hole also allowed the blast to reach directly where the worker was standing. The upper portion of his body was severely burned, and he inhaled toxic, superheated air.

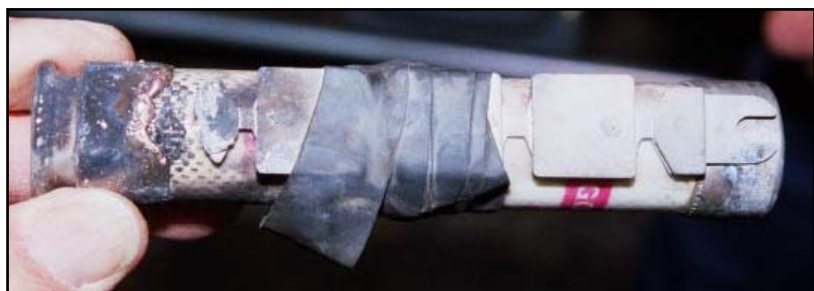
On the day prior to the incident, the production worker was shown a fuse that had been repaired by a coworker during the previous shift. Apparently, the appropriate replacement fuse was not available (or there was trouble getting it to work properly), and the coworker had taped a renewable fuse link to the outside of the melted, nonrenewable fuse cartridge. The production worker removed the rigged fuse to inspect it, and then reinserted it into the fuse holder.

A melted fuse was repaired by taping a renewable fuse link on the outside.

At 7 a.m. on the following day, the production worker started up the plant operation. Working alone, he began switching on the equipment in a standard start-up sequence. Switches were located in a large storage area adjacent to the fuse-panel room. The rigged fuse was connected to a three-phase 440-volt/30 amp electrical motor for a fan that collected dust emissions from the milling process. The motor was later inspected and found to be fully operational. The rigged fuse had evidently made good contact with the fuse holder earlier, but when removed and reinserted it remained loose enough to allow the renewable fuse link to “chatter” against the ends of the housing, due to vibrations from running equipment in the factory. When the worker hit the switch for the fan, an electric arc was generated across the poor connection between the makeshift fuse and the fuse holder. The wood dust that had accumulated inside the fuse panel ignited and exploded.

The poor contact between the makeshift fuse and the fuse holder was a primary risk in this incident. Fuse holders are designed to ensure tight electrical contact with the fuse end to prevent arcing. The makeshift fuse used in this incident defeated this design. In a renewable fuse, the fuse link is enclosed, and any sparks that might occur are contained. One-time-use fuses must be replaced with a new fuse once expended. A supply of appropriate fuses and circuit-breaker replacements should be maintained for each circuit in a facility.

Recommendation #1. Protection devices for electrical current, such as fuses, should not be altered or bypassed.
