**SUBJECT:** A construction laborer was struck in the head and killed by a falling steel beam.

## **SUMMARY**

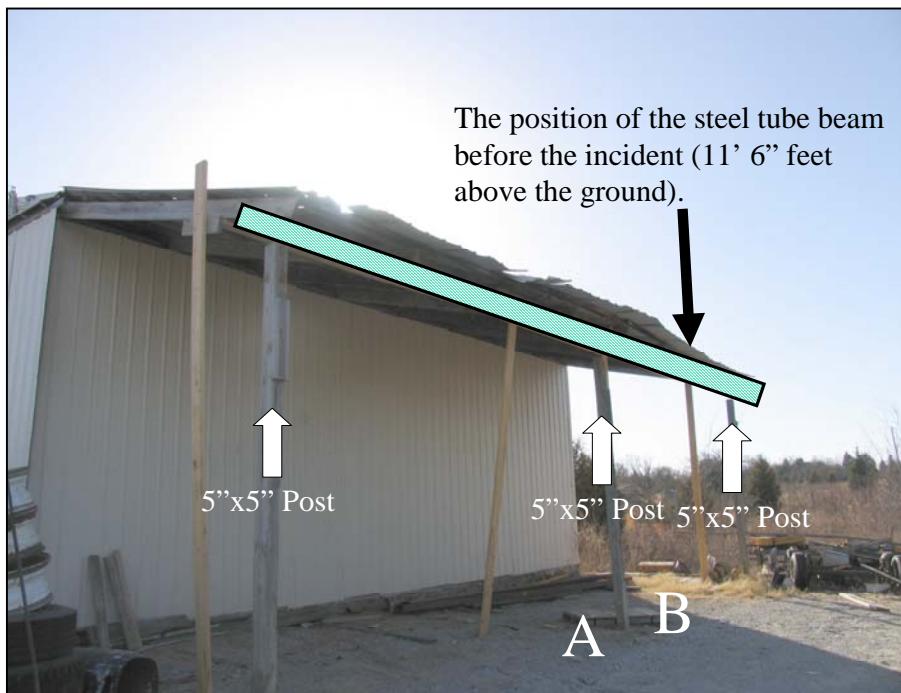
**Incident Scene:** The incident occurred on company property at the lumber storage building (Figure 1). The employer and three employees were present at the time of the incident. The work shift began at 8:00 a.m. and the incident occurred at 4:00 p.m. The ground conditions were dry level dirt.

Figure 1. Incident scene: A indicates the position of the forklift holding the steel beam, and B indicates the position of the forklift holding the platform.

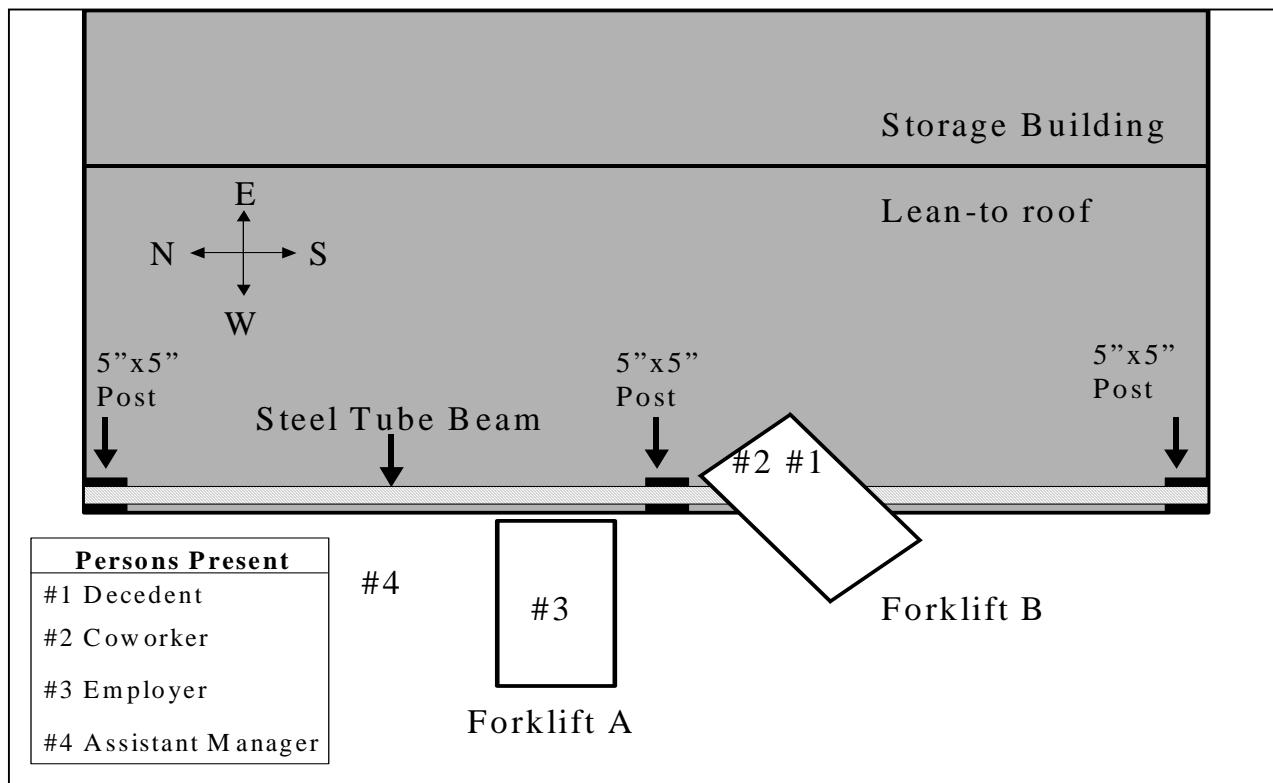
the beam, the decedent and a coworker were using two forklifts to replace a wood beam with the new rectangular tube steel beam on a lean-to roof of a storage building (Figures 1 and 2). The steel beam was composed of two 20-foot long rectangular shaped steel tubes measuring four inches by six inches with one-quarter-inch thick walls (Figure 3). The two tubes were welded together with a one-and-one-half-inch by three-inch steel channel welded to the top to form a single steel beam 40 feet long, weighing approximately 1,000 pounds. Three brackets, composed of 3-inch by 3-inch by 12-inch angle iron (L-shaped) (Figure 4), were welded to the six-inch face of the steel beam. Six inches remained to attach the beam to three new 5-inch by 5-inch by 11-foot, 6-inch treated wood posts. The decedent and coworker assembled the steel beam, steel channel, and angle iron brackets at the worksite. They worked together to shore up the roof, remove the old wooden beam, and place the new steel beam on top of the three support posts. Although hard hats were available, neither employee was wearing one.

Figure 2. Overhead view diagram of the scene at the time of the incident (not to scale)

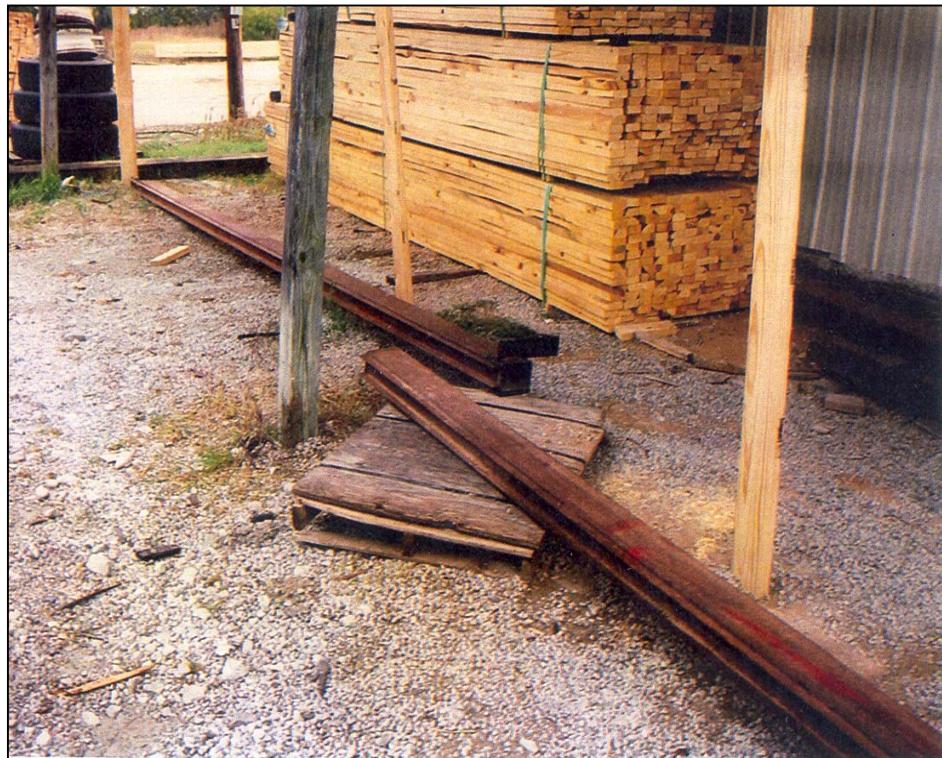
Figure 3. Two 20-foot sections of steel rectangular tube beam involved in the incident

decedent in the head and landed on him. After falling to the ground, the coworker climbed the mast of forklift B to push the steel beam off the decedent. When the decedent's coworker moved the 40-foot beam, it fell to the ground, breaking the weld. The forklift platform was lowered and a call was immediately placed for emergency medical response. The assistant manager of the company had just arrived at the site as the incident occurred and was standing on the north side of forklift A. EMS arrived in less than 10 minutes and transported the decedent to the nearest hospital from which the decedent was airlifted to a trauma facility. He was pronounced dead later that same day.

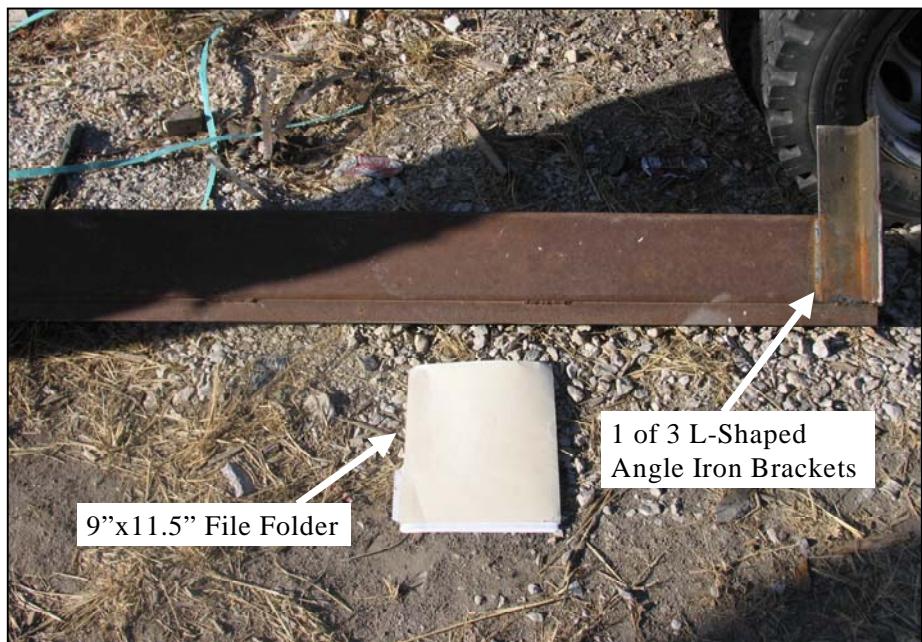
Figure 4. L-shaped angle iron brackets attached to the steel beam

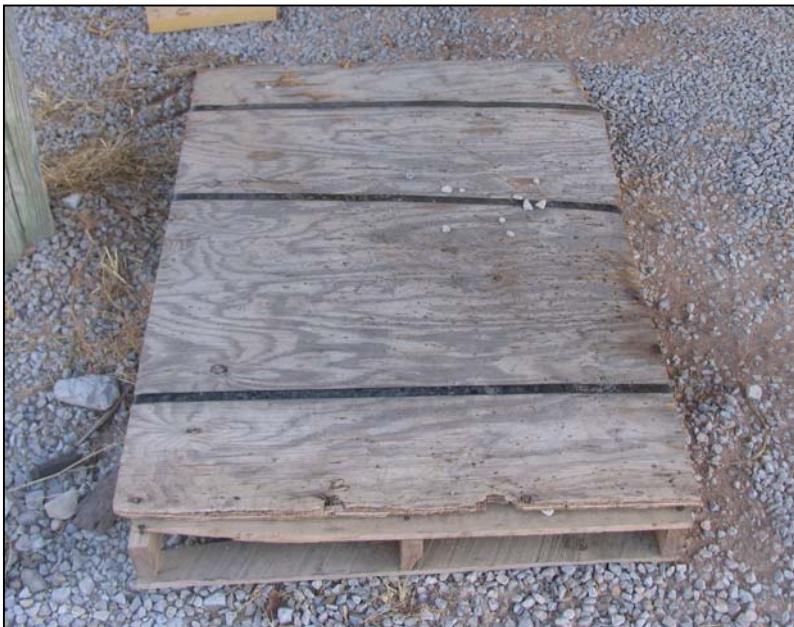
A wood forklift platform was used during the work to elevate the decedent and his coworker. The forklift platform was built with a 32-inch by 48-inch wood pallet and a  $\frac{3}{4}$ -inch by 33-inch by 48-inch piece of plywood banded to the pallet (Figure 5). Forklift A was positioned on the north side of the center wood post facing east and was used to elevate the steel beam to a height of 11 feet, 6 inches. Investigation records indicated that the hydraulic side shift on the carriage of forklift A, which controlled the side-to-side motion of the forks, was in need of repair. It is unknown if this malfunction contributed to the incident. Forklift B was located on the south side of the center wood post facing northeast. Forklift B was used during the incident to elevate the wood platform holding the decedent and coworker. Forklift A was approximately 20 years old and forklift B was 10 years old. The forklift platform was not an approved lifting device and it was not secured to the forklift; the forks of the forklift just went through the open slots on the bottom of the pallet.

Figure 5. Wood platform used during the incident

**Recommendation #3: Employers should ensure that forklift operators elevate personnel only with approved lifting cages that are properly attached to machinery.**

Discussion: Employers should provide an approved lifting cage when employees need to work at elevated heights. An approved lifting platform was not used during this incident. Company-built personnel platforms should comply with OSHA regulations and standards from the American National Standards Institute (ANSI) and the American Society of Mechanical Engineers (ASME). Employers should also consider consulting with their forklift manufacturer to identify appropriate personnel platforms designed for their particular machines. OSHA standards require lifting platforms and other types of scaffolding to be examined by a competent person before each work shift to ensure structural integrity. Approved lifting platforms should be equipped with a means of protecting workers from falling from the platform and also should be attached to the forklift to prevent the platform from falling. When lifting employees in an approved lifting cage, basic safety measures should be utilized. Basic safety measures include the use of restraining means, such as rails, chains, or body harnesses with lanyards or deceleration devices; elevating a worker on a platform only when the vehicle is directly below the work area; securing and leveling the platform to the forklift; and lowering the platform before driving to another location. Sway controls should not be used to make lateral movements while workers are on a raised platform; even small adjustments in the hydraulics can produce exaggerated, jerky movements of the forks and platform.
