## **Logger killed when stuck by rebounding tree**

**FACE 99-AK-021**

**Release Date: July 13, 2000**

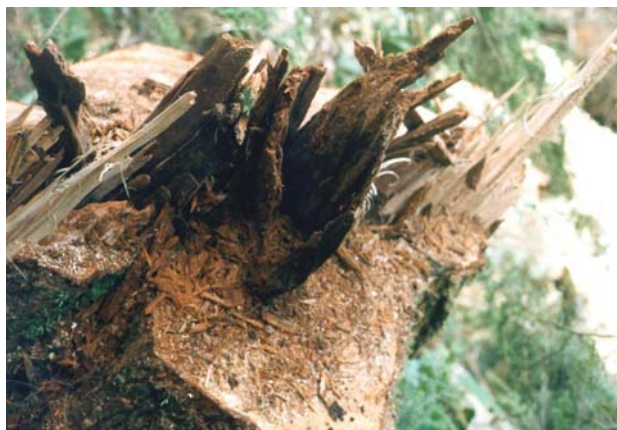
Figure 1. View of holding wood

However, the undercut penetrated an area of heart rot. Heart rot is more common in older trees and is usually caused by damage or injury to the trunk at an earlier stage of growth. The core can continue to degrade while the external wood heals around the original injury. This seriously compromises the holding wood that acts as a hinge to help control the tree's fall. Examination of the wedge or shavings from the undercut may have shown signs of discoloration or rot and indicated the wood within the core was substantially weaker than the peripheral wood of the trunk.

**Recommendation #1: Employers should ensure that all cutters are capable of casing trees for internal rot so that they can modify their cutting procedures, if necessary.**

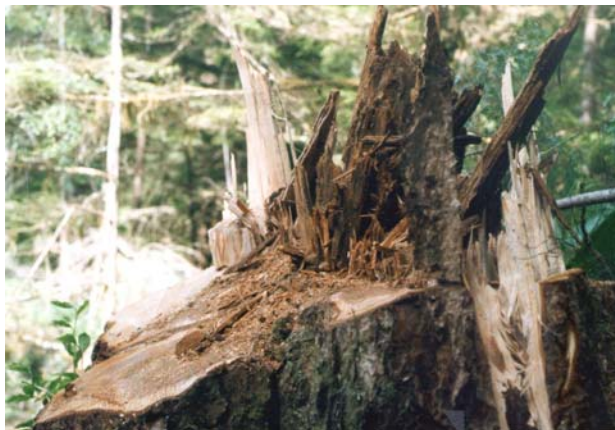
Figure 2. View of holding wood and Humbolt (face) cut

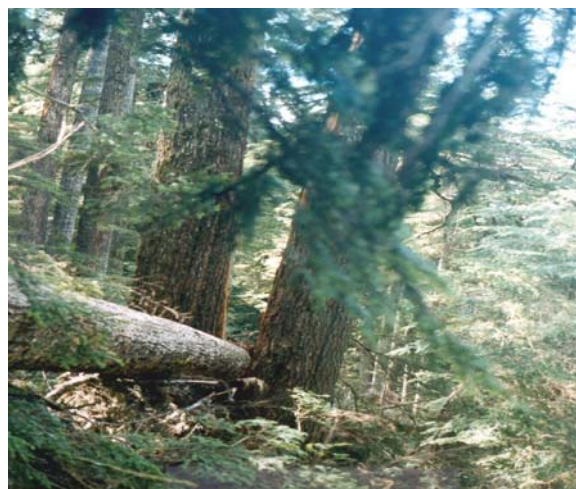
(Figure 3). The falling tree lodged in the fork (Figure 4), causing the top 40 feet of the felled tree to break off. The remaining log pivoted in the fork, and the butt rebound upslope. The butt of the log struck the victim's upper back.

Figure 4. Actual lay

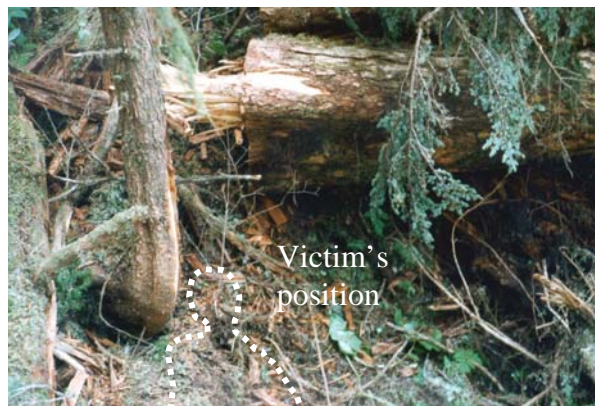
Figure 5. Victim's position below log
