# **ALASKA FACE**

## **FATALITY ASSESSMENT & CONTROL EVALUATION**

### **Logger killed when struck by a dislodged limb**

**FACE 99-AK-015**

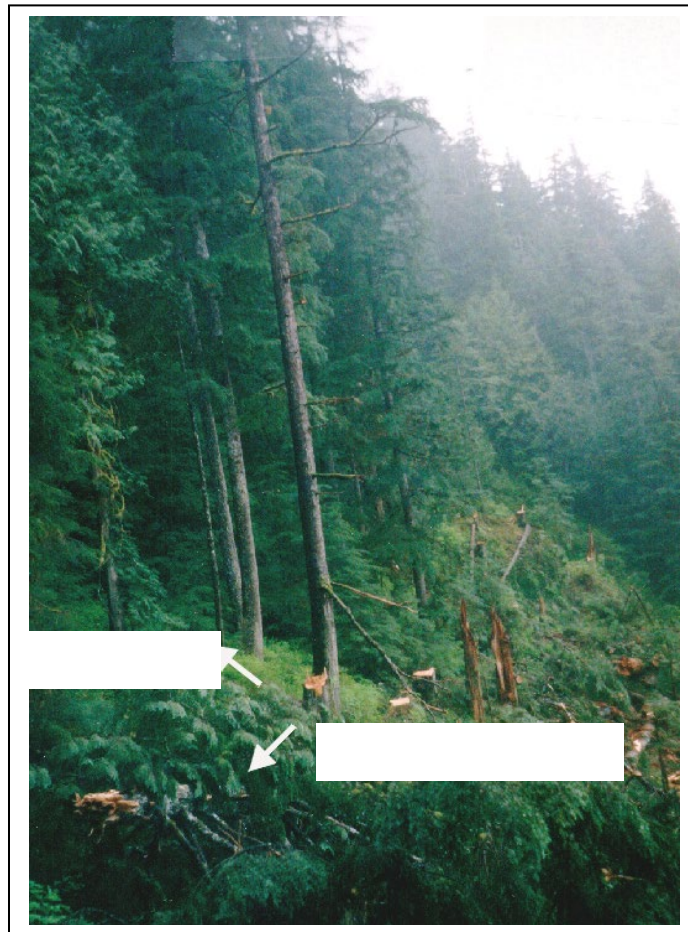
Two trees, both hemlock, were located on a small rise, 15 to 20 feet uphill from other trees that were felled in a pattern across the hillside (perpendicular to the slope). The two trees were less than 1 foot apart at the base of their trunks. Trunk diameters were 30 to 36 inches; tree heights were estimated to be 90 to 120 feet. Based on the cuts to one of the tree (described below), the victim apparently intended to fell the first tree across the hill, which was consistent with the

pattern of previously felled trees in the stand (Figure 1). If the victim intended to fell the second tree in the same direction, its intended lay (an area on the ground where the tree would fall) would have been over the stump of the first tree. An escape route was brushed uphill, approximately 120° from the position of the intended lay of the first tree.

Figure 1. View of fallen tree, stump, and uncut tree

However, the direction of the lay of the first tree and the felling pattern would have required the second tree to fall across the stump of the first tree, producing a domino effect (Figure 1). This is not an accepted industry practice unless the first tree is assessed as a hazard. Timber cutters have the greatest risk of logging-related injury due to their close proximity to trees. A limb or other loose material, also known as a "widow-maker," can fall or be thrown from a tree at any time and may not be seen nor heard due to the noise and the cutter's attention to the immediate activity. Because trees that may be tied together present one of the greatest hazards (due to the danger of a limb or dry top that may break and fall onto the cutter), they should be evaluated

**Recommendation #2: Employers should ensure that timber cutters are aware of the hazard of cutting trees tied together and use appropriate control measures.**

carefully. If either tree appears particularly hazardous (due to lean, rot, dead branches, wind conditions, etc.), then the trees should be left and the cutting supervisor consulted about removal by an alternative method.

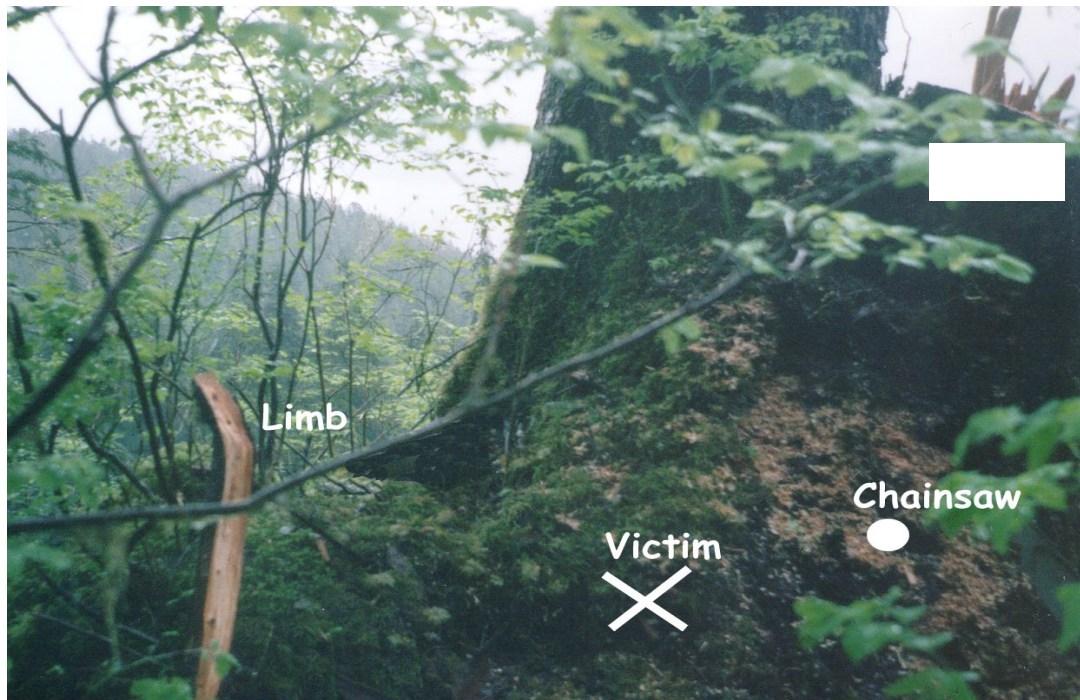
dent near the forehead area, which corresponded to the bruising and swelling on the victim's head and face. The limb was 5 to 6 inches in diameter at its base and approximately 9 feet long. The end of the limb (where it had broken off from the trunk) did not have any bark strips attached. This indicated that the limb was older and was probably snapped as the tree began to fall. It could not be determined if the limb broke off the felled or the uncut tree.

At approximately 1:00 p.m., the victim's cutting partner walked down to the access road to be transported from the site. During the last 1½ hours of work on the slope, he had periodically seen the victim and heard his chainsaw. However, he did not see the victim at the truck and attempted to make voice contact. When the victim did not respond, he walked up the slope to the victim's last known location. He found the victim lying face down at the base of the cut tree. The victim's chainsaw was near the right side of the body, which was oriented with the bar pointing between the uncut tree and the stump. A limb was near the left side of the victim's head (Figure 2).

Figure 2. Position of tree limb, victim, and chainsaw
