Driller's helper electrocuted when mast of drill rig contacted overhead power lines

FACE 99-AK-019

Release Date: July 12, 2000

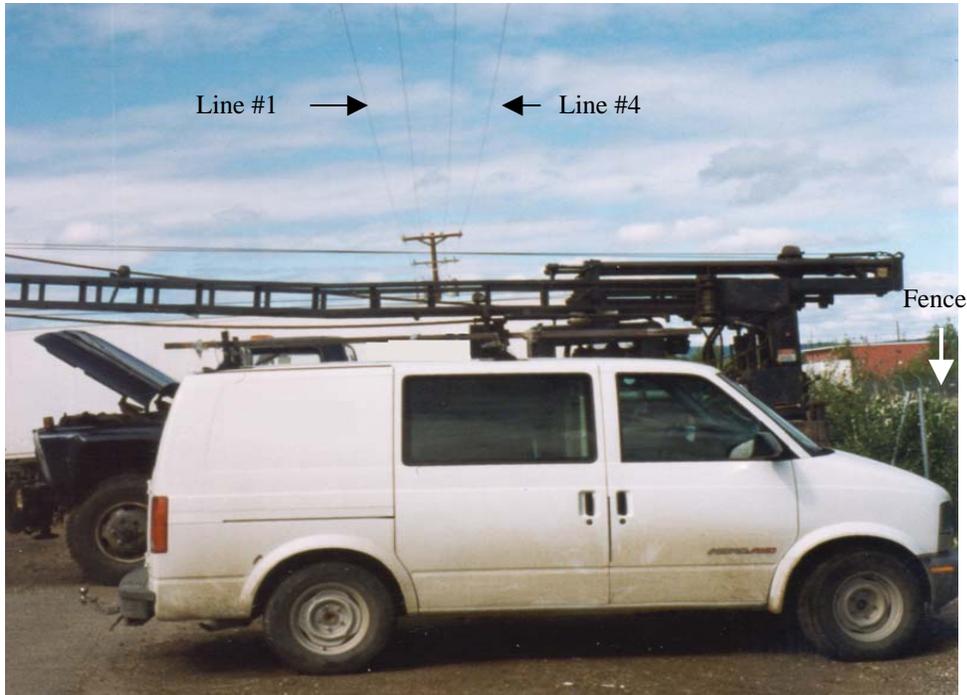
Figure 1. Location of van and drill rig under overhead power lines

Drilling was briefly delayed due to the late arrival of the drill rig, but the activity was still on schedule. No other delays or problems had occurred while drilling the first two holes at the back of the lot. The truck was relocated to the front of the lot to drill the last hole. The marker was by the fence at the edge of the lot, and the truck was backed into position under the overhead power lines. The truck was parked at a 90-degree angle (perpendicular) to the fence and the power lines. The back of the truck was 7 feet from the fence. The distance from the ground (at the truck's location) to the overhead lines was 31 feet. A van owned by the contractor was parked parallel to the truck, approximately 12 feet from the truck's driver side.

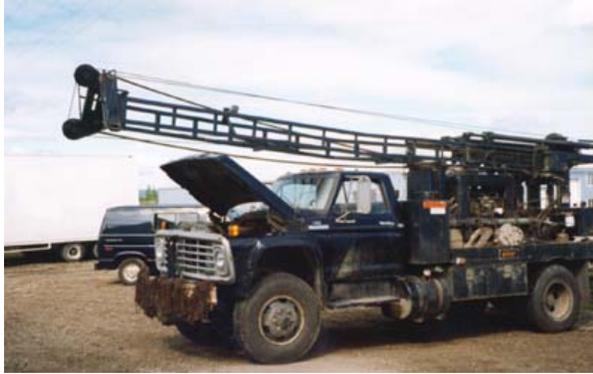
The equipment involved in the incident was a 1979 auger (mechanical rotary drill) mounted to a truck bed (Figure 2a and 2b). The truck was equipped with three outriggers: one at the front, mid-distance from both side; and two at the rear. The master derrick (or mast) was approximately 27 feet long with a maximum vertical rotation of 90 degrees from a rear pivot point 3½ feet from the end of the mast. The mast's pivot point was 8 feet above ground level. The height of the mast when fully raised was 31½ feet. All mast, drill, and pump controls were located at the rear of the truck. The control panel was in poor condition with worn and weathered labels (Figure 2c). An operator's platform consisted of a small metal grate attached to the rear of the truck below the control panel (Figure 2d).

Figure 2a. View of drill rig, front driver's side

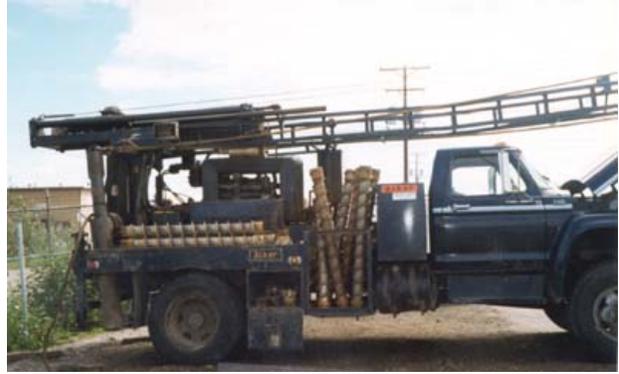
Figure 2b. View of drill rig, passenger side

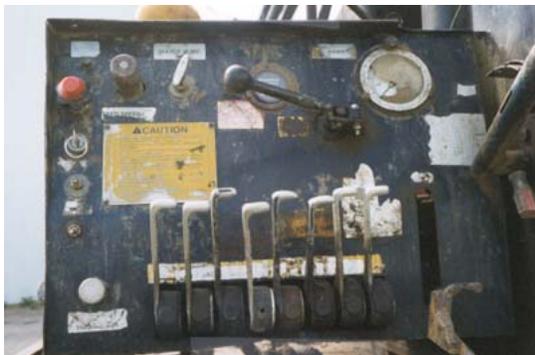
Figure 2c. Control Panel

Discussion: Manufacturers recognized the increased risk for fatal injury when operator controls are not clearly labeled. Employers should ensure that all operator controls are clearly labeled before placing equipment in use. In the event of an emergency, basic operation or an emergency stop can be done.

Recommendation #6: Drill rig owners and operators should ensure that all operator controls are in good working condition and are clearly labeled.

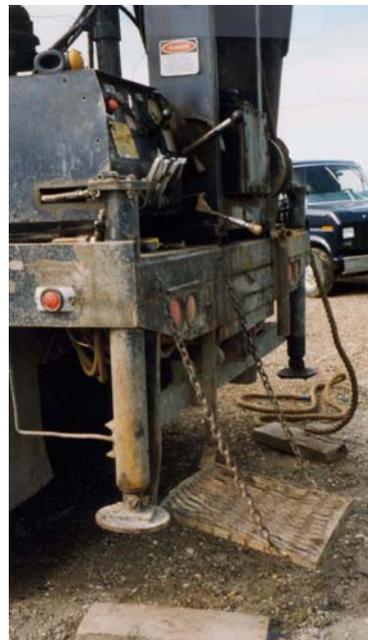
Figure 2d. Control Panel and operator's platform
