### **Deckhand killed when struck by collapsed boom**

**FACE 99-AK-020**

**Release Date: August 28, 2000**

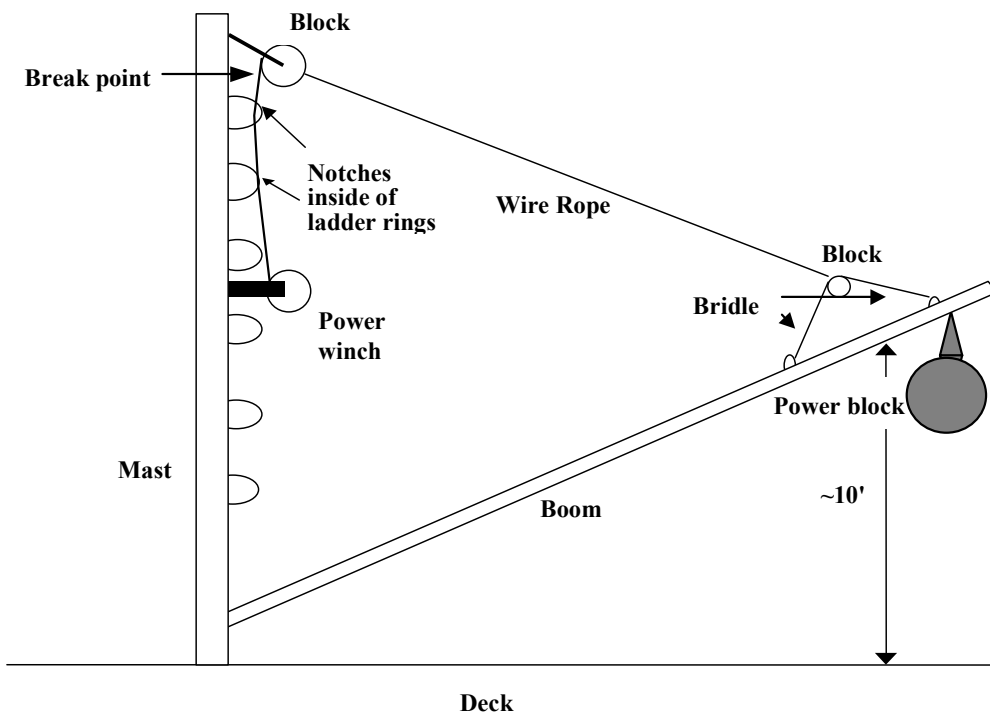
Figure 1. Diagram of rigging arrangement

The vessel was a 41-foot purse seiner with a 19-foot A-frame mast with a crow's nest. The boom was made of aluminum, weighed approximately 150 pounds, and was 25 feet long. The rigging assembly included a block at the top of the mast and a power winch located 7 feet below the block (Figure 1).

The rope was graded with a total lifting capacity of 2,700 pounds. During the investigation, about 5 feet of wire rope on the boom side of the break point appeared corroded (rusty). The last documented replacement date was in 1991. The manufacturer recommended replacement every 2 years. The wire rope ran inside the two highest step rungs on the mast. This arrangement caused the rope to rub against the step rungs and form notches on the inside surface. The deepest notch was on the top rung, immediately below the mast block, with a depth of approximately ½-inch (Figure 2).

As part of the rigging, a bridle was attached to the boom. The bridle consisted of approximately 6 feet of wire rope attached to the boom at two points, approximately 4½ feet apart. The bridle ran through a block that was attached to the end of the rigging rope (Figure 1). No modifications were made to the rigging by the owner/operator since buying the vessel in 1991.

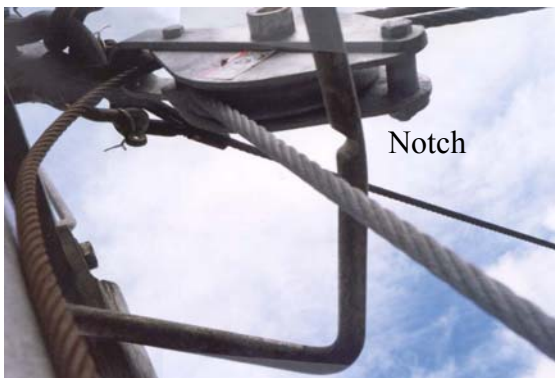
Figure 2. Notch in step rung

*Discussion:* In this incident, because the rope passed inside the metal step rungs located between the winch and the mast block, it rubbed against a ladder rung, producing weak spots. Wire rope winding over a winch drum and through sheaves will incur normal wear. However, the wrong sheave size, contact with surfaces and obstacles, or crushing from cross winding on a drum can markedly reduce the life of the rope. Rigging, as well as nearby surfaces, should be inspected for

deterioration or abrasion, and the rigging rearranged to eliminate factors that cause additional wear and reduced rope life.

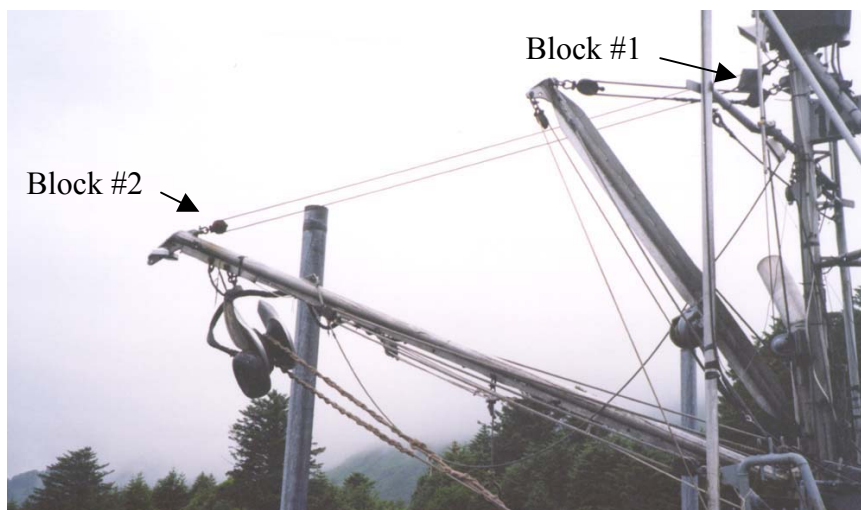
Figure 5. Block arrangement and rigging

*Discussion:* The rigging consists of wire rope and pulleys, functioning as a block and tackle, that trades force for distance. In this incident, the combined weight of the boom, power block, wire rope, net, and fish was placed on the wire rope. Fishing vessels normally have a rigging arrangement with at least two blocks (Figure 5). Using a single block (or pulley) allows only a change in the direction of force needed to lift the boom. However, adding a second block (or pulley) suspends the weight by two lines rather than one, and half the force is needed to lift the same weight. This arrangement effectively reduces the stress placed on the wire rope and the winch although twice as much rope will be pulled to lift the boom the same distance.

**Recommendation #2: Employers/vessel owners should ensure that at least two blocks are used in the boom rigging arrangement to improve weight distribution.**
