# Fatality Investigation Report

OR 2006-05-1

## Mechanic killed when collar caught on PTO driveline

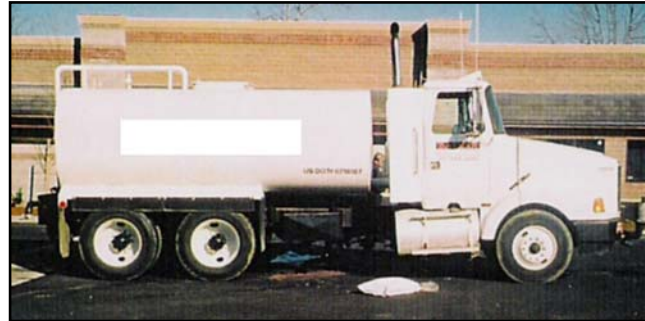
A field mechanic was apparently checking his repair work underneath this water truck when his collar caught and tangled in the rotating power take-off drive shaft.

While he was underneath the rear undercarriage of the water truck, the collar of the field mechanic's coveralls caught on the protruding set screw on the PTO driveline, which entangled his coveralls and shirt. His head was pulled against the rapidly rotating shaft, causing massive trauma as the set screw repeatedly struck him on the back of his head and neck.

- **Prior to performing maintenance operations on any machine, make sure to de-energize, isolate, and block all forms of hazardous energy.**
- **Do not crawl under, on, or over unguarded power take-off (PTO) drivelines while the PTO is operating.**
- **Equipment should be designed or retrofitted to shield any open, unguarded power take-off drivelines.**
- **Employers should develop and implement a comprehensive safety program that includes training in hazard recognition and avoidance for all tasks that may expose workers to the release of hazardous energy.**

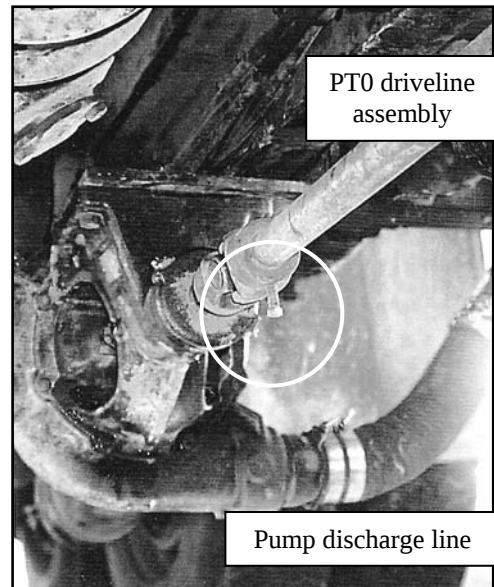
The 1989 Volvo truck was equipped with an unguarded 32½ in. power take off (PTO) driveline on the rear undercarriage of the vehicle, transferring power from the truck's engine to the water pump. The driveline is fitted with a smooth metal collar held in position by a 3/8 in. diameter set screw that projects from the collar by 1 in. The driveline rotates at about 1600 rpm, with a 21 in. clearance between the turning shaft and the roadbed.

On the rear undercarriage of the water truck, the protruding set screw can be seen on the PTO driveline, near the U-joint connection, which caught the collar of the victim's coveralls and entangled him.

**Recommendation #3. Equipment should be designed or retrofitted to shield any open, unguarded power take-off drivelines.**

Power take-off equipment should be properly fitted with guards that fully enclose the entire exposed driveline. The guard should enclose all power take-off stubs, driveline collars, and any protruding bolts, pins, or set screws. Kits are available to retrofit shields on older equipment.
