# Fatality Investigation Report

OR 2004-21-1

## Truck driver crushed by front-end loader in mill yard

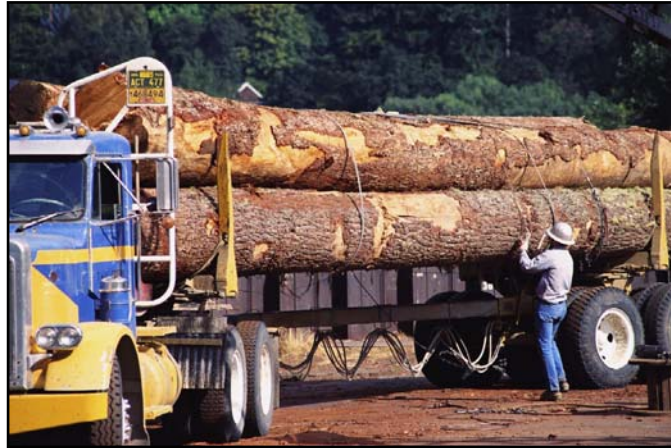
This stock photo shows the general position of the log truck driver in this incident as a front-end loader at the mill yard approached the load.

In this incident, the loader operator assumed the driver was in the cab of his truck, because he was not visible, and it appeared the middle two wrappers on the load were already removed. The operator moved the front-end loader forward to secure the load on the truck, so the remaining two wrappers could be safely removed. The view in front of the loader, though well lit, was obstructed by the unloading arms of the machine.

A second loader operator working in the yard at the time saw a hard hat on the ground near the truck, and radioed to the first operator to back away. The log truck driver was evidently still in the process of removing the first two wrappers from the load as the front-end loader approached. The victim was found dead at the scene, having been crushed between the loader and the load of logs.

### **Recommendation #1. Eye contact and a designated “ready” signal must be established between a mobile machinery operator and a truck driver working together to load or unload a truck.**

An operator of mobile machinery may often find the view forward obstructed by the raised arms of the loader, especially when loaded. An operator should never approach a load on a truck without first establishing eye-to-eye contact with the driver of the truck and receiving a “ready” signal by hand or other means from the driver. Drivers should stand outside, to the front or rear of the truck, and not remain in the cab. By standing outside in a visible location, the truck driver provides a second set of eyes for the operator, and also avoids hazards associated with remaining in the cab during a loading or unloading operation. In some instances, injuries have occurred when the hydraulics have failed on a front-end loader, causing the load to slam back down on the truck hard enough to tip the truck on its side.
