SUBJECT: A lumberyard forklift operator died after being crushed between two railcar couplings.

SUMMARY

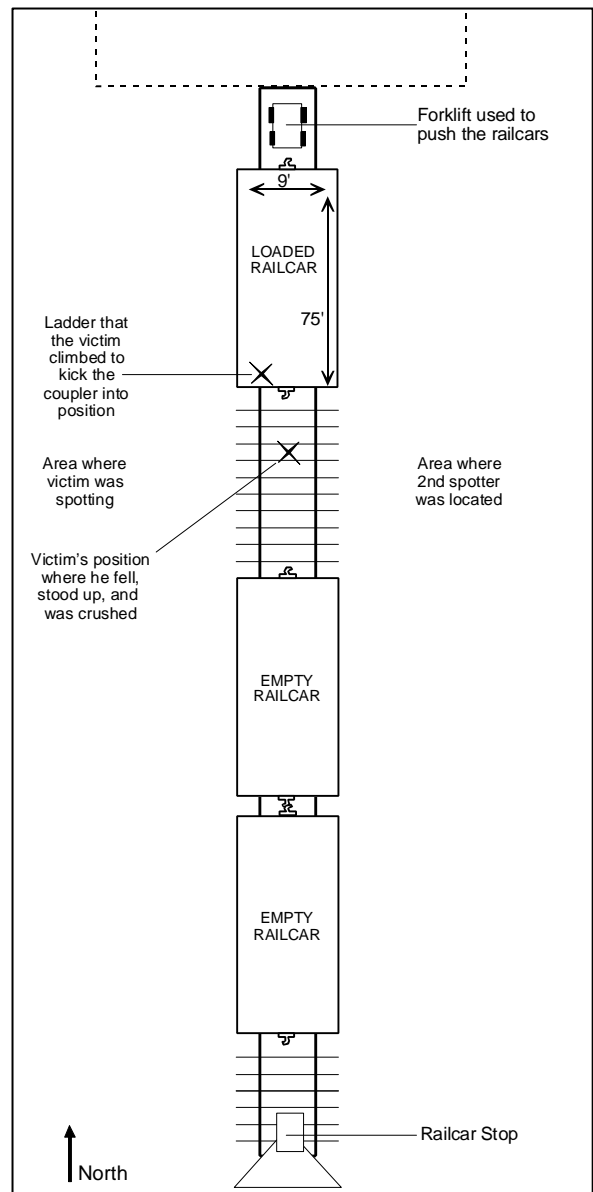
Figure 1. Diagram of the Incident Scene (not to scale)

Incident Scene: The incident occurred on a dead end rail spur, which had a covered, open-sided loading shed and an outside railcar stop. Empty railcars were delivered to the plant by the railroad, and the lumber employees loaded and moved the cars around on the spur line as needed. Railcars were loaded in the shed area and then pushed outside by a forklift, where up to four cars would be connected. On the day of the incident, two empty railcars sat outside on the spur line, while a loaded car was being pushed out of the shed. The incident occurred near the end of the first shift, at approximately 5:00 p.m. The victim and his two coworkers were the only employees in the immediate area.

On the day of the incident, a three-person crew in the lumber shipping area was working to position railcars to fulfill an order that had been received that afternoon. Railcars were not loaded in a particular order, but there were designated railcars for designated loads of lumber. There were four railcars on the spur line; one was north of the loading shed and was not a factor in the incident (Figure 1). Two empty cars were sitting outside on the spur line, south of the loading shed and just north of the railcar stop. The fourth railcar, which was 9-feet wide, 75-feet long, and loaded with 177,600 pounds of lumber, was being pushed south out of the loading shed. The southernmost railcar needed to be loaded, so the plan was to connect the loaded railcar to the two empty ones and pull all three back north into the loading area. The incident occurred during the process of connecting the three railcars.

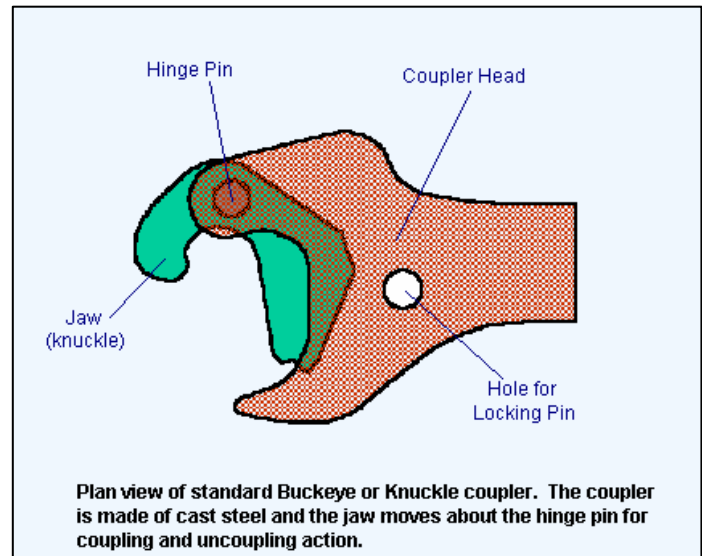
Figure 2. Diagram of a coupler device similar to the ones involved in the incident. Reprinted with permission from PRC Rail Consulting Ltd.

As the forklift operator moved the railcar at approximately two to three miles per hour and it approached the nearest stationary railcar, the decedent noticed that the coupling devices (Figures 2 and 3) were not aligned properly and would not connect. He proceeded to run up to the moving loaded railcar and climb the ladder on the end (out of the forklift operator's line of sight). He stood off to the side on the ladder and began trying to realign the coupler by kicking it with his foot.

Meanwhile, the other spotter was yelling at the victim to get out of there. Before the decedent could get out of the way, the railcars collided and bounced apart. The couplings were still misaligned, so the railcars did not connect. The impact of the hit caused the decedent to fall off the ladder and onto the ground between the couplings. The force caused the empty railcars to collide with the rail stop and recoil back toward the victim, who was now standing between the couplings. The recoiling empty car slammed back into the loaded car, crushing the decedent in between the two couplings.

Recommendation #1: Employers should ensure that employees do not enter the space between railcars that are being moved, including during procedures of coupling and uncoupling.

Discussion: The area between moving railcars should be considered hazardous and should not be entered. The Federal Railroad Administration recommends a minimum distance of 50 feet between railcars for safe entry by workers. Employers should continually educate their employees who work around railcars on how to move and maneuver around them. Employees should be instructed and monitored on not using outdated practices that are shown to be dangerous, such as kicking couplers. In situations where couplings are observed to be misaligned, workers should stop the operation, separate the railcars by at least 50 feet, and ensure that the railcars are completely stopped before entering the area and realigning the couplings.
