WISCONSIN FACE INVESTIGATION: # 05WI054

SUBJECT: Maintenance Worker Dies After Pinned Between Overhead Bridge Crane and Roof Truss

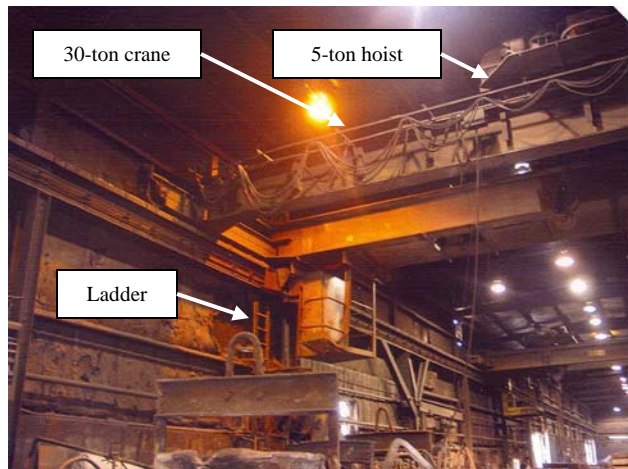
The victim and another maintenance man were going to adjust the brakes on the 5-ton hoist on the crane (Figure 1). While the operator of the Whitney crane had his back turned from the controls, a second operator came over and moved the crane. He did not know that the victim and another maintenance man were working on the crane above. The first operator realized what was happening and yelled to stop the movement, but it was too late.

Figure 1. 30-ton Whitney bridge crane with 5-ton hoist.

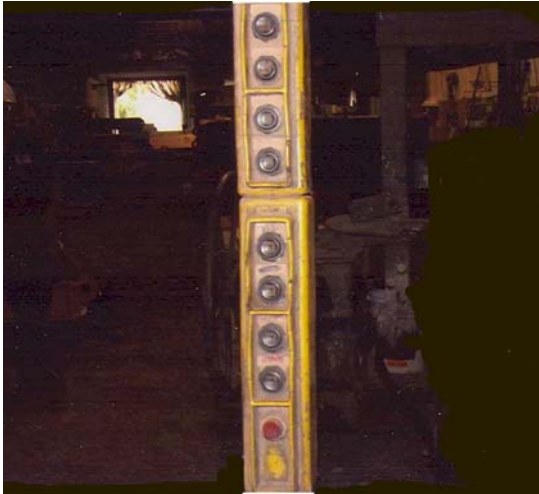
The victim and his supervisor climbed up a 20-foot ladder to the overhead bridge crane. They went across the bridge to where the 5-ton hoist was located. The crane operator was located on the floor of the foundry (Figure 2). The pendant control moved the 5 and 30-ton hoists up and down or in a side to side motion (Figure 3). The pendant

Figure 3. Close-up of pendant control.
