# Fatality Investigation Report

OR 2005-18-1

## Temporary mill worker dies in fall from tower catwalk

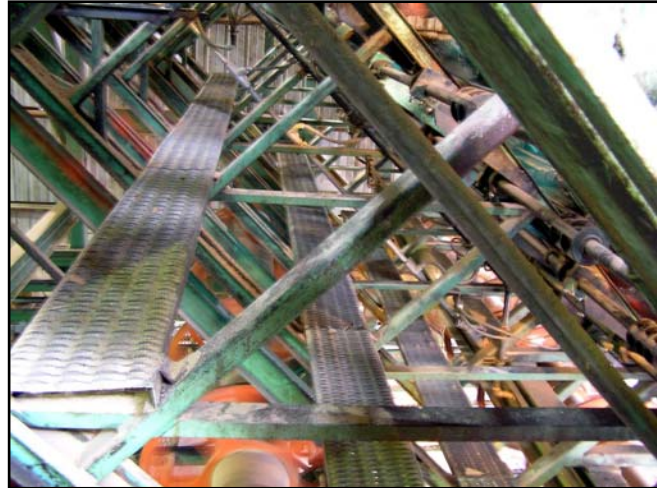
Catwalks in the tower planer provided access to areas where lumber occasionally jammed in the conveyor system.

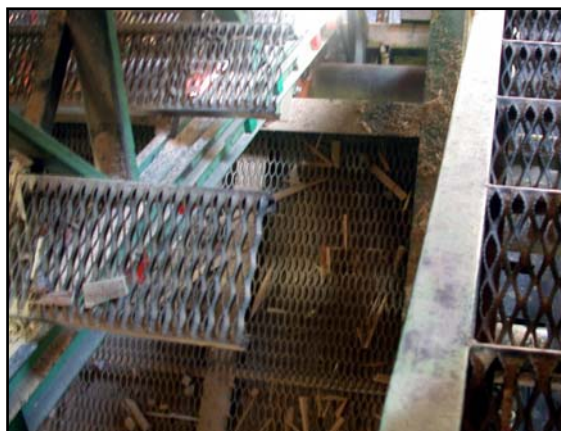
While backing off the catwalk pulling a board, the tower operator fell when he missed his footing at the end of the narrow catwalk.

The unguarded, narrow walkway in this incident was the primary risk factor, exacerbated by difficult access and the 2 ft gap at the end of the catwalk. Guardrails are required on all open sides of any regularly used access walkway that is situated 4 ft or more above the adjacent floor or ground level (29 CFR 1910.23(c)). Special-purpose walkways may omit the guardrail on one side, provided the width of the runway is at least 18 in. wide. In this incident, the catwalks were only 12 in. wide and the installation of guardrails was not feasible through the interior crossbeams of the machine. The employer has since modified the stairway and landings to allow better access to the catwalks, and has installed wire cables along the length of each catwalk as part of a new tower fall-protection system. Workers accessing the catwalks are provided and required to wear a body harness with lanyard attached to the cable. (Leg protection for chainsaw use has also been added to the tower operator's personal protection equipment.)

**Recommendation #1. Guardrails must be installed on regularly used access walkways that are 4 ft or more above the ground. If guardrails are not feasible, alternative fall protection must be employed.**
