SUBJECT: A Hispanic car wash supervisor died when an air tank exploded in a car wash equipment room.

SUMMARY
California FACE Report #05CA010

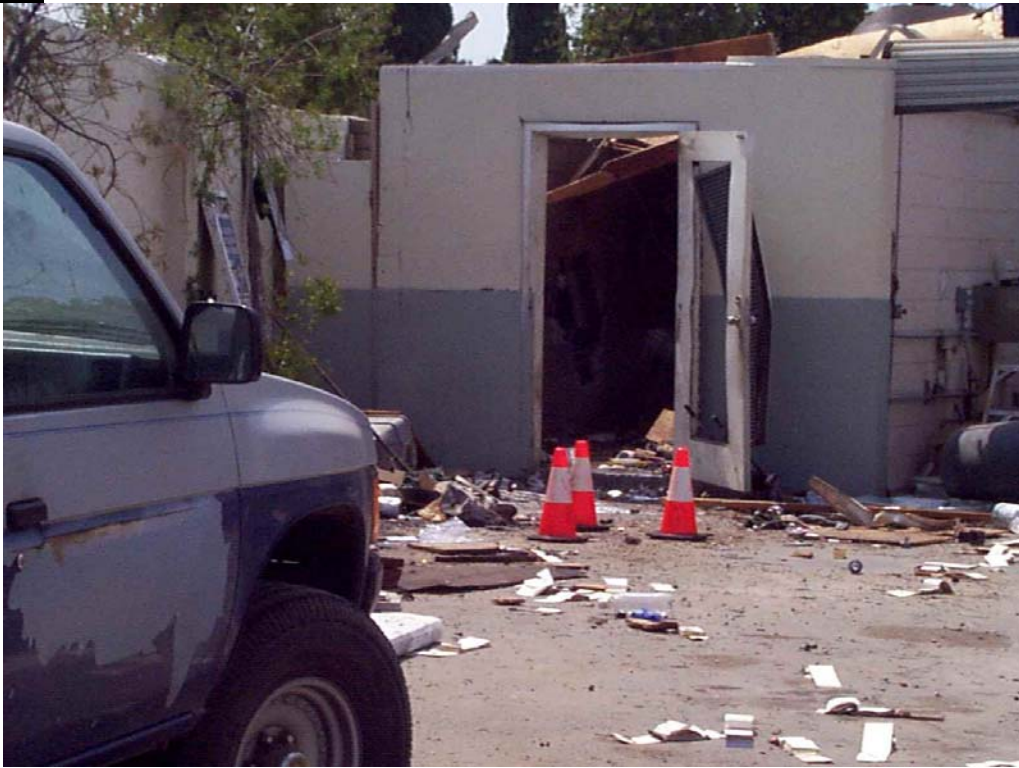
Exhibit 1. The equipment room after the explosion.
