SUBJECT: A gas well drilling floorhand died when he was struck by a hoisted wellhead equipment stack.

SUMMARY

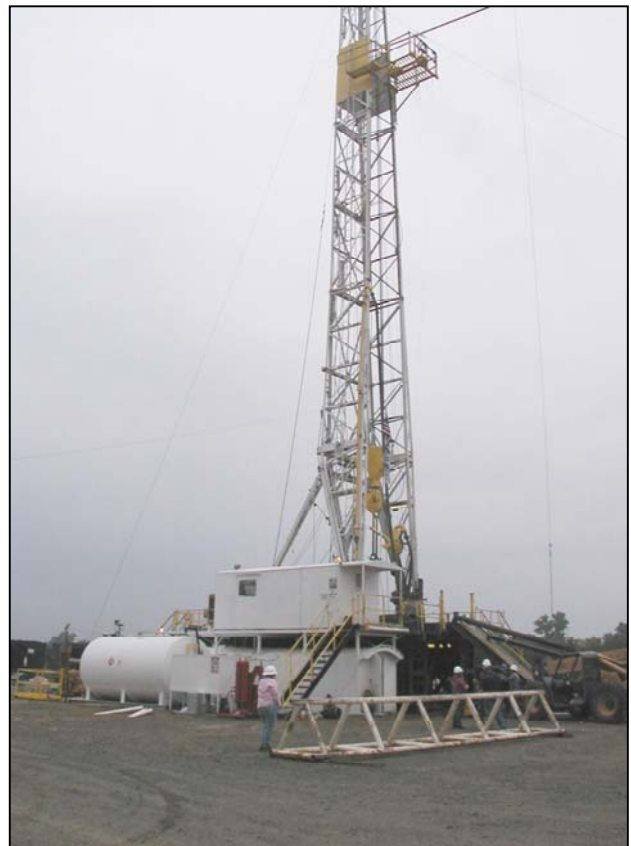
Figure 1. Drilling site where the incident occurred

Incident Scene: The incident occurred on a gas drill site where the company had been operating for 21 days (Figure 1). The incident took place on the ground under the drill floor at a wellhead (Figure 2 and Table 1). The ground in the area was level, but muddy, and oily.

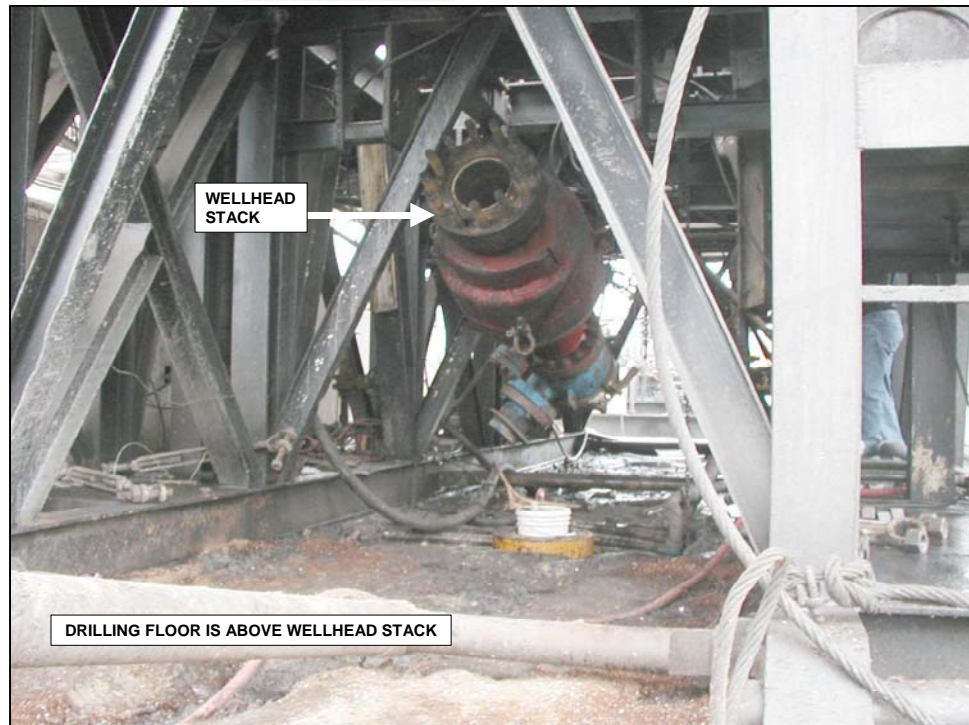
Figure 2. Wellhead stack involved in the incident

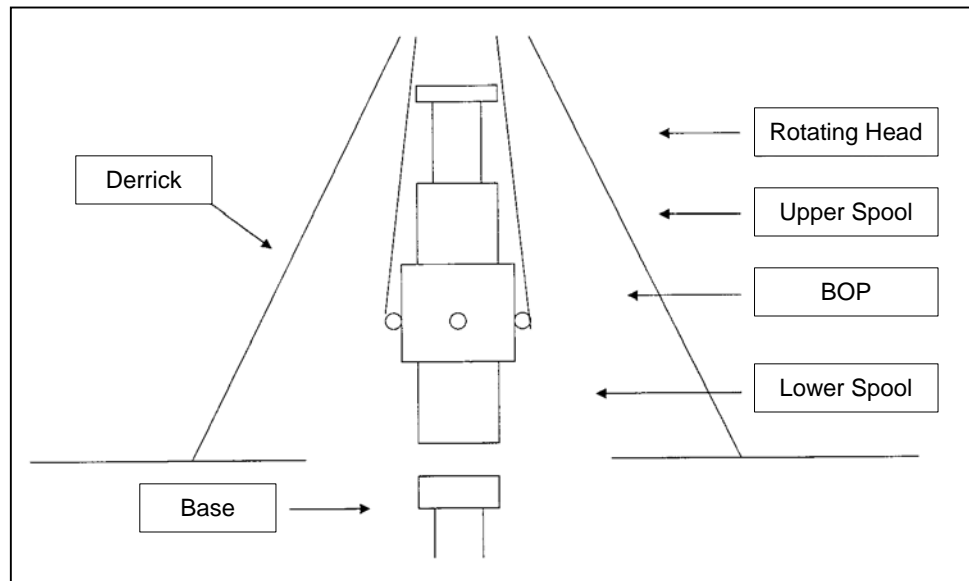
The incident involved a wellhead located below the drill floor. The wellhead equipment stack weighed approximately 18,000 pounds and was composed of four stacked components including a lower spool, BOP, upper spool, and rotating head (Figure 3). Under normal operations, wellhead components may be replaced or serviced several times throughout a drilling operation. The wellhead was being removed to replace the lower spool to accommodate a change from 7-inch to 4-inch pipe during the drilling operation.

Figure 3. Diagram of wellhead stack involved in the incident

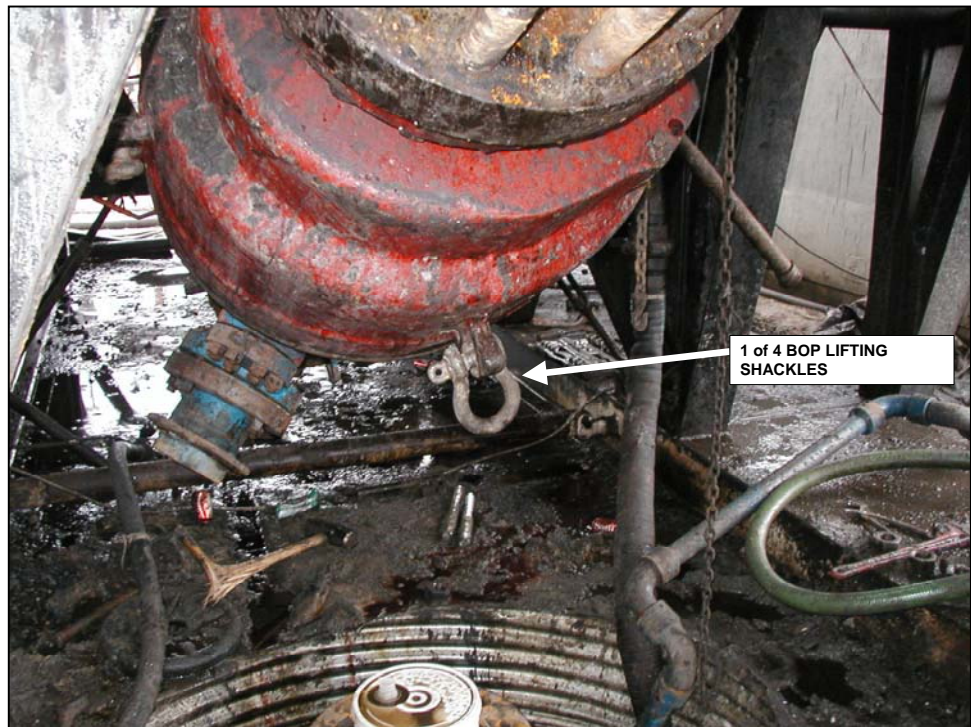
Disassembly of the wellhead usually took two hours. On the day of the incident, the tool pusher was supervising operations, but left the immediate area to get a drink of water and relinquished control of the wellhead removal to representative #2 who was acting as a third party on site. Representative #2 directed the crew to lift the fully assembled wellhead stack as a single unit to save the time and work of disassembling. Representative #2 directed employees to use a two-chain sling attached to two of the four lifting shackles located on the BOP (Figure 4). According to the BOP manufacturer, all four lifting shackles should be used during lifting operations and were designed only to lift the BOP, not other ancillary equipment. The stack was top-heavy during

the lifting operation because the lifting sling was attached to the BOP near the bottom of the wellhead assembly.

Representative #2 then directed that the two-chain sling be rotated

90 degrees to attach to the other two lifting shackles of the BOP than the ones previously used. The points of attachment to the lifting shackles were changed to get more clearance between the wellhead and the bottom of the overhead drill floor. The stack was lifted again while the victim and a coworker used a hammer and crowbar to remove the lower spool. As the lower spool came off the bottom of the BOP, the wellhead tipped over toward the victim and coworker, striking the coworker and pinning the victim to the ground. Coworkers immediately freed the victim and called for emergency response. EMS arrived at the scene within 10 minutes and transported the victim to the nearest hospital. He was transported by helicopter to another hospital where he was pronounced dead a few hours later in the emergency room. The coworker was not hospitalized and suffered primarily bruises, contusions, and abrasions.

Figure 4. Lifting shackle of blowout preventer (BOP)

Recommendation #1: Employers should ensure that employees do not position themselves under suspended loads.

Discussion: The OSHA standards for materials handling and storage that address the use of lifting slings indicate that all employees should be kept clear of loads about to be lifted and of suspended loads. The areas below and adjacent to suspended loads should be controlled access zones. Employees should not occupy controlled access zones while a load is suspended. Employees should use tag lines or other means of remote control to steady and

control elevated loads while allowing employees to maintain adequate clearance. Safe working load limits of tag lines should be considered when selecting tag line materials.
