# Fatality Investigation Report

OR 2005-24-1

## Excavation worker killed by flying rigging when hook fails

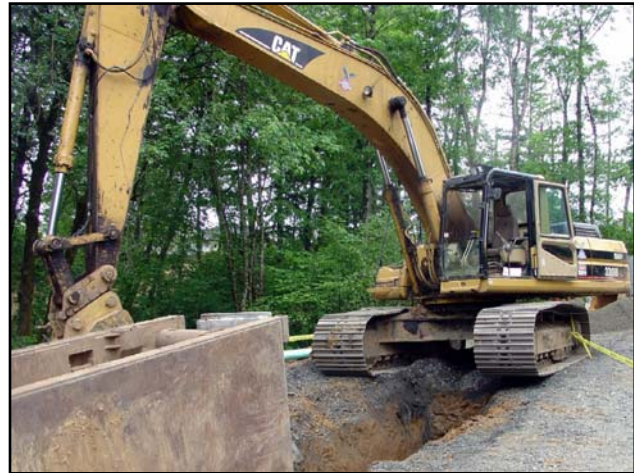
The track-hoe involved in this incident was pulling a trench shield forward in a trench for a sewer system when a hook failed and the rigging snapped loose.

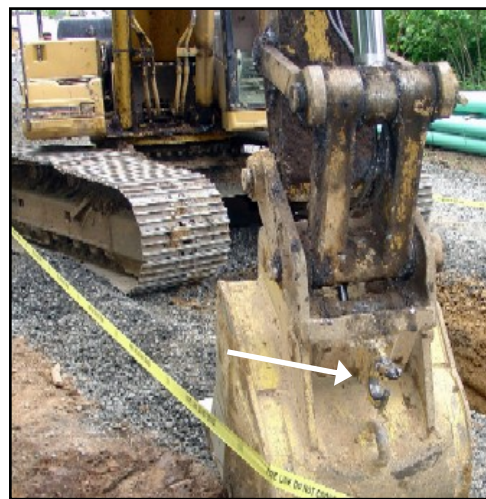
latched hook welded onto the quick-coupler to replace the original closed "lifting eye" supplied by the manufacturer.

The Hendrix Quick Coupler comes from the manufacturer equipped with a closed lifting eye, which the employer removed and replaced with the latched hook to allow an easier rigging setup. Manufacturer safety instructions warn that the coupler and components should not be modified. In addition, the advantage of quicker setup is not clear, because the J-hook and shackle attached to the quick coupler always remained on the arm of the track-hoe, even while digging.

A few weeks prior to the incident, the construction crew replaced the latched hook on the quick coupler, because the spring and latch mechanism was plugged with clay and would not stay closed, which allowed the J-hook and shackle to fall off. A new UKN10 latched hook was welded to the quick coupler, but the latch problem recurred. A week later, the maintenance department came to the job site and tack-welded shut the latch on the UKN10 hook, making it a closed ring.

While towing the trench shield on the day of the incident, the latched UKN10 hook on the quick coupler failed. The weight of the load was concentrated on the latch mechanism instead of the working part of the hook, resulting in the hook tip bending outward and releasing the rigging. The J-hook and shackle attached to the coupler flew off, disengaged from the sling, and struck the pipelayer in the trench shield on the back of his hard hat. The hook and shackle weighed 32 pounds.

Employers and workers need to know and follow safety instructions supplied by equipment manufacturers. In this instance, the closed lifting eye on the Hendrix Quick Coupler attachment should not have been replaced. The manufacturer's lifting eye was closed and circular in shape, maximizing its ability to withstand lifting and pulling forces from any direction, vertical or horizontal. The latched Gunnebo Johnson Model UKN10 hook that was welded to the quick coupler to replace the original lifting eye was designed for vertical lifting. When using the track-hoe to pull the trench shield, the load was mostly horizontal and the force was concentrated at the tip and latch of the hook, which were incapable of carrying the load.

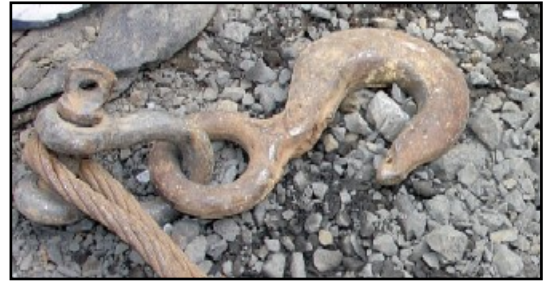
The hook and shackle attached to the track-hoe, like the one shown here (without the cable), snapped loose when the rigging failed and struck the pipelayer.

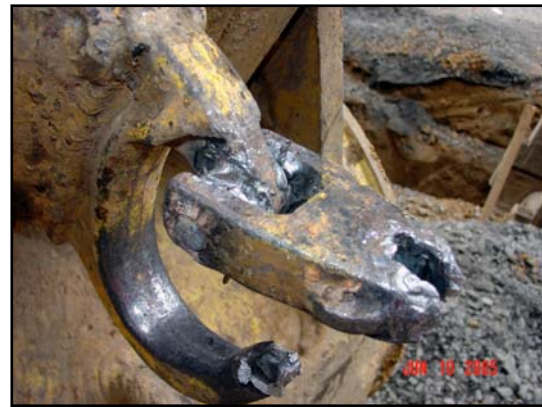
Part of the latch remained attached to the hook welded on the Hendrix Quick Coupler on the arm of the track-hoe.

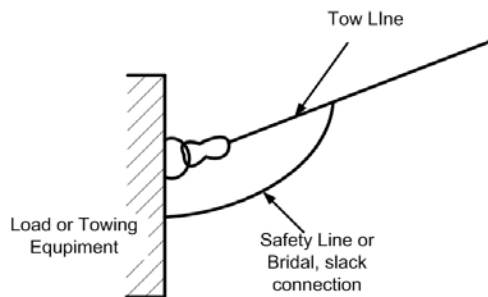
Figure 1, Diagram of safety line hook up

In this incident, the J-hook attached to the arm of the track-hoe disengaged from both the arm of the track-hoe and the tow line, making it a completely independent missile that could have injured workers well beyond the hazard area designated by the reach of the cables. With the original lifting eye on the Hendrix Quick Coupler, the attached hook and shackle would have been very unlikely to break free. In cases of less certainty, such as this one, the use of a latched hook instead of an open J-hook could keep the hook attached to the wire sling and reduce its range of flight in the event of failure.

Another safeguard involves the use of a secondary connection through a bridal or safety line attached near each end of a tow line, connected to the towing equipment on one end, and the load on the other. The bridal remains slack during towing (Figure 1).
