## **WISCONSIN FACE INVESTIGATION: #05WI049**

### **SUBJECT: Car Carrier Truck Driver Dies When Crushed By Ramp of Car Carrier**

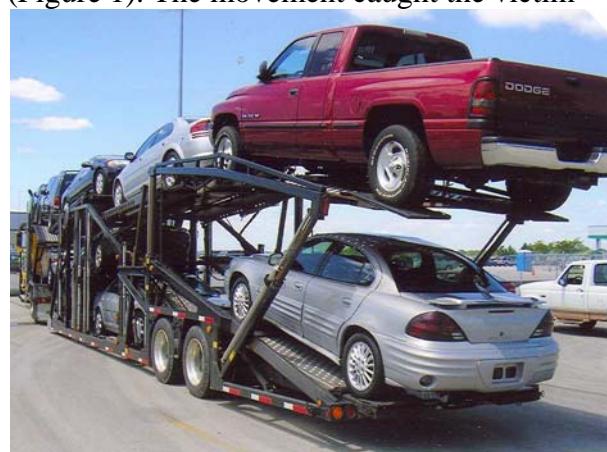
On July 26, 2005, a 59-year-old truck driver (the victim) was fatally crushed while loading used cars onto the auto transport truck carrier. The victim was working alone when he unknowingly activated the hydraulic controls to the ramp for one of the carriers causing it to move forward and downward (Figure 1). The movement caught the victim and pinned and crushed the victim into the hood and windshield of a car positioned on the ramp. Two employees from another auto transport company who were picking up vehicles found the victim pinned under the car carrier ramp. The employees of the other auto transport company contacted the auto auction security personnel who called 911 Emergency Medical Services (EMS) at 4:34 p.m. EMS arrived at the scene at 4:39 p.m. The medical helicopter was contacted at 4:38 p.m. At 4:42 p.m., EMS stated there was no way to attempt resuscitation, so at 4:46 p.m. the request for the helicopter was cancelled. The medical examiner arrived on the scene and the victim was pronounced dead at 5:30 p.m. The FACE investigator concluded that to help prevent similar occurrences, employers should:

Figure 1. Auto transport Truck carrier.

### **Recommendation #1: Ensure that employers utilize retaining pins to prevent unintentional movement or collapses of the ramps when employees are loading cars on the trailers.**

Discussion: Proper insertion of the pins would prevent downward movement of the ramps or racks on the car hauler trailer. The metal pins were designed and strong enough to withstand the pressures of a loaded car on the ramps and racks.

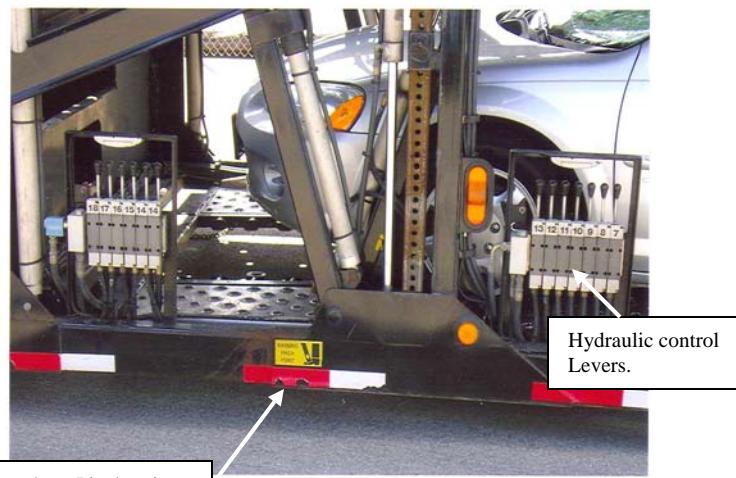
The victim was driving a 2005 Freightliner Classic Series Truck with a 2005 Boydston car hauler model 9178S. This particular car hauler had a capacity for hauling 10 vehicles. Platform ramps onto which the vehicles were loaded were operated by hydraulic cylinders which were activated from a bank of sectional hydraulic control valves. The lever for each ramp controls movement backward and forward. The control levers are located along the side of the hauler and are attached to the frame of the car carrier. The hydraulic control levers were easily accessible and only protected by steel plate that covered the top of the levers. The car hauler had warning decals attached, "Warning Pinch Points." When the victim was found, his knee was still pushing two of the hydraulic levers (Figure 2).

At the time of the incident, the victim was checking the tie down chains from the front of one of the ramps. During this activity, the victim came into contact with the hydraulic levers for two of the ramps. This caused the upper ramp to move down, pinching and crushing the victim between the bottom of the ramp and the car located on the bottom belly ramp.

Figure 2. Hydraulic Control Levers used to operate the platform ramp.

The hydraulic controls had a steel bar installed over the controls as a method of guarding the controls. The manufacturer of the car carrier trailer indicated that the steel bar was over the control levers to prevent a driver from falling onto or contacting the hydraulic control levers in the event that the driver was incapacitated for any reason. The hydraulic control levers were not protected from the inside of the car carrier and inadvertent operation of the levers from the inside was possible.
