WISCONSIN FACE INVESTIGATION: #05WI001

SUBJECT: Hispanic Butcher Dies After Being Struck By Semi-Trailer Gate

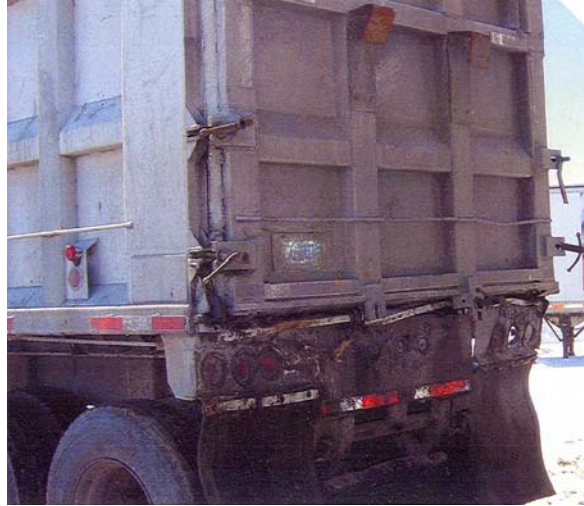
On March 1, 2005, a 32-year-old Hispanic butcher (the victim) was struck by the rear gate of a semi trailer dump truck (Figure 1). The crew consisted of the victim and his Hispanic co-worker, the Bobcat operator. The victim entered the semi-trailer to put a chain on a dead cow and the Bobcat operator dragged the dead cow off the semi-trailer using a Bobcat (skid steer) industrial truck. The procedure for chaining dead cows was repeated until the trailer was empty. While Spanish was the victim's primary language, the victim understood limited English. He could not write or speak English fluently. Spanish was also the Bobcat operator's primary language. In performing the duties of his job, the victim walked into the semi-trailer under the raised gate of the semi trailer. The victim was exposed to a crushing hazard of the gate each time he entered and exited the trailer. The semi trailer gate was unlatched and moved back to the loading dock. A wire sling was placed around the locking pins on each side of the semi trailer gate (Figure 2) and the gate was raised by using the Bobcat (Figure 3). The gate was maintained in a raised position by the wire sling attached to the semi trailer locking pins and to the attachment point above the door (Figure 4), but there was nothing in place that prevented the slings from

Figure 1. Rear gate of a semi trailer dump truck.

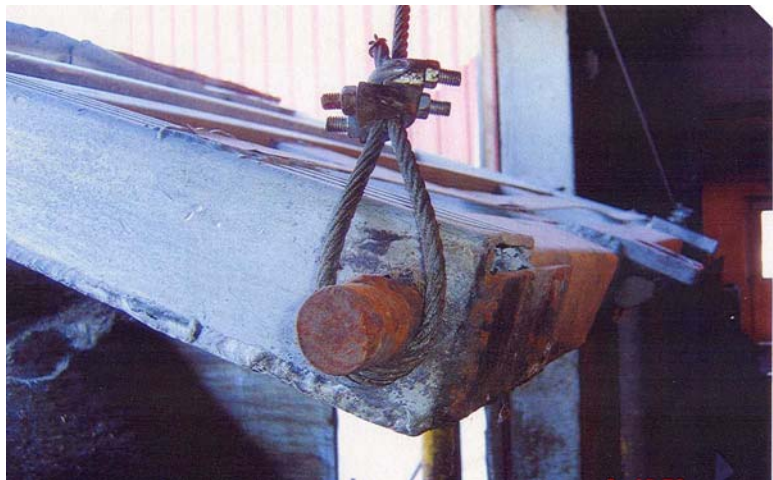
Figure 2. The locking pin and wire sling on the semi trailer gate.

One wire rope sling is attached over the pin and the same procedure is done on the other side, but nothing was done to secure the wire ropes. The gate is raised with the two wire rope slings to an attachment point above the door to a 3/4-inch bolt, which is drilled through the door overhead support (header). Evidence suggests that this could cause side-to-side motion and could cause the wire rope slings to slip off of the gate pins sideways.

Discussion: The employer should evaluate all hazards in the workplace. This would take into account the forces of gravity on the tailgate of semi-trailer. Efforts should be made that the semi-trailer tailgate is adequately supported. This can be done by securing the wire rope to the tailgate pins and blocking the tailgate in the upright position. This would eliminate the gravity effect of the tailgate falling down and striking an employee.

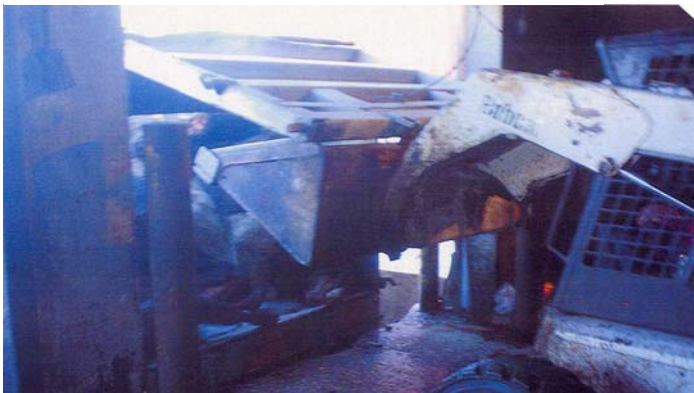
Figure 3. Semi trailer gate is raised with the Bobcat.

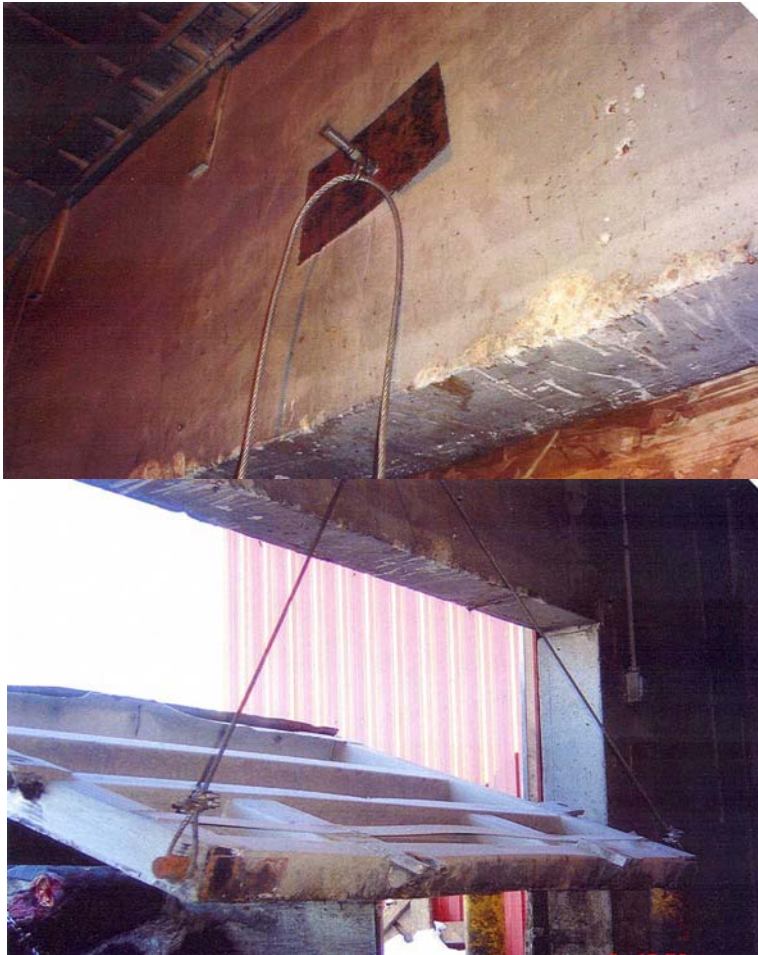
slipping off of the locking pins nor was the door blocked open. At the time of the incident, the wire sling slipped off of the pins causing the gate to fall down and the victim was crushed by it. Co-workers found the victim between the gate and the end of

Figure 4. The semi trailer gate maintained in a raised position by the wire sling attached to the semi trailer locking pin and the attachment point above the door.
