MIFACE INVESTIGATION: #05MI024

SUBJECT: Owner Of Excavating Company Dies When Excavator Overturns Into Water/Mud of Gravel Pit.

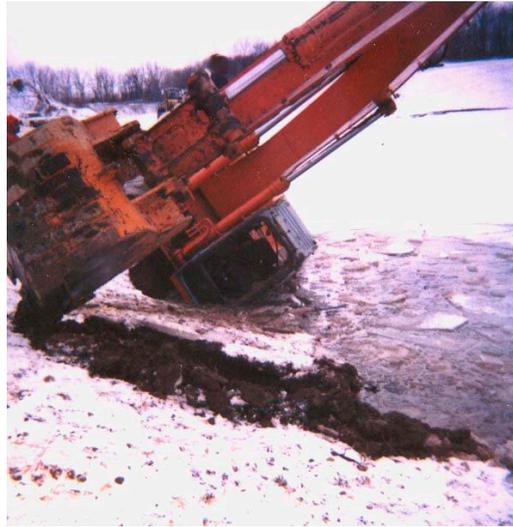
Figure 1. Excavator as being lifted from the water in gravel pit

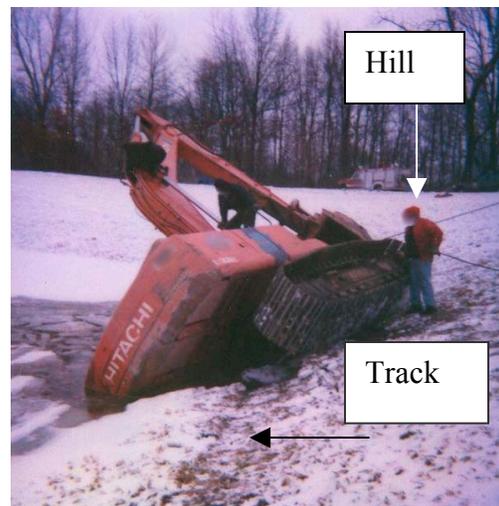
Figure 2. Excavator tracking along water edge toward wall to ascend

While his coworkers were gone, the victim backfilled the hole. Instead of tracking the excavator to the road at the top of the pit, he tracked the excavator around the water's edge, presumably to ascend the hill prior to the pond curve (See Figure 2). The excavator had traveled approximately 100 yards from the digging point, tracking closely to the edge of the water. The severity of bank slope started to increase as he tracked toward the hill. The slope at the location of the incident was estimated at approximately 45 degrees. The boom was placed in the direction of travel, elevated, and not facing uphill; thus the cab and its door faced the water surface. The ground surface supporting the track of the excavator next to the gravel pit sheared away. As a result, the excavator tipped in the direction of the water in the pit and resulted in the cab being submersed in the water and mud.

Although it was not required in this incident, the operator traveled across the gravel pit slope instead of along the existing roadway around the gravel pit. Although not recommended, it is sometimes necessary for an excavator operator to travel across a slope instead of uphill or downhill. Operators should keep the bucket in the lowest position

possible on the uphill side when it is necessary to travel across a slope. This maintains the center of excavator's center of gravity on the uphill side, and helps to prevent an overturn to the downhill side of the slope.

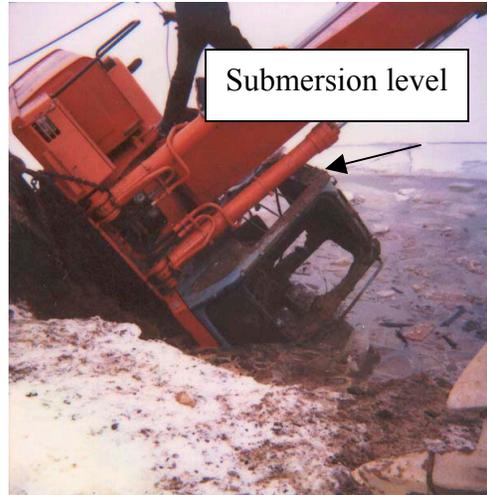
Figure 3. View of cab as excavator being lifted from mud

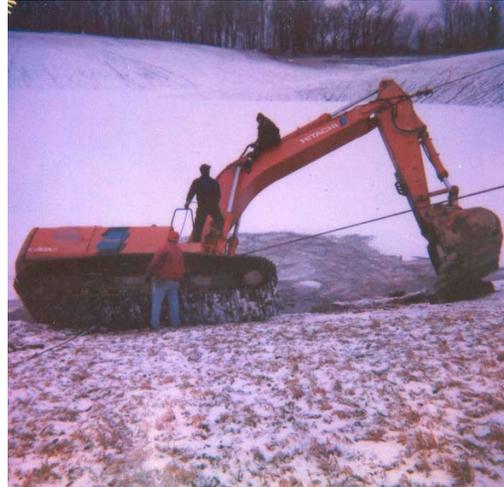
Figure 4. Divers hooking cables to excavator

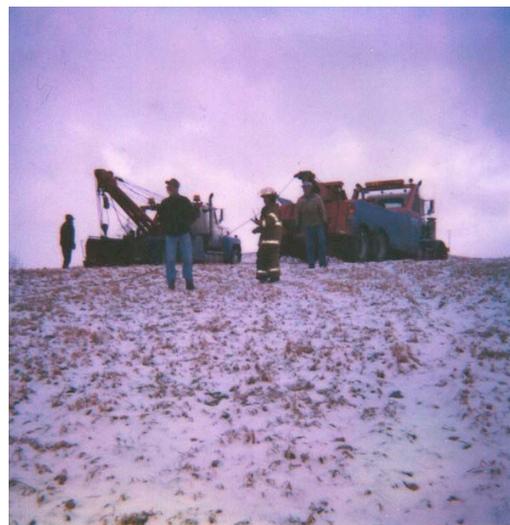
Figure 5. Tow truck operators watching extrication activities prior to their repositioning

not only to keep others safe, but also to ensure the safety of the tow operator him/herself. The tow company called by the victim's coworker had operators who were standing between the truck and the excavator. The fire department chief had to "threaten" the tow operators with police escort to move from their position to a safer observation area (See Figure 5). The broken chain flew past where they were standing, and according to the fire chief, the chain would likely have hit the operators as it flew past.

- Wrecker companies involved in heavy equipment recovery should ensure that their tow truck operators are appropriately trained and that equipment, such as booms and chains have been weight-certified.
