SUBJECT: A Facility Maintenance Mechanic Died When Crushed Between an Overhead Bridge Crane and Light Fixture

SUMMARY
California FACE Report #05CA011

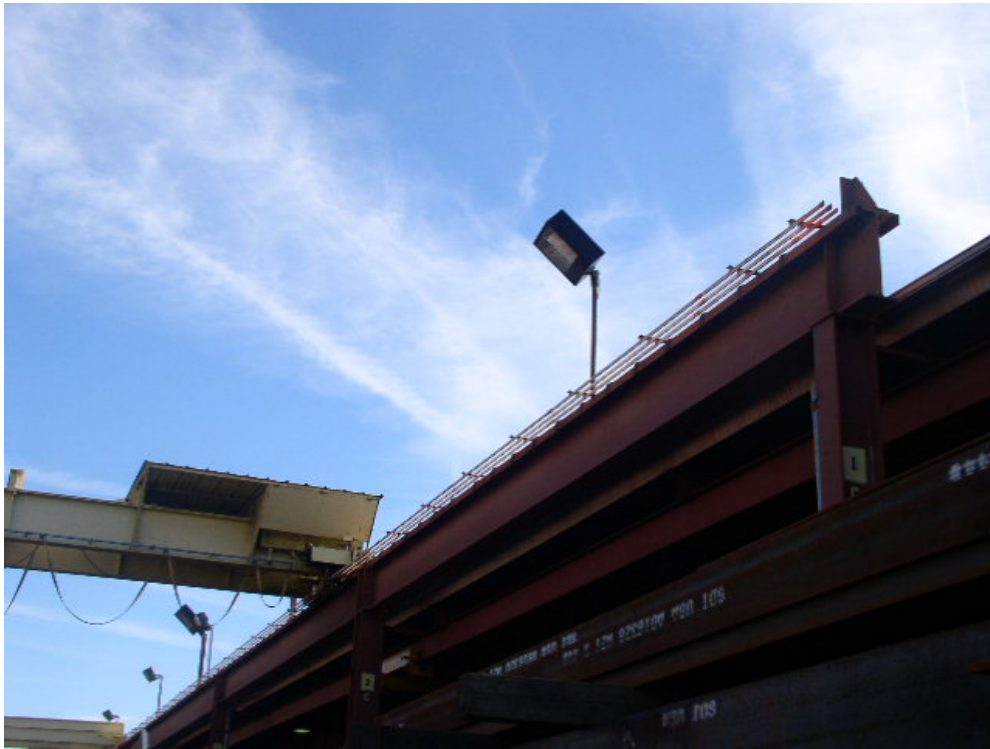
Exhibit 1. The gantry crane that was involved in the incident.

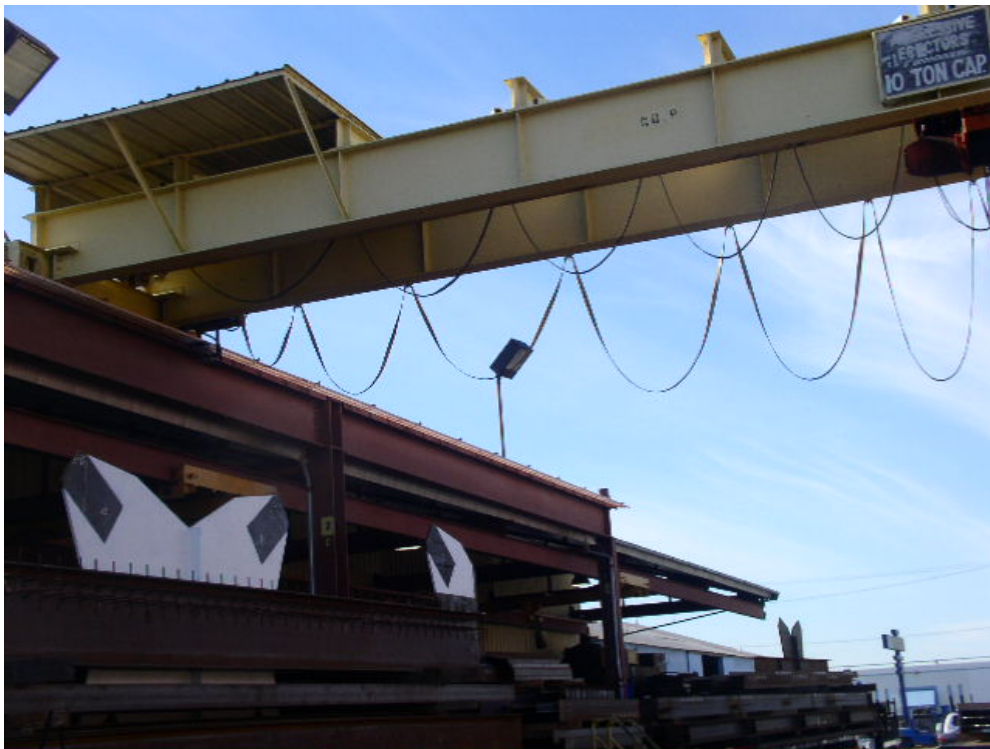
Exhibit 2. The gantry crane from a different angle.

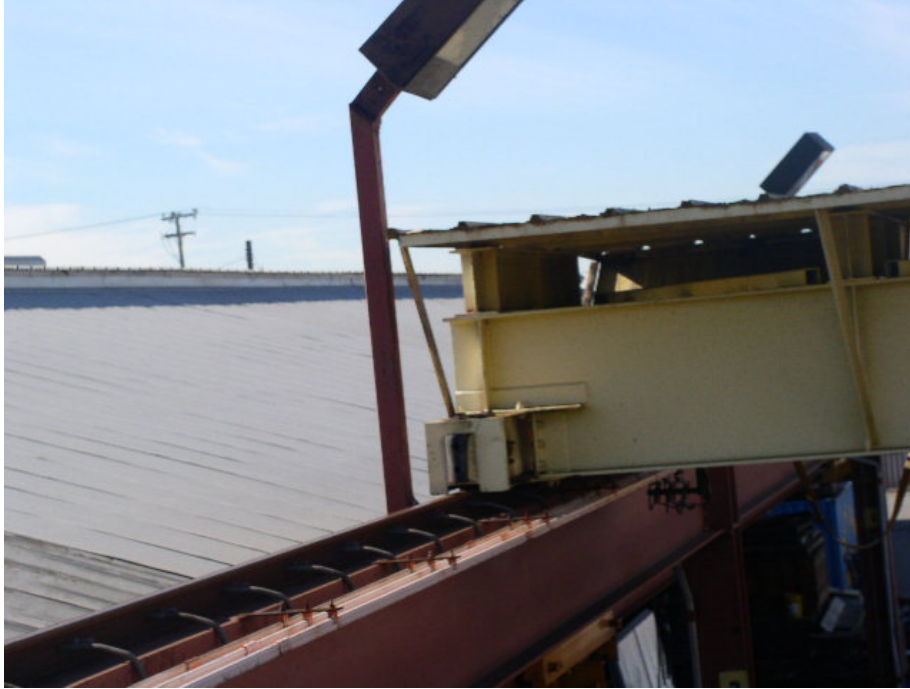
Exhibit 3. The gantry crane and the light standard against which the victim was crushed.

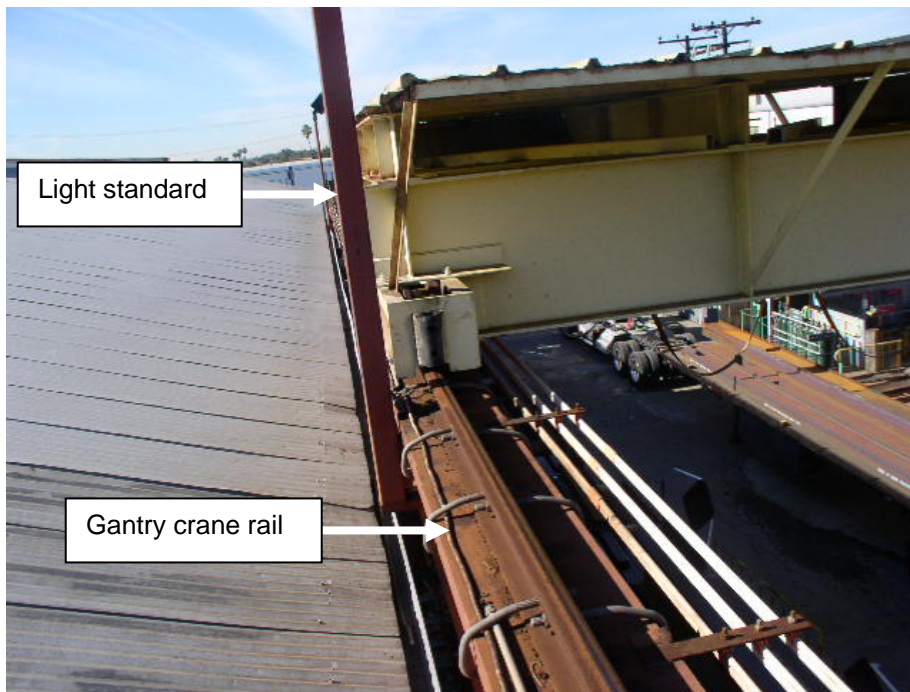
Exhibit 4. The rail the gantry crane rides on and the close proximity to the light standard.

Recommendation # 4: Companies might consider installing devices on the gantry cranes that sense obstructions on the crane's tracks.

Discussion: Devices exist that can warn operators and/or shut down machines when objects intrude into restricted areas. These devices can be found on most vehicles used today. They come in forms of warning lights or horns that alert the operator of any obstruction in their path as they are moving. Sensors are also used to shut down conveyor belts when objects or people enter assembly lines. These types of devices can be adapted for use with gantry cranes. Because the operators of gantry cranes are usually focused on the load they are moving more than on the rails the crane is traveling, devices of this nature might benefit future operations and prevent a future similar event.

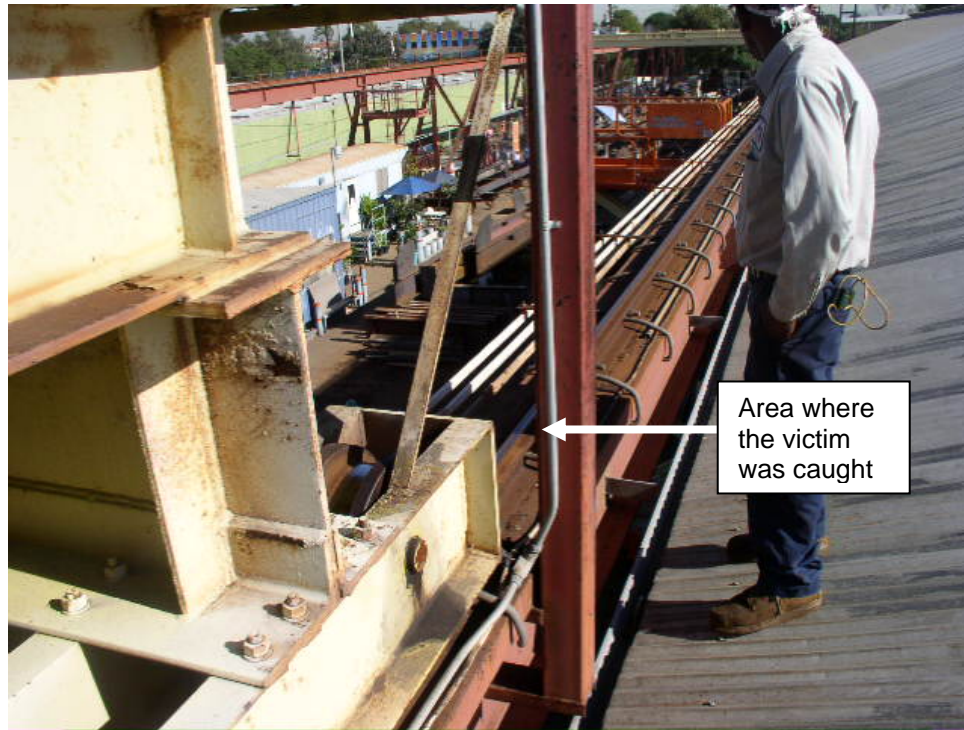
Area where
the victim
was caught

Exhibit 5. The area where the victim was caught between the light standard and the gantry crane.

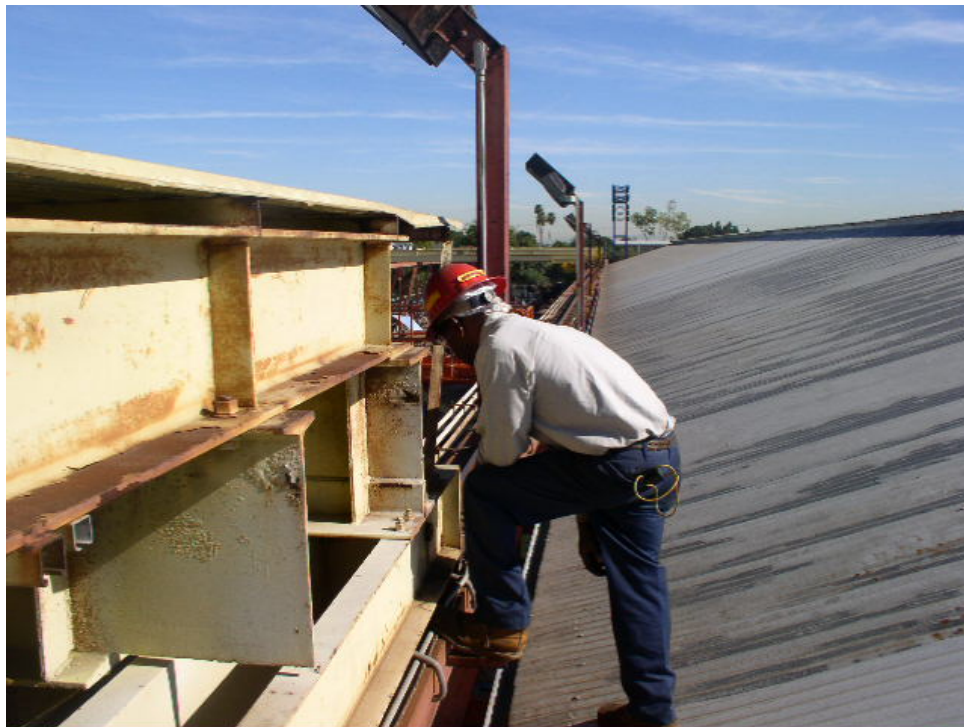
Exhibit 6. The approximate position of the victim just prior to the gantry crane making contact and pinning him against the light standard.
