**SUBJECT:** A forklift operator was killed when his forklift was struck from behind by a motor vehicle.

## **SUMMARY**

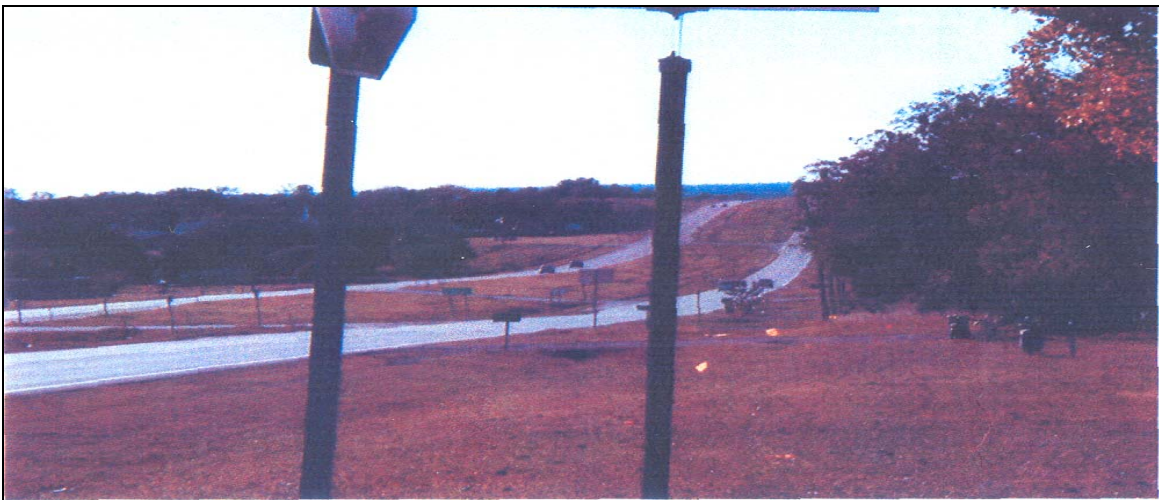
Figure 1. Highway where incident occurred

Incident Scene: The incident occurred on a straight, downgrade section of four-lane divided state highway (Figure 1). The posted speed limit was 65 miles per hour. Road conditions were dry asphalt. The incident occurred just before 4:00 p.m.

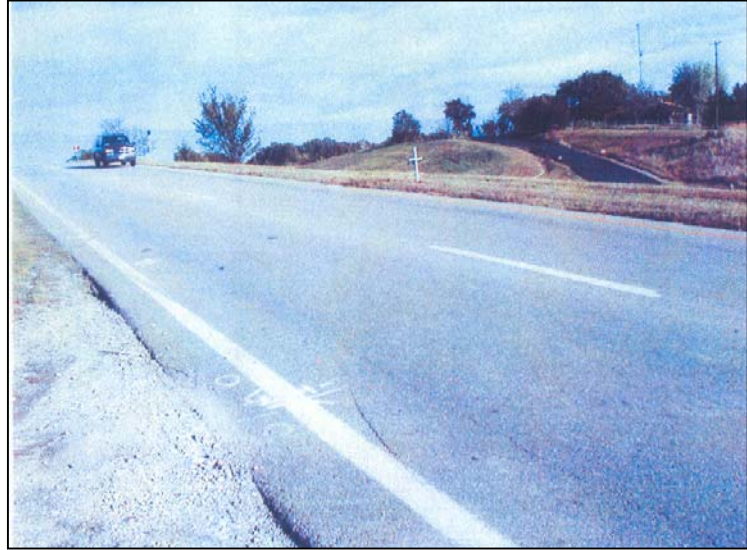
model with a maximum speed of 10 to 15 miles per hour, had only one flashing light on its top; there was not a slow-moving vehicle emblem or any other warning signs on it.

While the owner was gone, the decedent finished the job and decided to start driving back on the highway. After traveling only a short distance to the west, he needed to U-turn at an intersection to return to the east and head back into town. The decedent, traveling downhill, moved into the inside lane in preparation of where the highway widened with a left turn only lane. He was almost to the point where he could move into the turn lane and turn around the center median when a two-door motor vehicle crested the hill at 65 miles per hour. Without sufficient time to react to the slow-moving vehicle, the driver struck the back end of the forklift approximately 528 feet and 5½ seconds from the top of the hill and traveling 60 miles per hour. The driver tried to swerve right just before the collision. The motor vehicle went end-over-end twice and came to rest 130 feet west of the point of impact. The driver was pinned between the dashboard and the driver's seat for approximately 80 minutes before being extricated and airlifted to the hospital. The forklift overturned on its side 43 feet west of the point of impact. The decedent, who was not wearing a seat belt, was thrown from the operator's compartment and pinned by the forklift, which rolled on top of him.

Figure 2. Incident scene

**Recommendation #1: Employers should consider using a trailer or other means for transporting mobile heavy equipment, such as forklifts, between worksites.**

Discussion: In instances where it becomes necessary to move mobile heavy equipment between worksites, employers should consider using a trailer or other means of transport, rather than driving the machinery itself. This consideration should be made particularly when the machinery is slow-moving and cannot meet minimum speed requirements or is not equipped with proper lights and turn signals.

**Recommendation #2: Employers should ensure that forklifts and other powered industrial trucks are not driven off work premises and particularly not on public highways.**

Discussion: Forklifts and other powered industrial trucks should be operated within the confines of the work environment and should not be driven on public highways. Employers should discuss with employees the laws involving the use of specialized machinery on a roadway. In Oklahoma, specialized industrial equipment is not included in the exemptions made for farm equipment use on roadways. In this incident, the fact that the forklift's maximum speed was 10 to 15 miles per hour, that the planned trip route included obstructed views caused by hills, and that the forklift was not permitted or equipped with the proper visibility devices made operation of this type of equipment unsafe and unlawful on this public highway.

OSHA requires any vehicle, which by design moves slowly (i.e., 25 miles per hour or less) on public roads, to display the slow-moving vehicle emblem on the center rear of the vehicle. The emblem consists of a fluorescent yellow-orange triangle with a dark red border. The yellow-orange fluorescent triangle is a highly visible color for daylight exposure. The reflective border defines the shape of the fluorescent color in daylight and creates a hollow red triangle in the path of motor vehicle headlights at night. This emblem is required in addition to any lighting devices or other equipment required by law. Local and state statutes may also require particular registration and permitting of eligible specialized machinery to be operated on a public roadway (e.g., Oklahoma State Title 47, Sections 427 and 1129). Applicable permits and registration should be in possession of the operator and carried with the equipment at all times. Employers should also consider using other highly visible vehicles as escorts when driving lawful slow-moving machinery on roadways and should ensure that minimum speed requirements can be met.

**Recommendation #3: Employers should ensure that employees wear a seat belt while operating forklifts or other powered industrial trucks.**
