**FROM: Iowa FACE Program**

**Case No. 04IA06**

**SUBJECT: Farmer Dies When Entangled in Old Flight Elevator PTO Shaft**

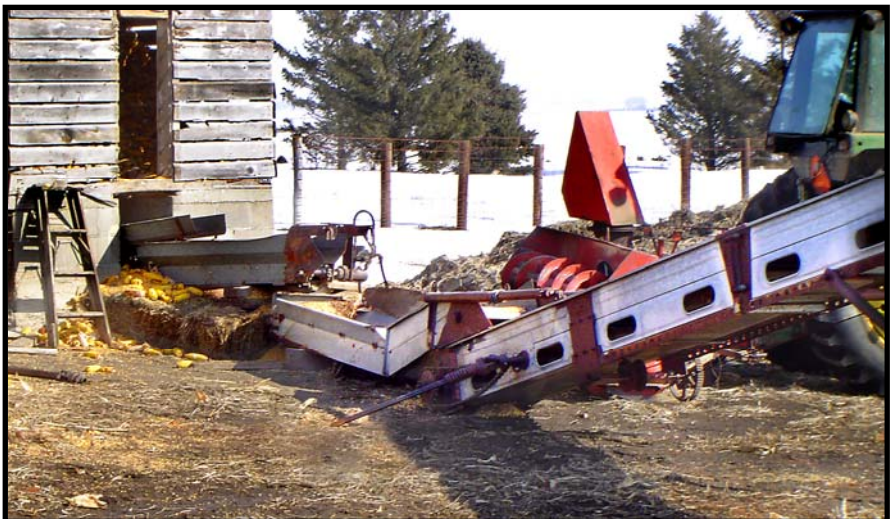
Photo 1 – Overview photograph of the area, showing the east end of the corn crib, the chain drag conveyor, and the flight elevator with half of the PTO driveshaft attached.

men were cleaning out the tunnel on that side while the victim was unloading corn from the other end of the crib (Photo 1). They heard the tractor engine slow down momentarily and went to investigate. The victim was found wrapped around the unshielded PTO shaft powering the elevator, with obvious severe injuries to one arm, leg, and his chest. After rescue crews arrived, the victim was transferred to a local hospital, where he was pronounced dead.

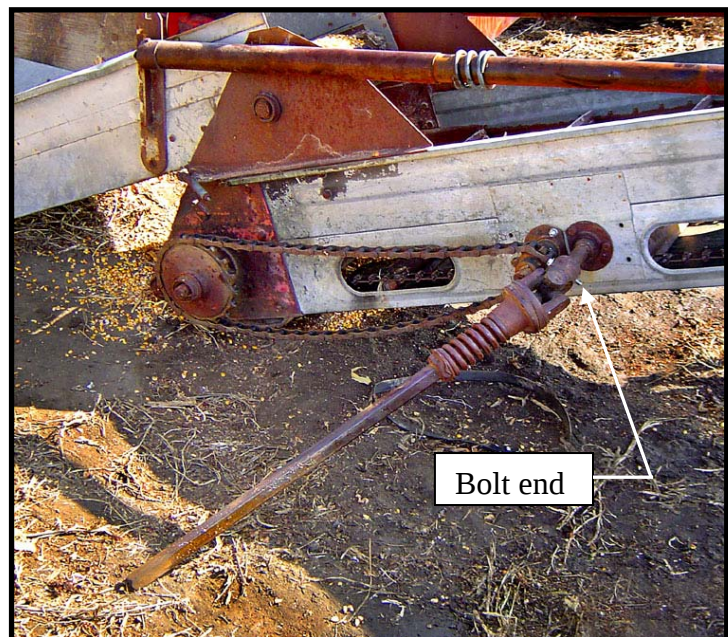
Photo 2 – Close-up of the implement end of the PTO driveline shaft showing the spring clutch and the protruding bolt.

The tractor used to power the elevator was a utility model purchased new in 1981. It was a diesel model 63 PTO horsepower, but the throttle was set to idle while it was operating the flight elevator. This old elevator had its original PTO (power take-off) driveline in place, which had a tubular design, was unshielded, and included a spring-loaded clutch at the implement end of the shaft (Photo 2). A bolt with its protruding, threaded end was used to secure the driveline yoke to the input shaft of the elevator. When the driveline is rotating, this bolt could easily snag someone's coat or jacket if they got too close while, for example, inspecting the movement of corn up the flights of the elevator.

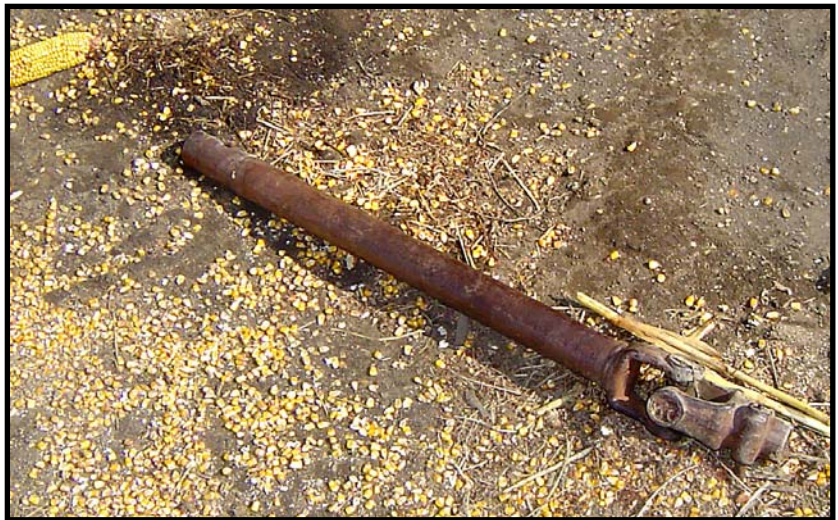
Photo 3 – Tractor end of PTO driveline, with no evidence of shielding.

**Discussion:** The PTO driveline for this elevator was not shielded, representing a threat to life and limb whenever anyone came near it while it was in use on this farm. Regardless of the speed of rotation or apparent hazard risk, exposed rotating machine components are dangerous. They must be identified and covered to protect workers from serious injury. It takes only a moment for a worker to be caught and killed by a rotating PTO driveline shaft which, at 540 RPM (revolutions per minute), revolves 9 times each second. Too many farm workers have been injured or killed in this kind of PTO entanglement incident. Rotating drivelines perform in demanding use situations and, over time, can develop sharp protrusions or spurs, and may be modified in ways which can snag a pant leg, sweat shirt, or sleeve of a jacket.

**Recommendation #1** *All PTO drivelines and other open drivetrain components on farms should be completely shielded to prevent accidental contact by workers or helpers.*

A total shielding system for a PTO driveline includes a tractor master shield, the PTO driveline shield(s) and an implement shield. These shields must be kept in place and properly maintained to guard against entangling a worker. Additional shielding may also be necessary to protect workers from exposure to other rotating or moving machinery components such as drive belts, pulleys, flywheels, and protruding ends of shafts that rotate.
