# Fatality Investigation Report

OR 2005-05-1

## Operator crushed while repairing running machine

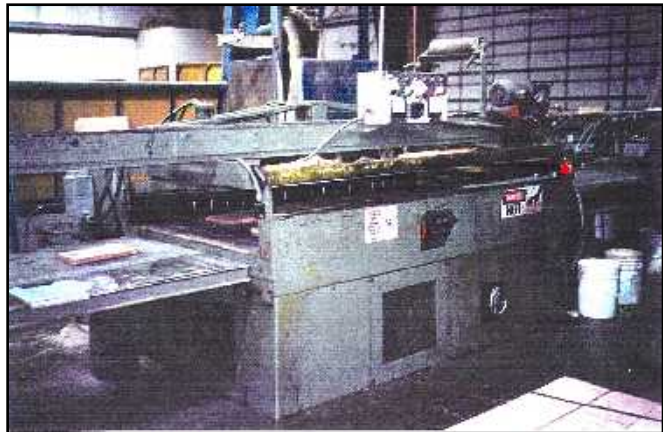
The glue press operates on an automatic cycle, with a conveyor running beneath a glue roller and into the press.

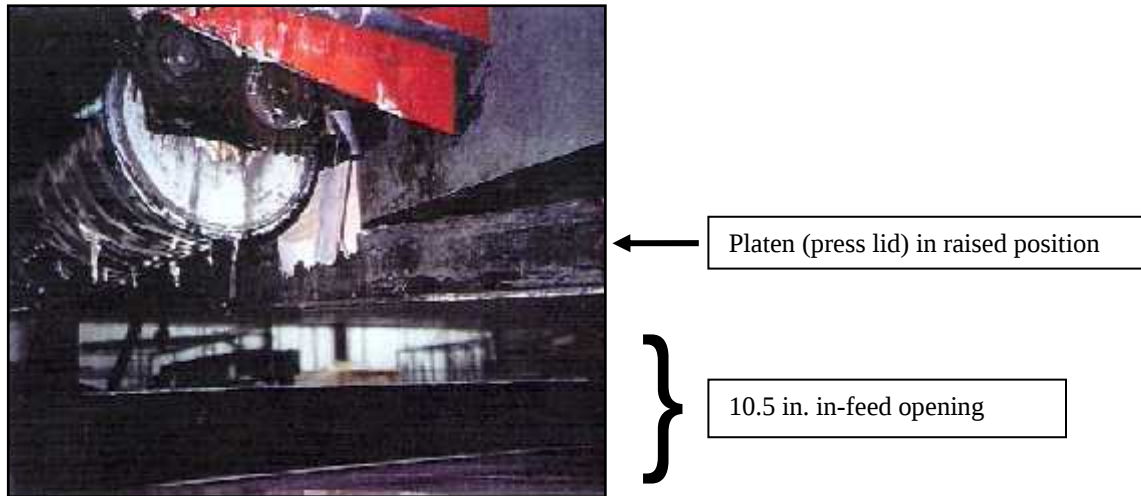
At the time of the incident, the glue-press conveyor chain and sprocket system, press opening, glue feed rolls, and loading-table mechanisms were unguarded. A makeshift repair to correct a

glue-dripping problem had been made by the operator 2 weeks earlier, using a piece of duct tape to hold a piece of wood veneer to direct dripping glue from the roller into the glue tray. The glue tray in front of the press in-feed had been removed to correct the glue-dripping problem.

A close-up view of the glue press in-feed opening shows the platen above, and the glue roller in front with a piece of duct tape attached.

Employers need to assess all machinery, especially older machinery, and install guards to prevent access to all moving, shear, and pinch points. In this incident, the glue press was an older machine, manufactured without guards, but a retrofit guard is available through the press manufacturer. In cases where specific retrofit guards are not available, private suppliers can provide a wide variety of guards to bring older machinery into compliance with safety standards.
