May 3, 2006

Nebraska FACE Investigation NE 2006-02

Hispanic Asbestos Remover Falls to Death from Ladder

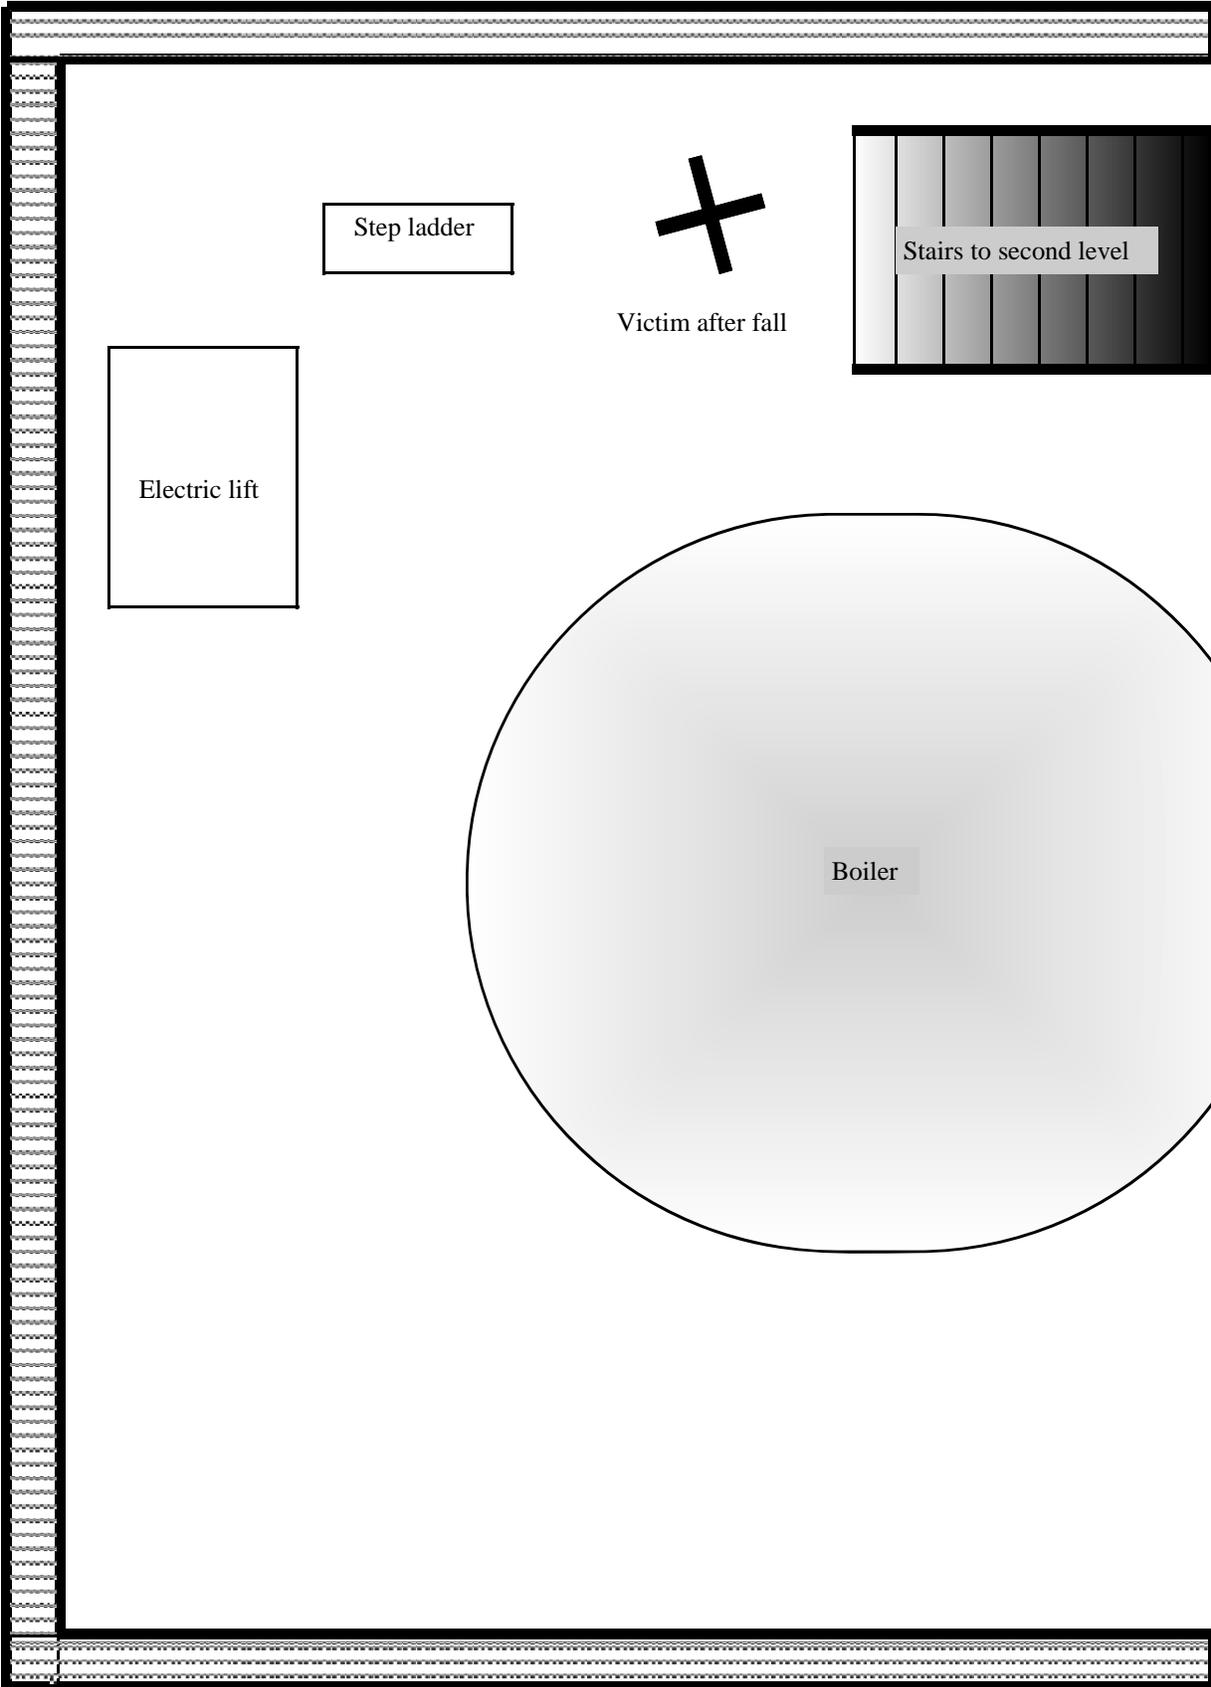
Attachment 1. Site diagram (not to scale)

As he did so, the pipe and board pulled away from the ceiling, causing them both to fall towards the ground. The board and sheeting remained attached to the ceiling by another board that was previously attached to the ceiling. The metal pipe fell out of the lift, falling approximately 14 feet, striking a 45 degree slanted roof that was directly underneath. The pipe then flew approximately 3 feet sideways, striking either the victim or the ladder he was standing on.

The victim fell 8 feet from the ladder to the concrete floor below. Worker #3 had his back to the victim. He stated he heard a noise, possibly from the pipe hitting the slanted roof. When he turned around he saw the victim lying on the concrete floor next to the ladder. He yelled at worker #2 in the lift, telling him the pipe had hit the victim and he was hurt. Worker #2 immediately lowered the lift and tried to render assistance to the victim. Worker #4 was not in direct line-of-sight of the accident and did not witness the fall.

Step ladder

Victim after fall

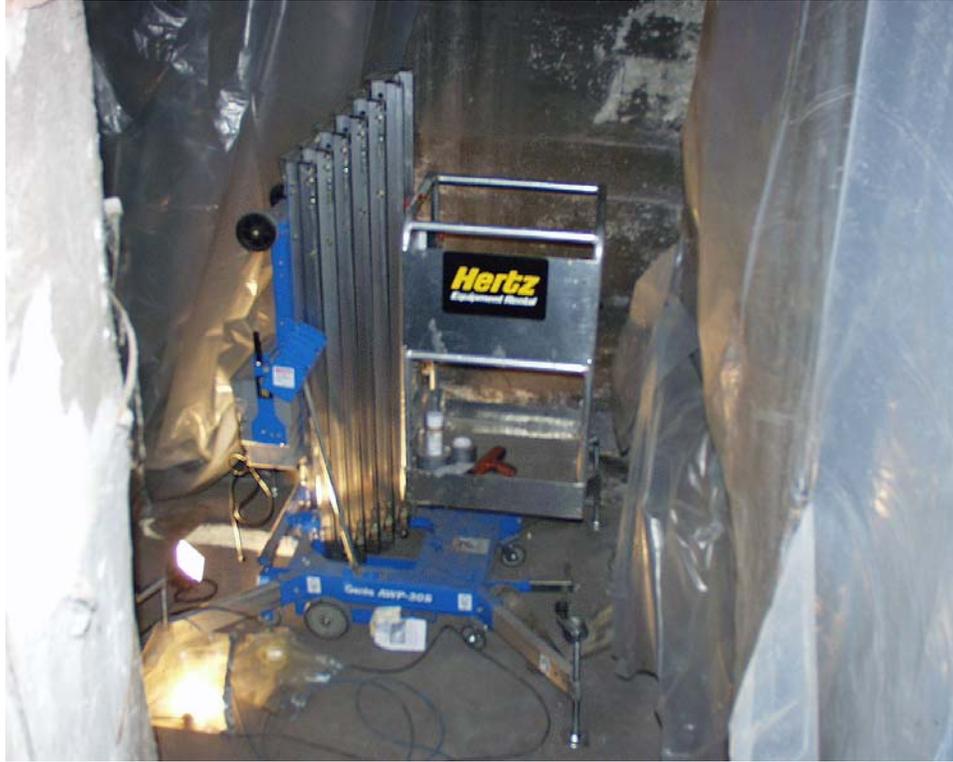
The site supervisor (worker #2) was attaching 6 mill plastic sheeting to 1"x 2"x 6' long wooden boards also on the lower level. Once attached, he climbed into the Genie 30 foot single-person electric platform lift. While holding onto the plastic sheeting, he raised the lift to the ceiling, approximately 29 foot overhead. While holding the board against the ceiling with one hand worker #2 used a Remington powder-actuated ram set gun with the other hand to shoot a nail through the board into the concrete ceiling. Realizing the sheeting was too heavy to hold with one hand, he lowered the lift far enough to have worker #3 hand him a piece of metal pipe that was lying nearby. The pipe was 5' 8" long, 3" in diameter and weighed between 12-15 pounds. He raised the lift back towards the ceiling, and then braced the pipe between the lift platform floor and the overhead board.

While holding the pipe with his left hand, he used the ram set gun to shoot the second nail into the board. Although the nail remained sticking out of the board by ¼ inch, he thought the board was secure and removed his left hand from the pipe.

Genie 30' Electric Lift

Discussion: Although not a regulatory requirement, every effort should be made to secure materials and/or equipment being utilized above other employees. The use of a simple lanyard equipped with snap hooks on both ends to attach to a tool and to the lift railing could prevent them from striking an employee below if dropped. If some form of “brace” is to be used again to support the overhead boards and sheeting, employers should consider drilling a hole through the pipe end and securing it to the basket, or using a tool that has less likelihood of rolling if loose. The toe board around the floor pan of the electric lift prevents materials that are placed there from falling off when not being used.

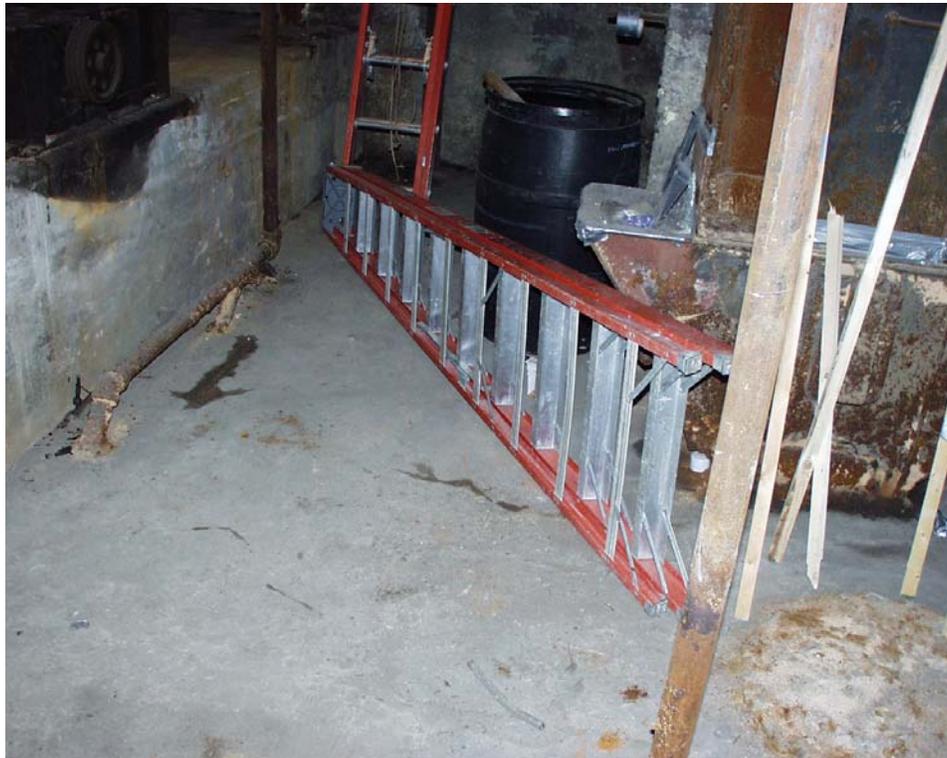
The victim was on the lower level, standing on a ten foot step ladder, stringing and installing temporary construction (drop) lighting with the assistance of worker #3. Worker #4 was on the second level changing filters on the HEPA vacuum system.

10' Step ladder involved in accident.

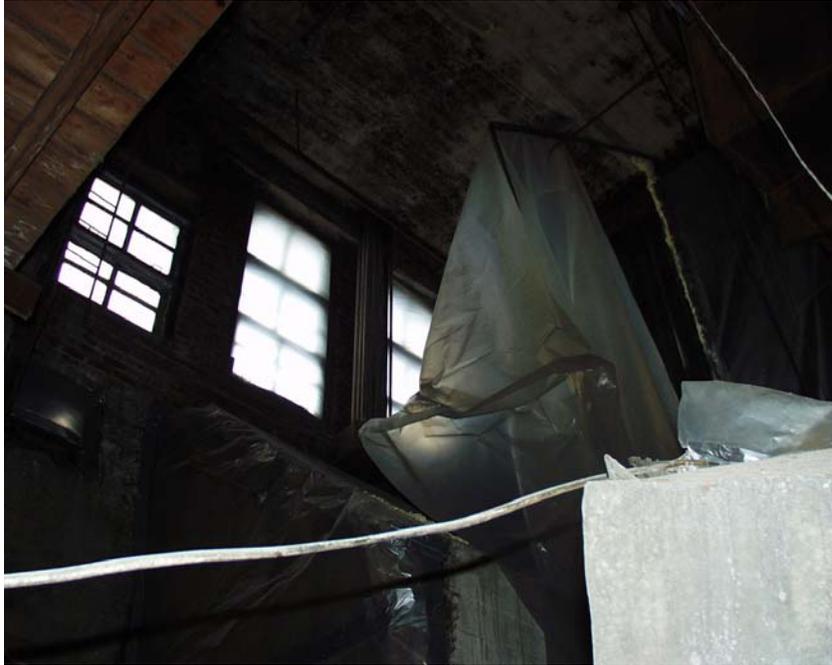
Plastic sheeting hanging from ceiling after accident.

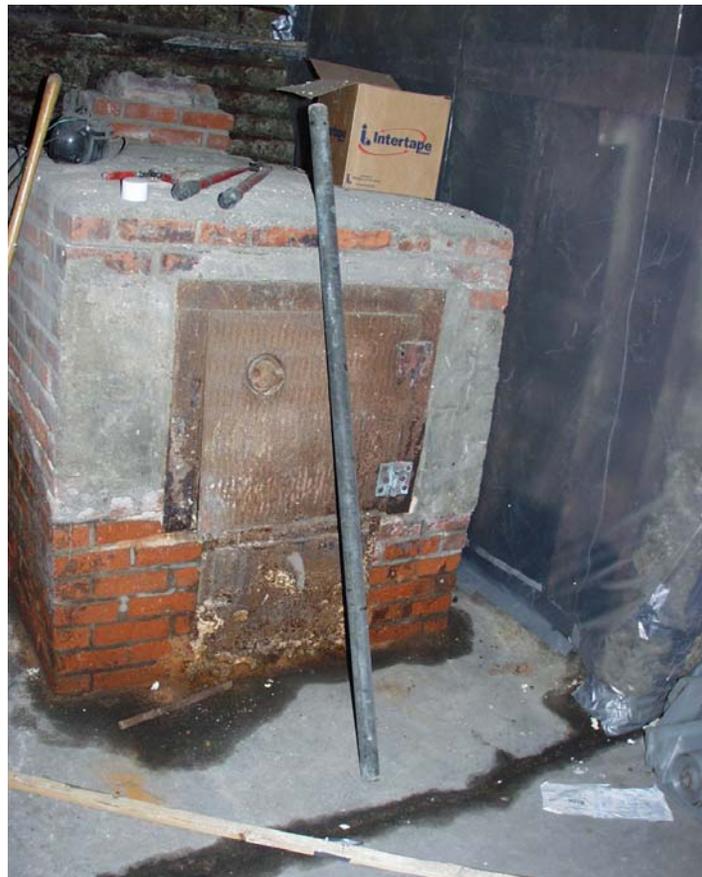
Note: The coroner stated that it could not be conclusively determined if the metal pipe used by worker #2 struck the victim, or if the victim struck some metal pipe hand rails when he fell.

Metal pipe that struck either the victim or ladder he was standing on.
