Two Vietnamese Floor Sanders Die When Wood Floor Finish Product Ignites - Massachusetts

Investigation: # 04-MA-032

Release Date: January 31, 2006

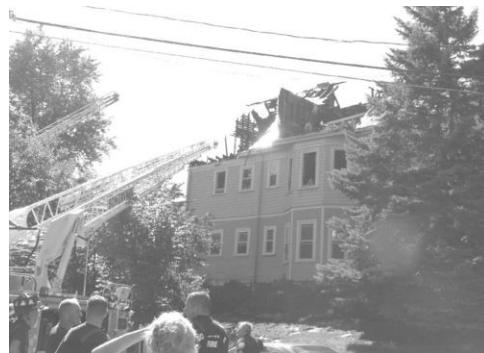
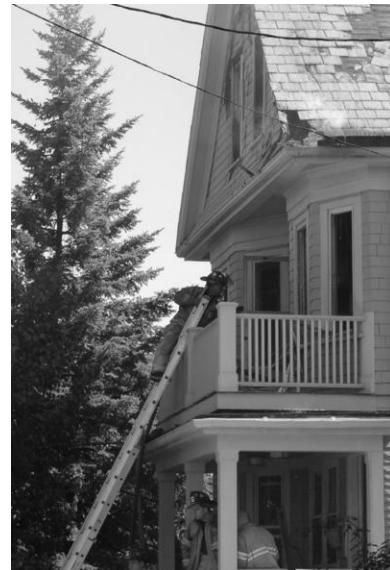
The company was hired to refinish the wood floor in a third floor unit and two sets of wood stairs leading up to the third floor in a multifamily house (Figure 1). One stairway connected the first floor to the second floor and the other stairway connected the second floor to the third floor. At the time of the incident, the third floor unit was vacant and the bottom two units were occupied. The owners of the multifamily house lived in the first unit, which comprised the entire first floor and a section of the second floor. The remaining area on the second floor comprised the second unit and the entire third floor was one unit. The owners of the house were home at the time of the incident and the second unit occupants were not home.

When the vapors from the lacquer sealer ignited it caused an explosion and created a fireball that traveled through the two stairways down to the first floor. The explosion also resulted in a fire that engulfed the entire third floor of the multifamily house. The two surviving floor sanders had been the furthest from the explosion and were the first two workers to exit the burning house. The floor sander who was located in the stairway that led to the third floor unit (victim #2) exited the house with his clothes on fire shortly after the two surviving workers exited the house. The fourth floor sander (victim #1), who was working inside the third floor unit, did not exit the burning house.

Victim #1 was found by fire fighters inside the first floor stairway and was pronounced dead at the scene. The three floor sanders who exited the house were all taken to a local hospital. At the hospital, a second floor sander (victim #2) died of his severe burns the following day. One of the two surviving floor sanders was released from the hospital a few days later, and the other remained in critical condition in the hospital for an extended period of time with severe burns. A short time after the incident, the house was torn down due to extensive fire damage.

Figure 1 – Two photos of the house involved in the incident
