Two Window Washers Fall 90 Feet When Their Horizontal Static Line Failed - Massachusetts

Investigation: # 03-MA-010-01

Release Date: February 16, 2006

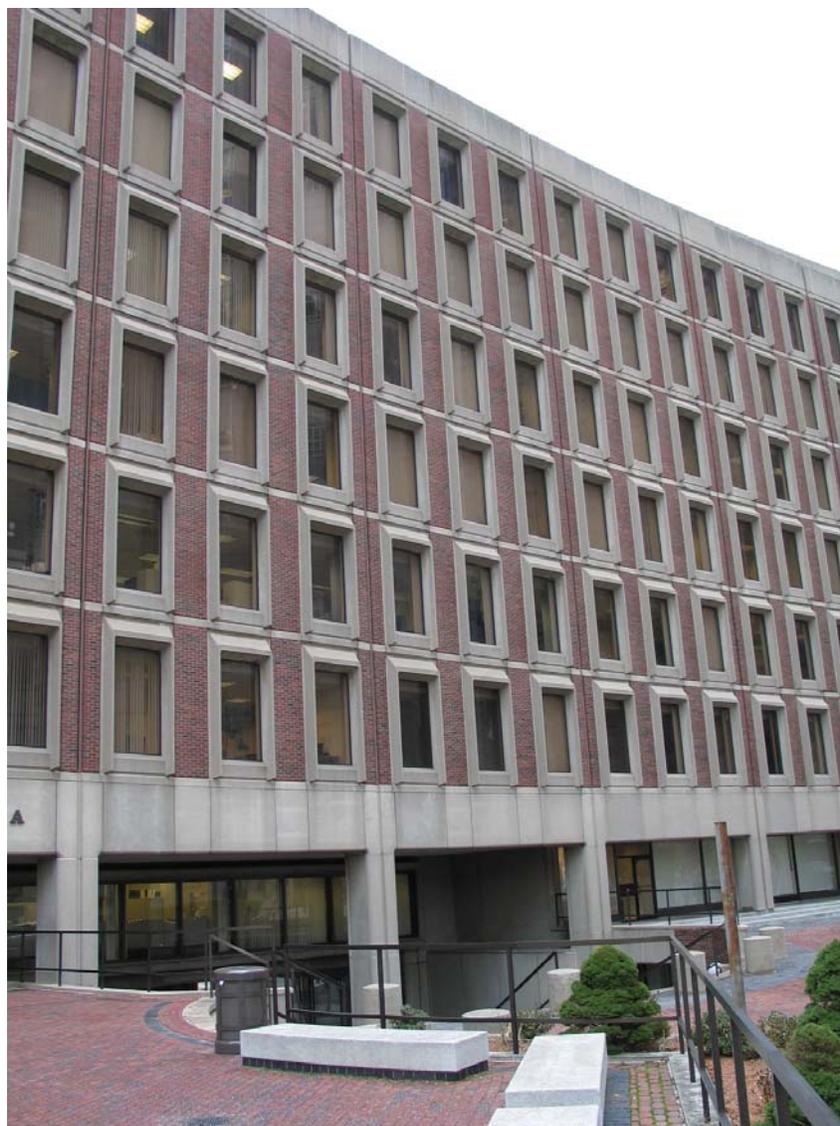
Figure 1 – Building where the incident occurred

At approximately 6:30 a.m. the work crew arrived at the work site (Figure 1). Once on site, the victims set up the horizontal wire rope static line, which would be used as their anchorage point for their descents. There was neither a competent person nor a supervisor onsite to ensure that the horizontal wire rope static line, descent control devices, and personal fall arrest systems were properly setup. The area below the windows to be cleaned was a cement and brick courtyard.

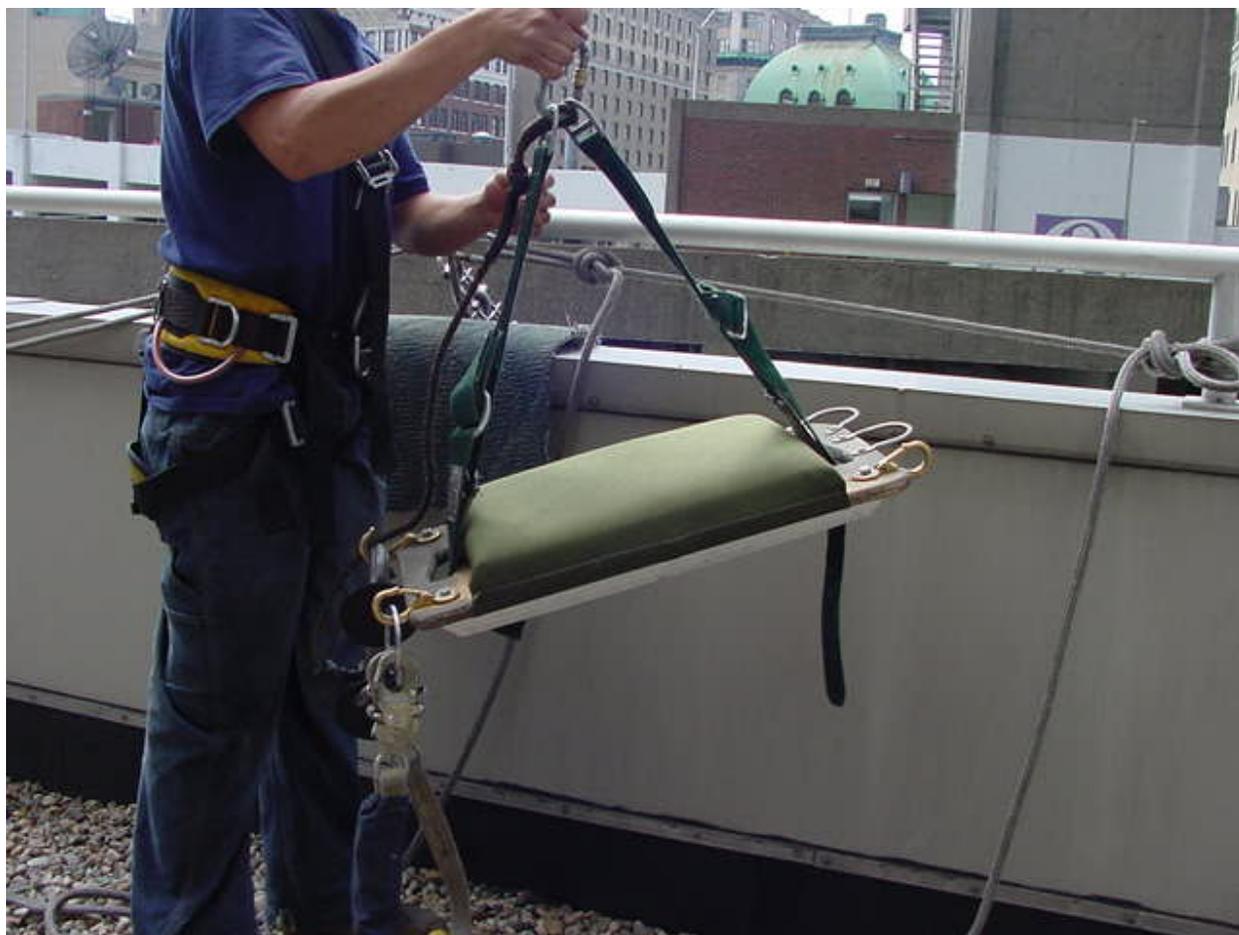
Figure 2 – Similar rope descent system with a seat board

On the day of the incident, each victim's equipment consisted of a body harness, lanyard, descent control device, and seat boards suspended from a rooftop anchor point (Figures 2 and 3). The rooftop anchor point was a single 5/16-inch 365-foot galvanized steel wire rope. The wire rope was stretched horizontally through a series of carabiner D-rings and then attached to two of the building's existing tiebacks. The existing tiebacks/anchor points were originally designed for a different type of window washing operation, a scaffold system, which was no longer used. The victims had fabricated turn back eyes at each end of the wire rope. The turn back eyes consisted of three 5/16-inch wire rope U-bolts at each end. The turn back eyes had been formed without the use of thimbles and the U-bolts were tightened without the use of a torque wrench (Figure 4). The two turn back eyes of the horizontal static line were attached to the two existing stationary tiebacks. Most of the hardware used by the company for the horizontal static line, descent control devices, and the personal fall arrest systems was purchased from local hardware stores. The U-bolts used by the victims were made out of cast iron and not forged steel as required by OSHA.

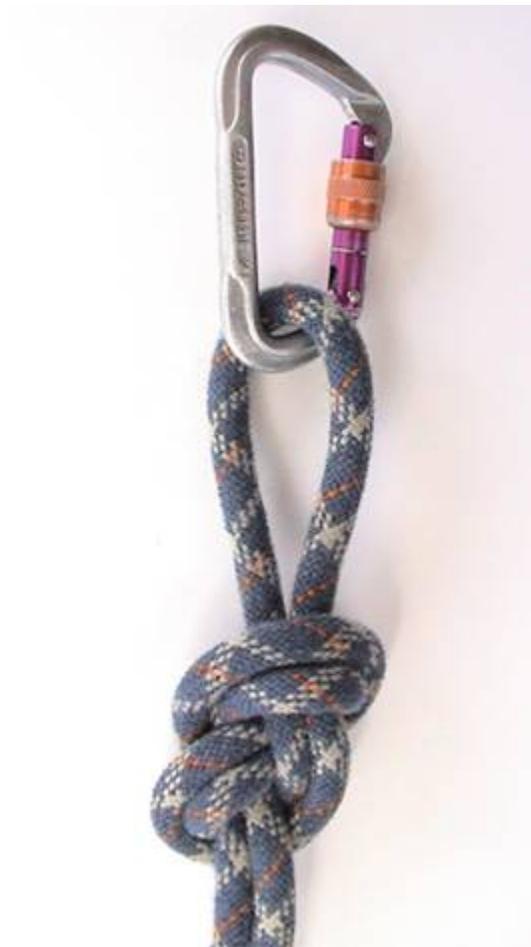
Figure 5 – Figure 8-knot with a carabiner attached to an “anchor loop”

The horizontal static line setup created a "single" rooftop anchor point. Both victims' had been using one nylon rope each with a figure 8-knot tied in the middle of each rope to comprise "two ropes". Each rope had an "anchor loop" located at the figure 8-knot. A carabiner was attached to each anchor loop on each rope and then the carabiners were attached to the same single horizontal wire rope static line (Figure 5). One side of each nylon rope was attached to their descent control system and the other side of the each nylon rope was attached to their personal fall arrest system. During the decent each end of the two nylon ropes hung over the roof's edge. A carpet strip was placed in between the nylon ropes and roof's edge to minimize wear to the rope.

Discussion: In this case, each victim had been using one nylon rope with a figure 8-knot tied in the middle to comprise "two ropes". One side of each nylon rope was attached to their descent control system and the other side of the each nylon rope was attached to their personal fall arrest system. Each nylon rope was attached to the same single horizontal static line. Therefore, when one of the two horizontal static line anchor points failed, both victim's ropes were no longer attached to a secure anchor point causing each victims' decent control system and personal fall protection system (one rope for each victim) to fail, resulting in fall to the ground below.

During window washing tasks where descent control devices are used, employers should ensure that workers are protected from falls by a fall arrest system that has an anchor point completely independent of the descent control device. The fall arrest system should be utilized in such a manner that failure of any component of the descent control device or its support system (seat board, harness, support line, or anchorage) will not affect the ability of the fall arrest system to operate properly. In addition, the employer should ensure that tieback points being used are adequate for the intended load.
