Floor Sander Dies When Wood Floor Refinish Product Ignites - Massachusetts

Investigation: # 05-MA-044

Release Date: March 31, 2006

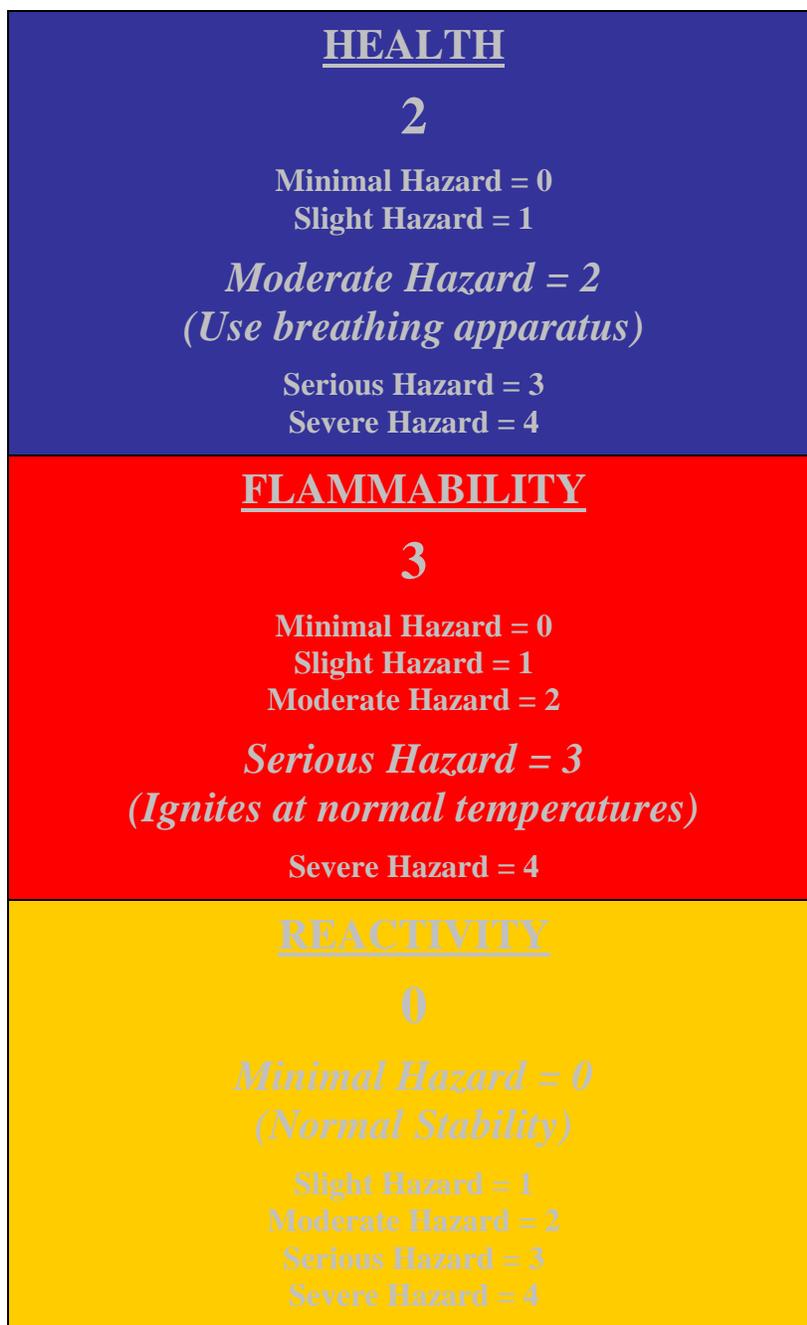
- Hazardous Material Identification System (HMIS) ratings of: health (2), flammability (3), and instability (0). HMIS is a numerical rating system ranging from zero to four: minimal hazard (0), slight hazard (1), moderate hazard (2), serious hazard (3), and severe hazard (4) (Figure 1).
- Vapor density rating greater than one (this lacquer sealer is heavier than air).

Figure 1 – Example of a Hazardous Material Identification System (HMIS) label with the HMIS ratings for the lacquer sealer used in this incident.
