SUBJECT: A car wash attendant dies when pulled into a side arm rotating brush in a car wash

SUMMARY
California FACE Report #05CA004

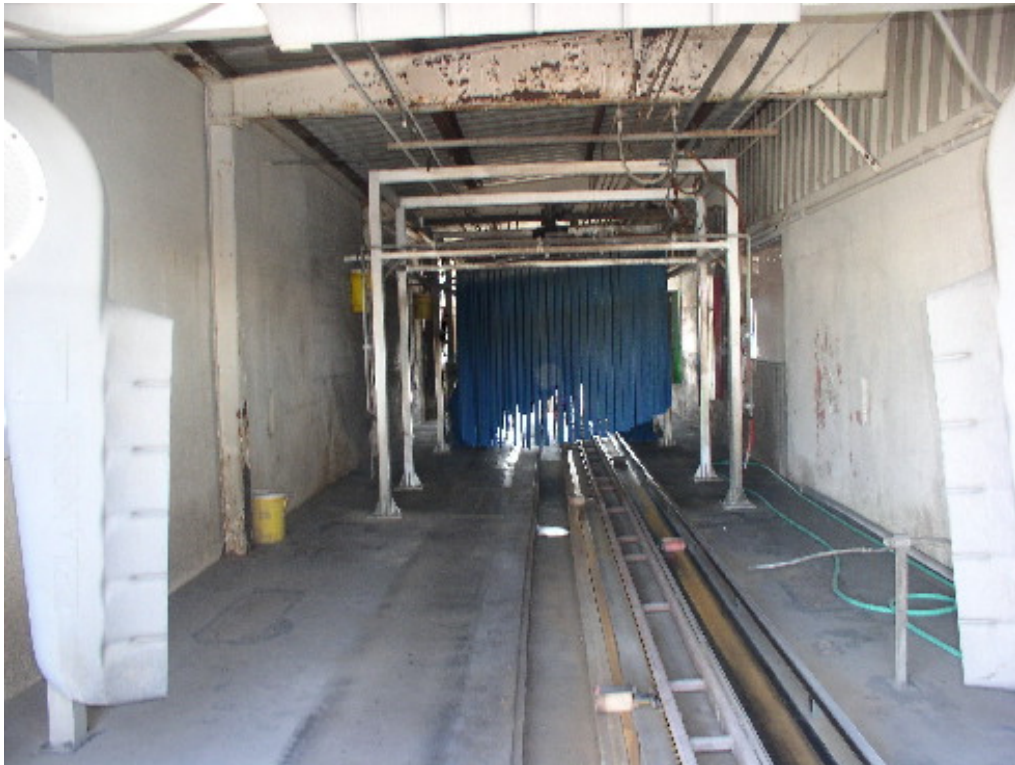
Exhibit 1 The car wash tunnel looking from the tunnel exit.

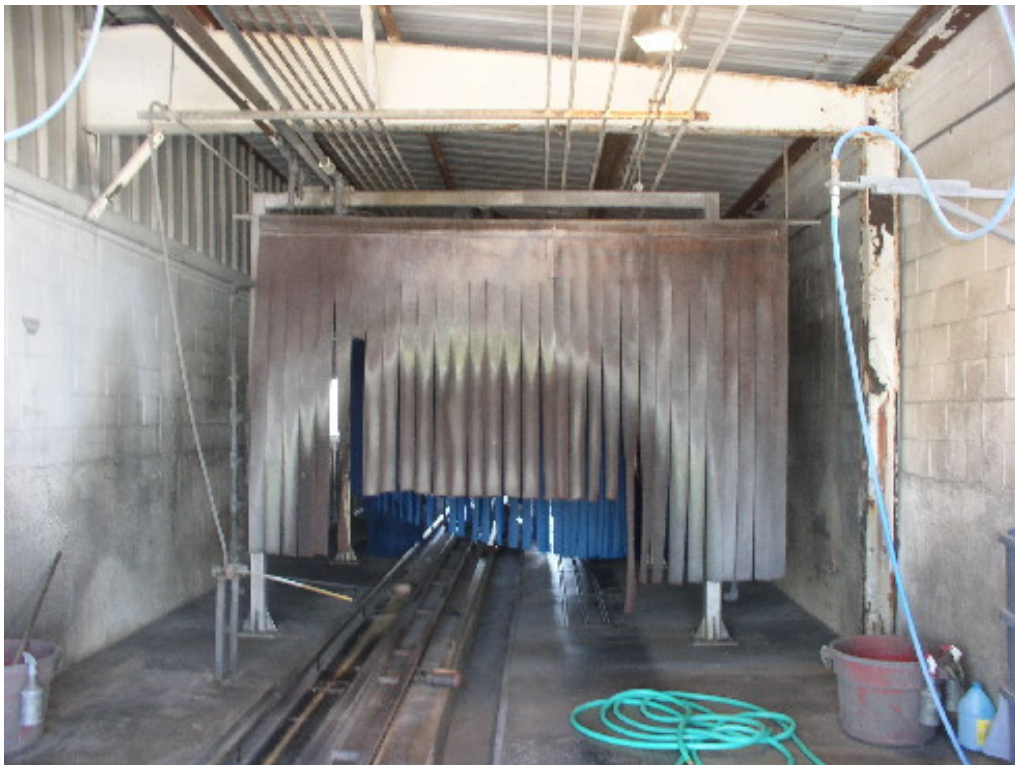
Exhibit 2 The car wash tunnel looking from the tunnel entrance.

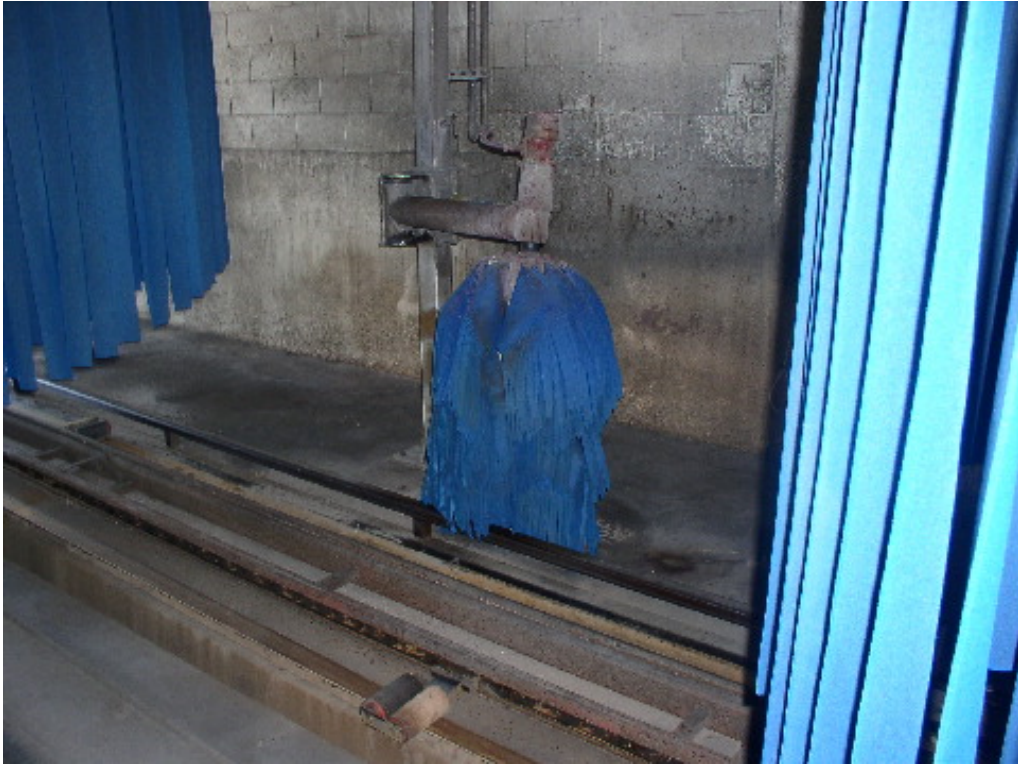
Exhibit 3 The side arm brush involved in the incident.

Recommendation #3: Owners of older car washes should consider modifying their systems with updated safety equipment.

Discussion: The car wash system involved in this incident was approximately 30 years old. Since then, there have been significant improvements in the safety features of car washes. The system involved in this incident was hydraulically operated and was turned on and off by a single wall-mounted switch. Newer systems have safety features such as torque-limited brushes and vehicle-activated pressure plates. When owners of older car wash systems update their safety equipment, they significantly lessen the chances of an incident similar to this one from occurring.

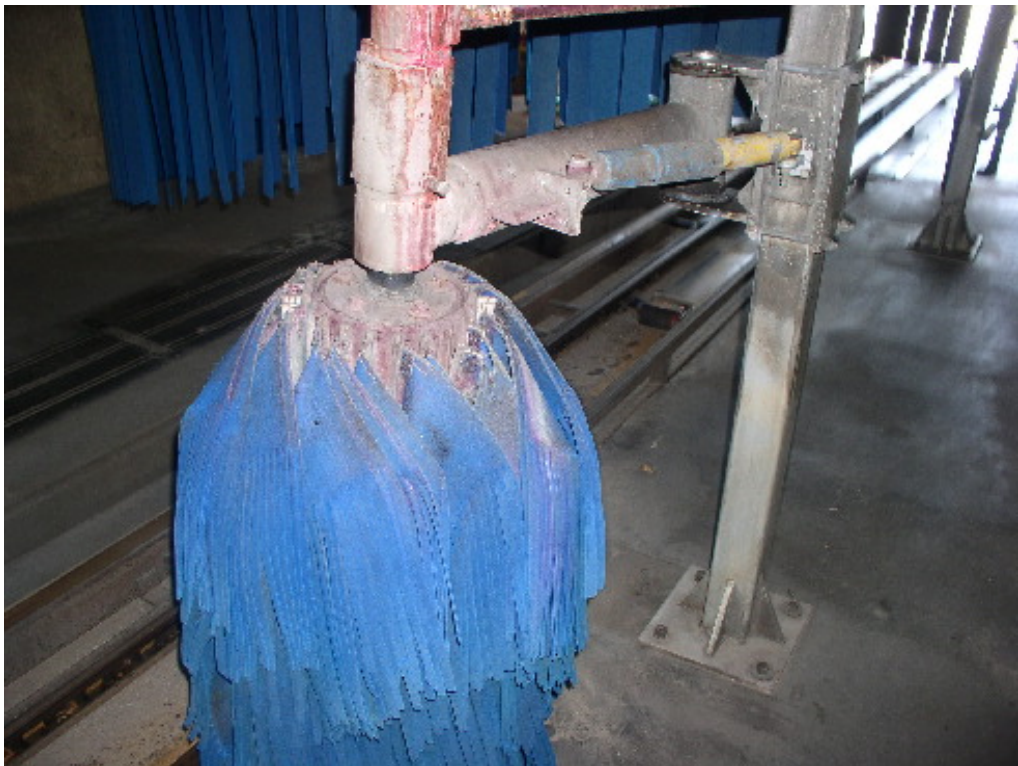
Exhibit 4 A close-up view of the side arm brush.

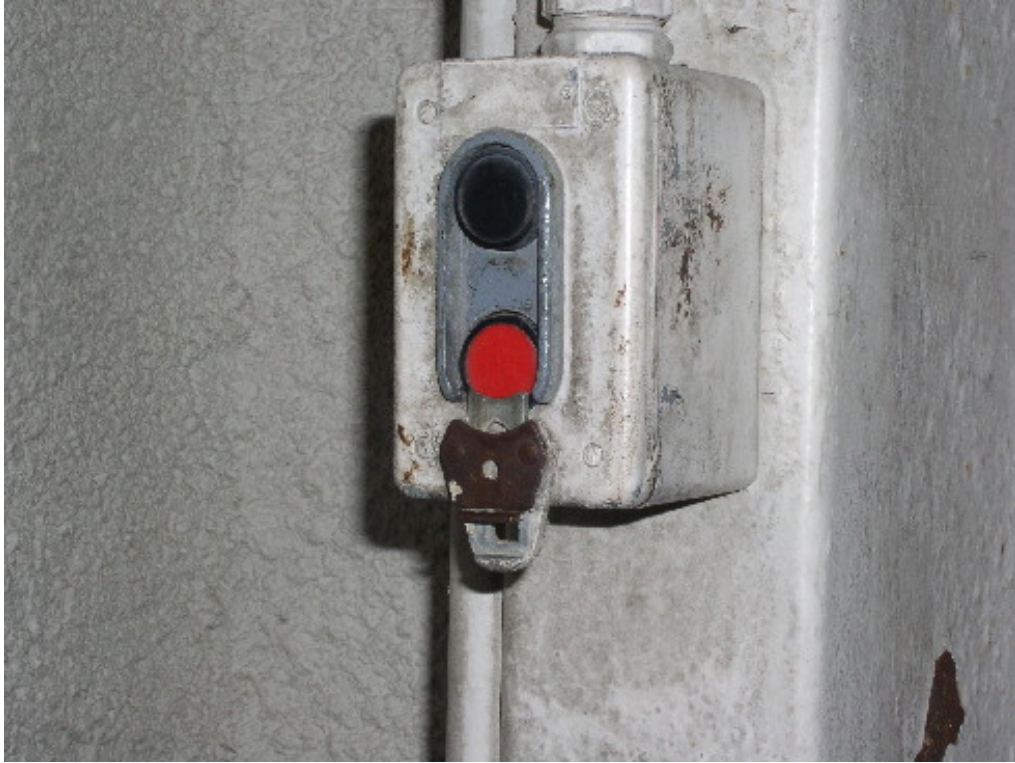
The site of the incident was a drive-through car wash. The car wash had a tunnel that cars and trucks were pulled through by a conveyor on the floor after the vehicle's interior was thoroughly vacuumed and the exterior was pretreated. The conveyor would pull the vehicle through a series of brushes that would wash the vehicle, and then a high volume water rinse was applied. The vehicle would go through a high-pressure air blower that would remove most of the water from its exterior, then be brought to the dry area where it would be towed dry and windows cleaned inside and out. The car wash equipment in the tunnel was turned on and off by a push button mounted on the wall of the entrance and the exit of the tunnel (Exhibits 5 and 6). All the equipment within the tunnel was connected to these switches.

Exhibit 5 The equipment on/off switch at the exit of the tunnel.

Recommendation #2: Develop and implement a lockout/tagout program for the car wash.

Discussion: The car wash did not have a lockout/tagout program. In this case a lockout/tagout program might have prevented the victim from being in the tunnel while the equipment was running. Lockout/tagout programs should address the following issues:

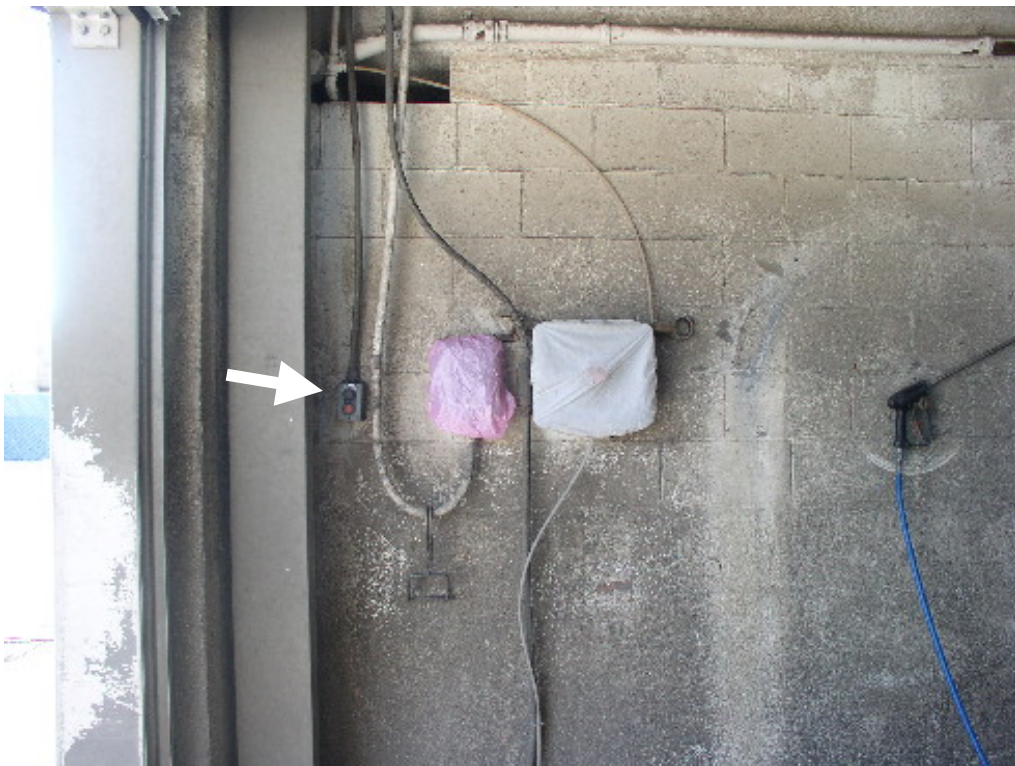
Exhibit 6 A picture of the control switches at the entrance of the car wash tunnel.
