FACE INVESTIGATION # 03WI003

SUBJECT: Laborer Dies After Being Struck by Detached Excavator Bucket

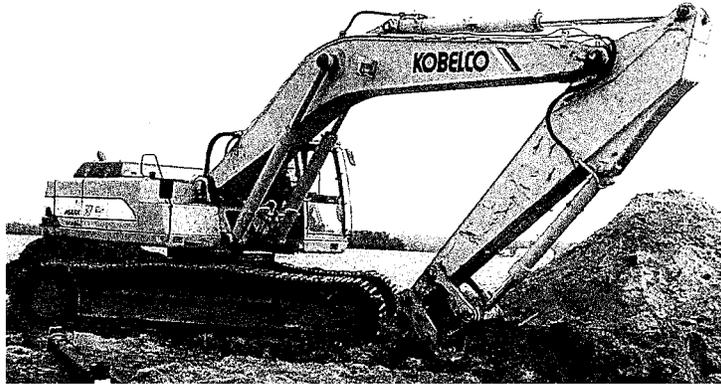
Figure 1. Photo of Excavator Involved in Incident

the depth, while the excavator operator switched buckets from a narrow bucket to a larger one. After he attached the larger bucket, the operator raised the bucket to work on an adjacent trench. The bucket suddenly disconnected from the bucket arms, fell to the edge of the trench and rolled into the hole onto the victim. The operator immediately saw the victim was injured, and called 911 from a cell phone. He used a chain to pull the bucket away from the victim with the backhoe. EMS responders and Med Flight responders arrived within several minutes. The victim was pronounced dead at the scene.

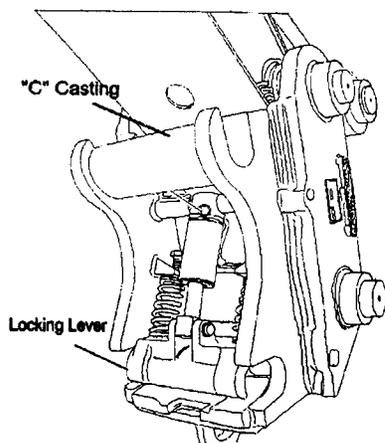
Figure 2. Diagram of coupling mechanism showing original locking lever design

A retrofit kit for the coupler that attached the buckets to the excavator arm had been sent to the employer two years before the incident, but was not installed on the excavator. The coupler manufacturer recommended installation of the free retrofit items to prevent the locking lever from opening when the bucket was used. It was the excavator owner's responsibility to modify the coupler by drilling holes to accommodate the mechanical locking pin. To change a bucket with the retrofit in place, the operator must manually insert the locking pin and two lynch pins in the coupler before and after each bucket change. The manufacturer also recommended a series of bucket maneuvers that should be performed close to the ground and away from all personnel after each bucket change, to test the connection.

Recommendation #1. : Employers should install and maintain positive locks on quick-disconnect equipment according to manufacturers' specifications and recommendations.

Discussion: A retrofit kit for the coupler that attached the buckets to the excavator arm had been sent to the employer two years before the incident, but was not installed on the excavator. The coupler manufacturer recommended installation of the free retrofit items to prevent the locking lever from opening when the bucket was used. It was the excavator owner's responsibility to modify the coupler by drilling holes to accommodate the mechanical locking pin. To change a bucket with the retrofit in place, the operator must manually insert the locking pin and two lynch pins in the coupler before and after each bucket change. This would have prevented the bucket from detaching from the arm.
